Flood Investigation Report

South Cave Flooding on 20 July 2014

December 2014

EAST RIDING
OF YORKSHIRE COUNCIL

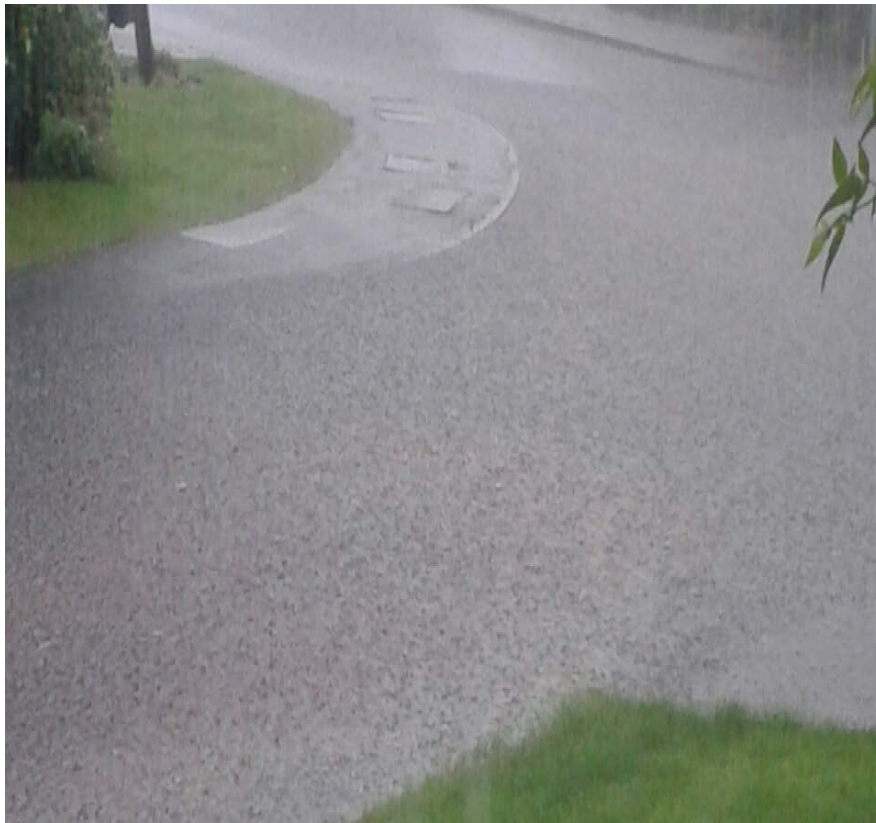
Photo 1: Highfield off Beverley Road, showing the intensity of the rainfall

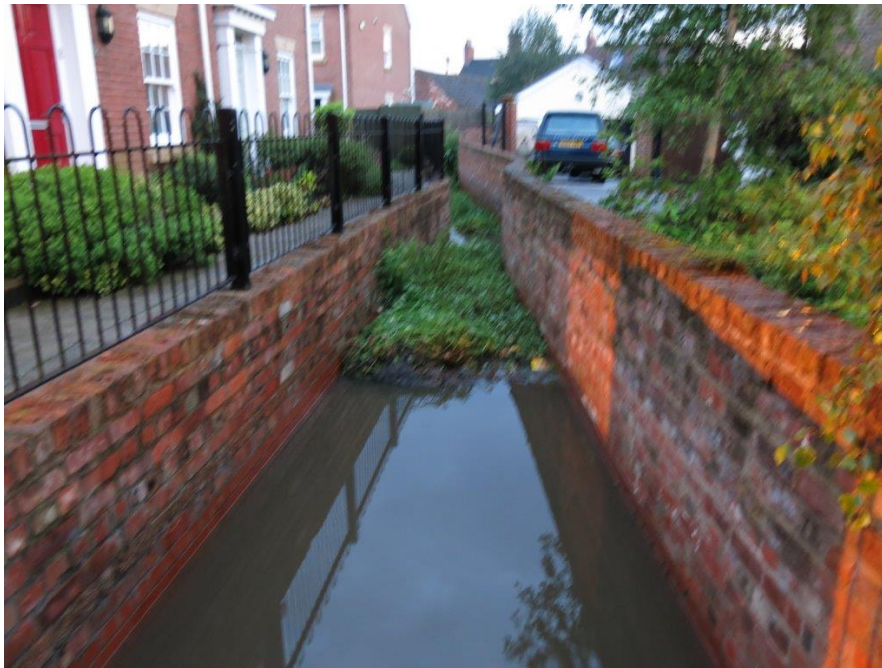
Photo 2: South Cave Beck at Trinity Fold, Beverley Road, (weeds now removed.)

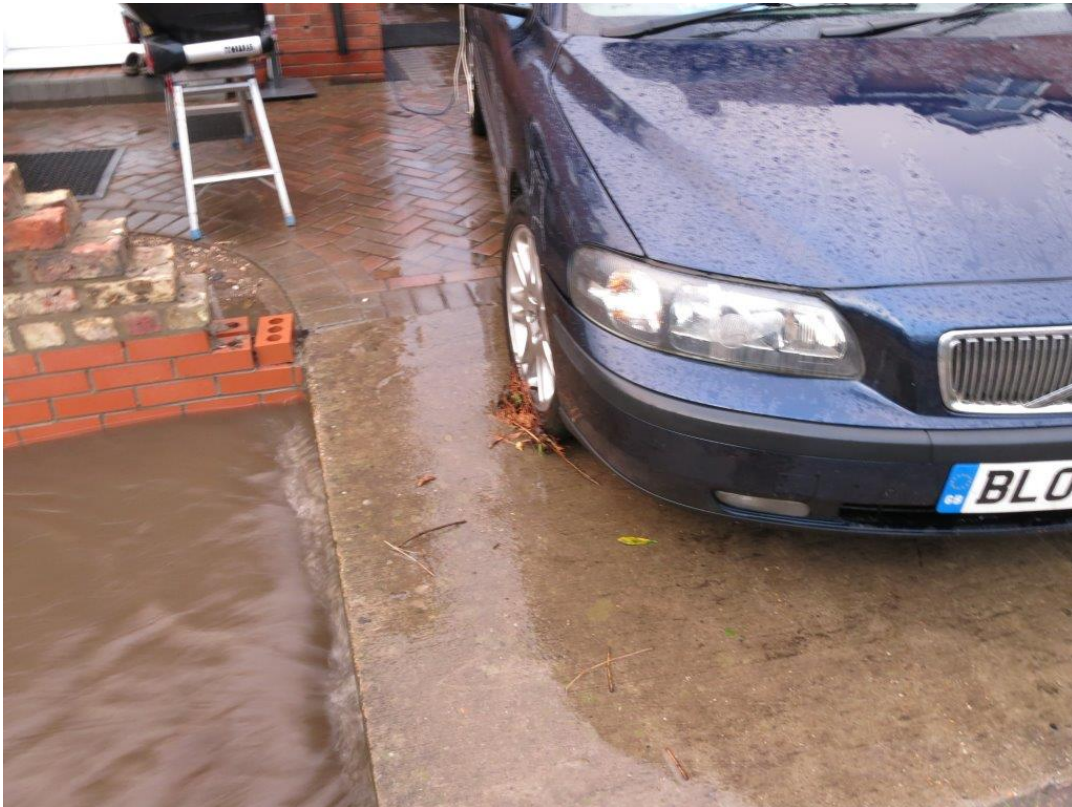
The Beck runs adjacent to Beverley Road (see figure 2) and the bank is low in places and so during times of high flow, overtops its bank into the highway. This led to water flowing across the frontage of properties lower down and has subsequently caused flooding. It also leads to additional surface flows into the Market Place with water running down from three directions towards the Sheep Wash (an entrance to the culvert) and then follows the contours of the land, down Church Street where low-lying properties are also affected.

Photo 3: South Cave Beck at Trinity Fold showing evidence of overtopping of the drive crossing

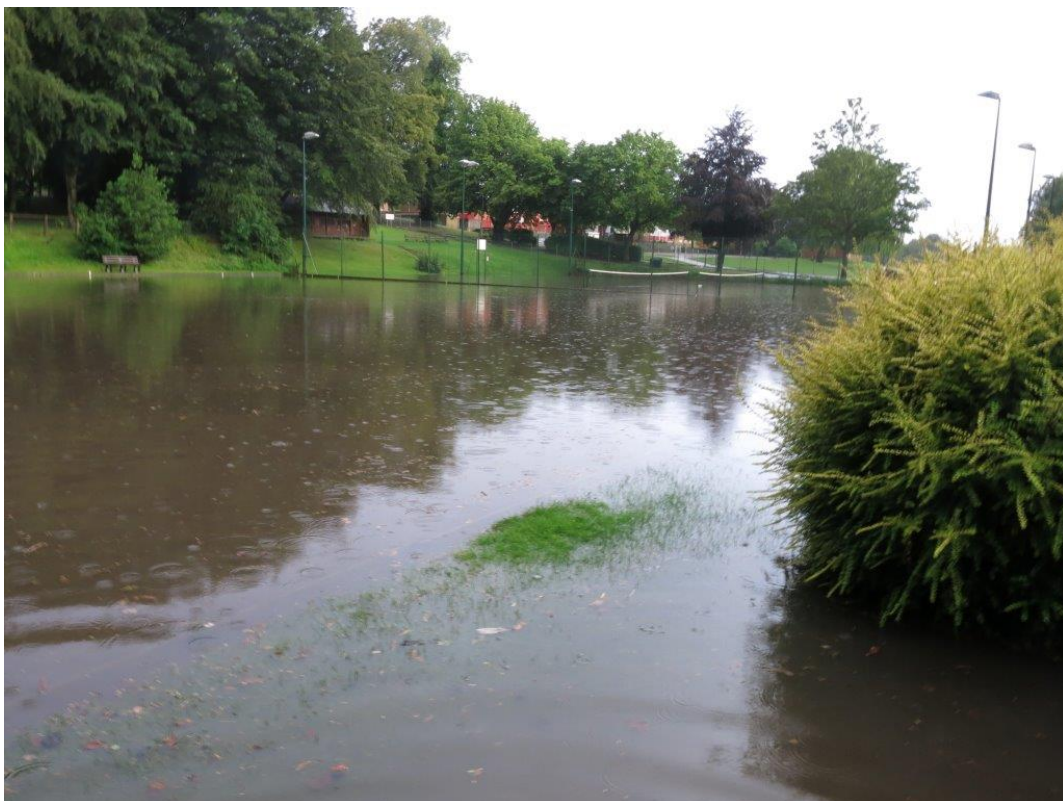
The Beck runs in a culvert largely under the southern footpath along Church Street, with additional flows entering the culvert from developments to the north of Church Street. Flooding occurred along Church Street and at the Bowling and Tennis Clubs as well as on the road in front (see photos 4, 5, 6 & 7). There is a short open section of the beck across the bottom of Bull Pasture (see Appendix 1) before entering another culverted section from Thornham Close. The screen on this culvert entrance was found to be partially obstructed with debris after the event and this will be replaced by the Council by the end of the financial year.

Photo 4: Bowling green and tennis courts, Church Street

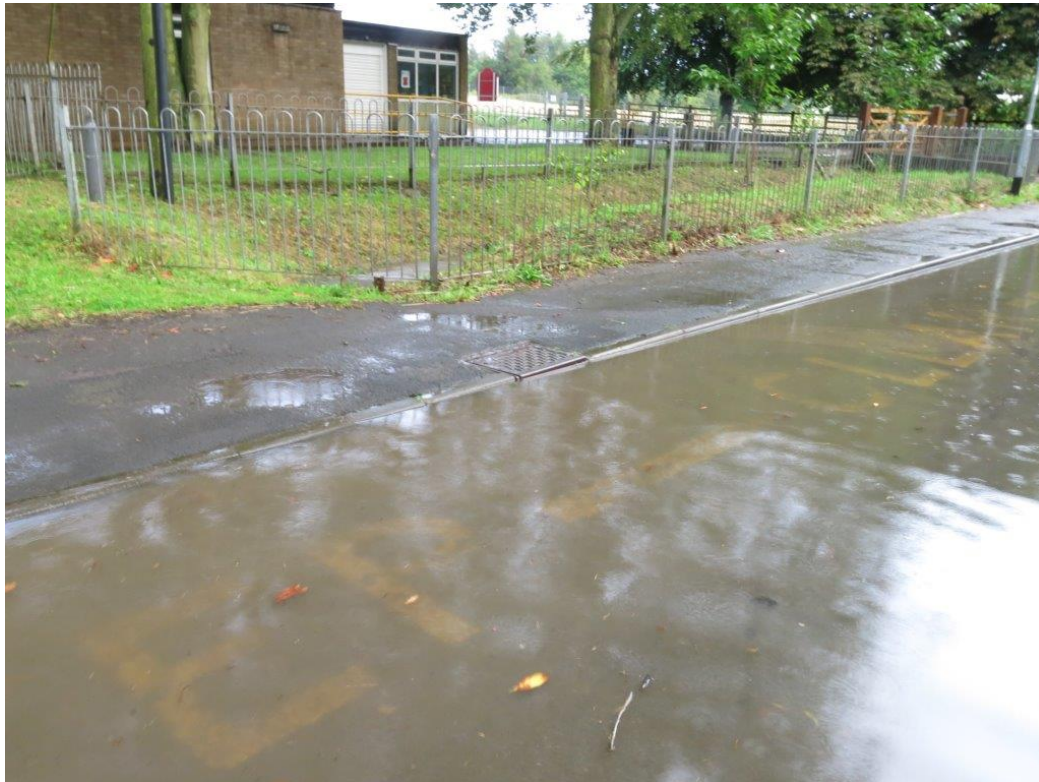
Photo 5: Church Street, road flooded and open section of the Beck

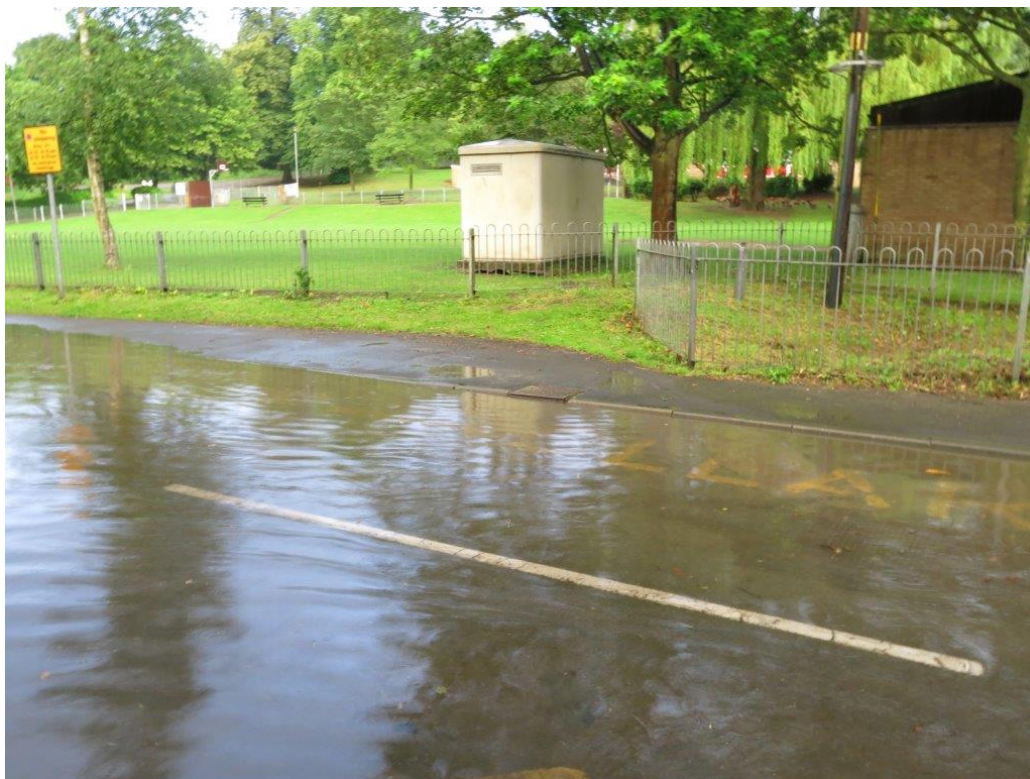
Photo 6: Church Street, road flooded and open section of the Beck

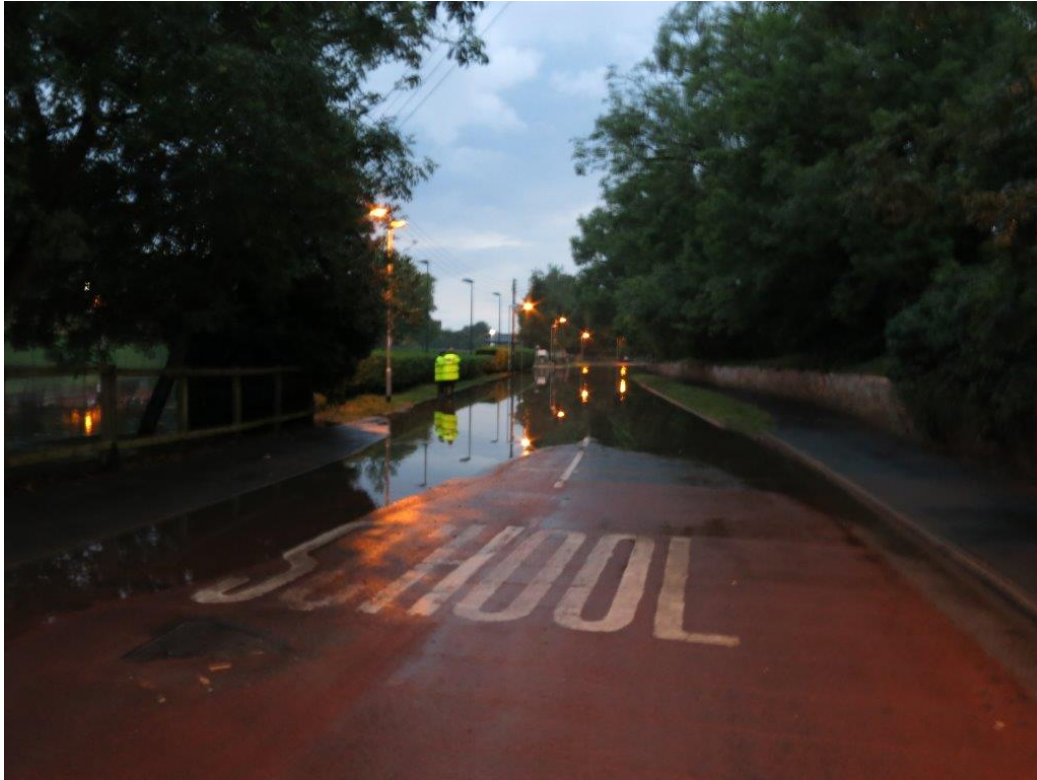
Photo 7: Church Street, draining down slowly

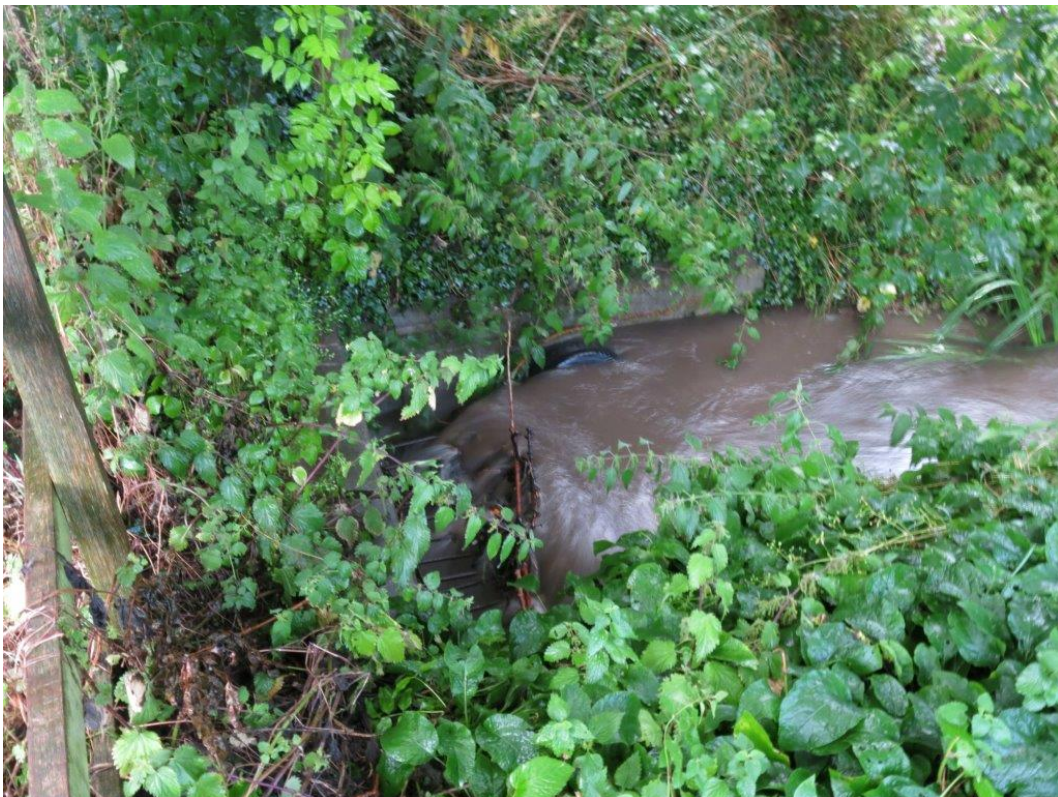
Thornham Close- EXT flooding on field reported. CCTV of SW line found silt issues, now removed . Culvert screen found to be blocked

Field located east of Thornham Close SW sewer, large amounts of silt were found during CCTV investigation, this has now been removed. The inlet to the culvert (non YW) was also found to be blocked.

Photo 8: Thornham Close, Bull Pasture Screen (which ERYC are replacing)

The existing trash screen at Bull Pasture, Thornham Close is to be replaced by the Council during this financial year.

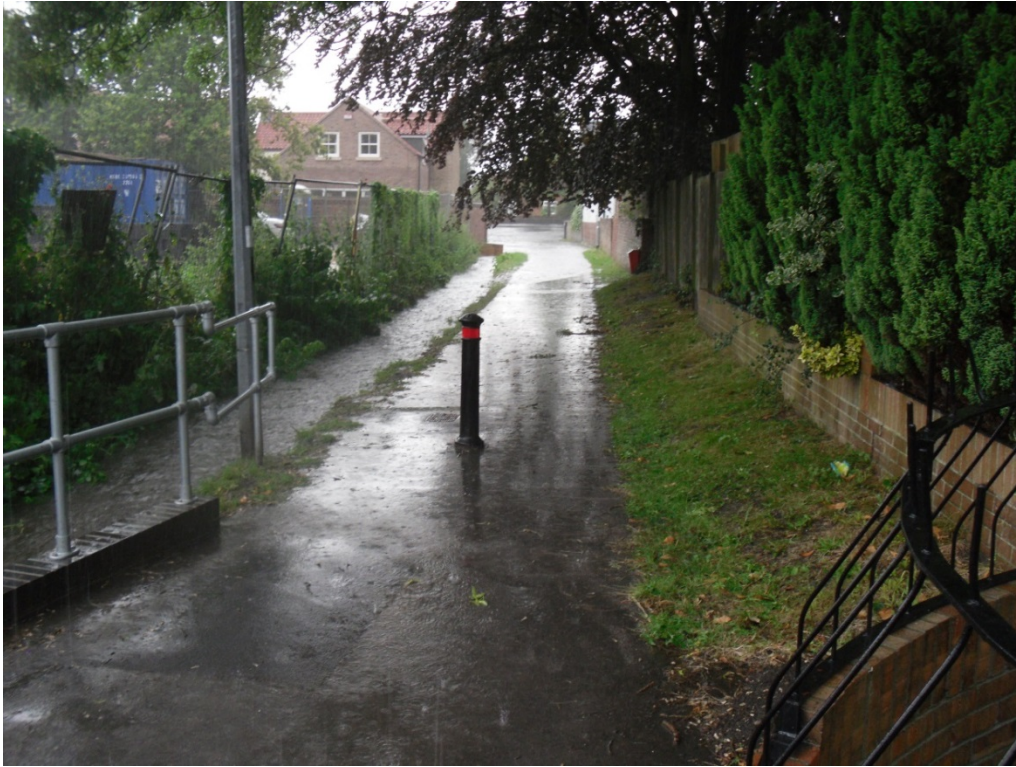
Photo 9: Beck Lane looking upstream towards West End

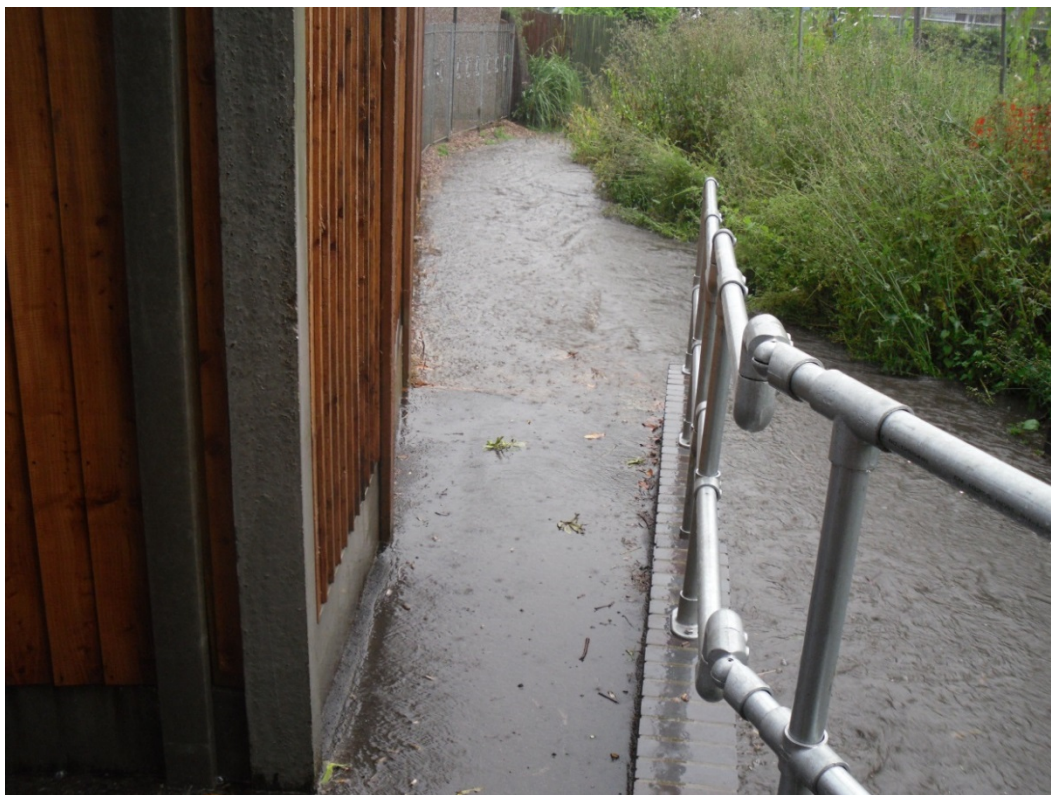
Photo 10: Beck Lane looking downstream, (walkway on the left under water)

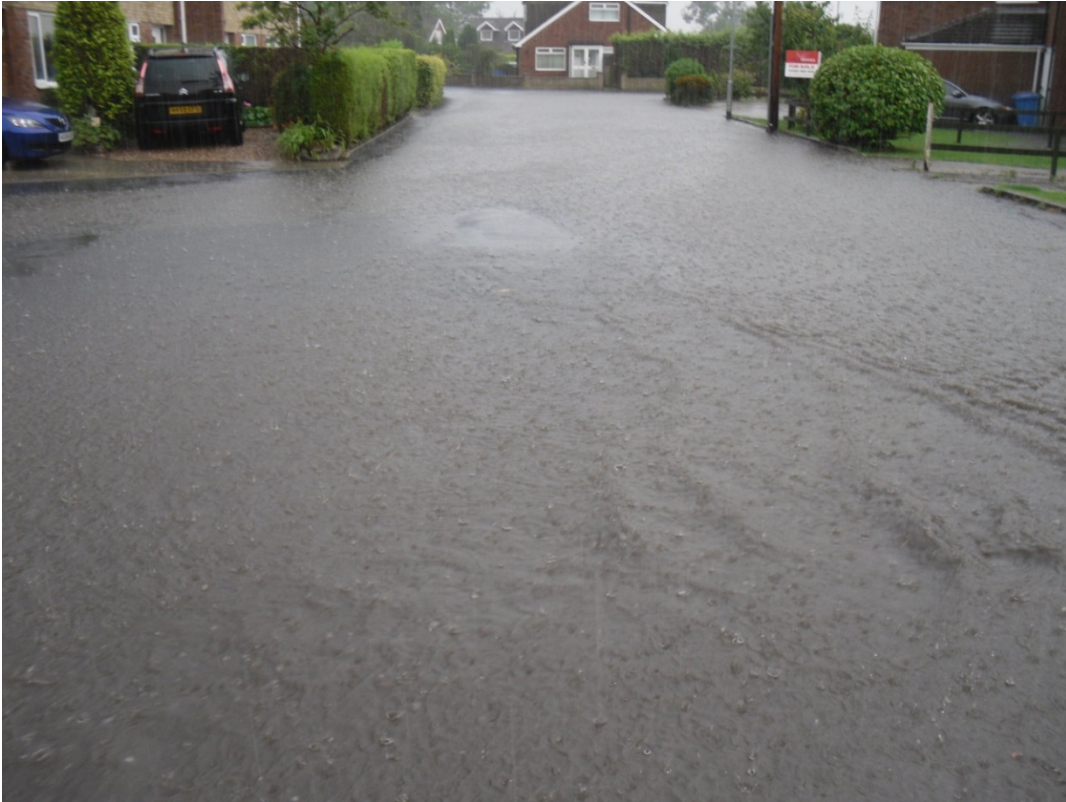
The beck banks are very low at the head of Barnards Drive, and service connections across the beck, to a recent property also restrict the flow leading to water overflowing from the beck into Barnards Drive and West Hall Garth. Additionally Jobsons Close and Lloyds Close cul-de-sacs were also flooded. Water then flowed out onto Pinfold with flows also coming down Annie Med Lane to the junction with Pinfold before passing under the A63. With water unable to flow away quickly enough the area was flooded.

Photo 11: Barnards Drive, Beck overflowing into the road

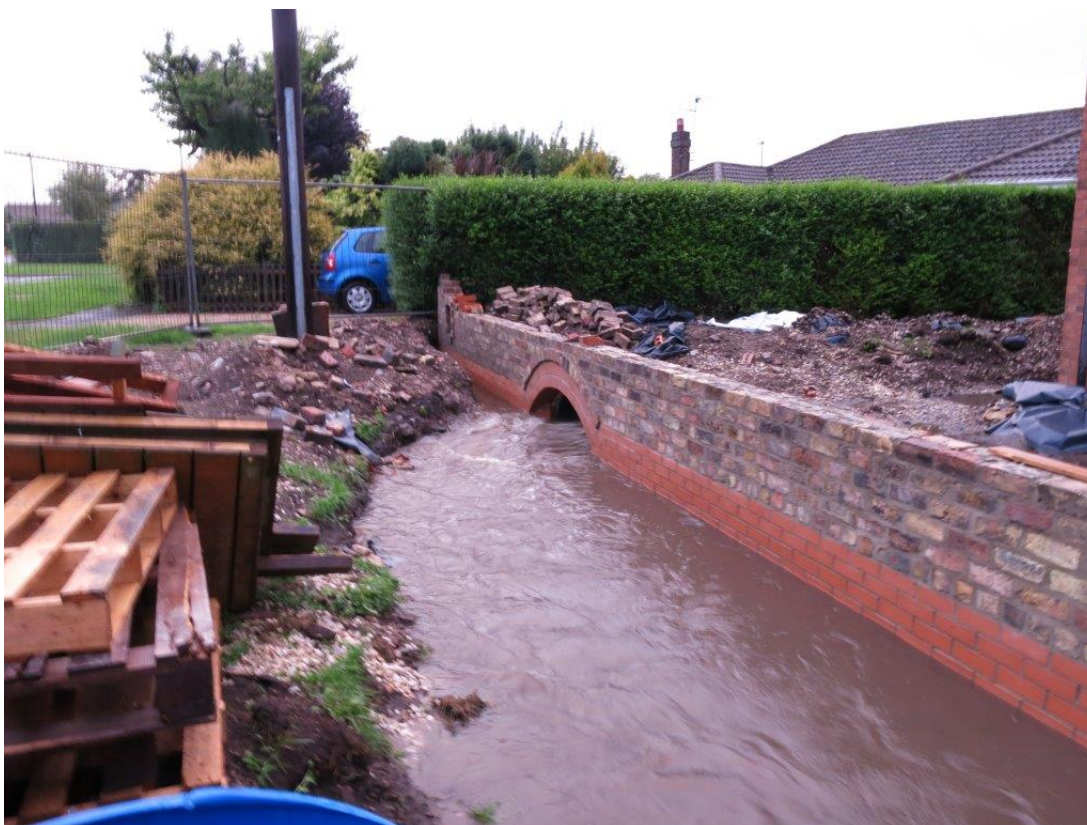
Photo 15: The Beck at Pinfold, showing new culvert outlet
