Flood Investigation Report

Cottingham Flooding July 8 2014

October 2014

EAST RIDING
OF YORKSHIRE COUNCIL

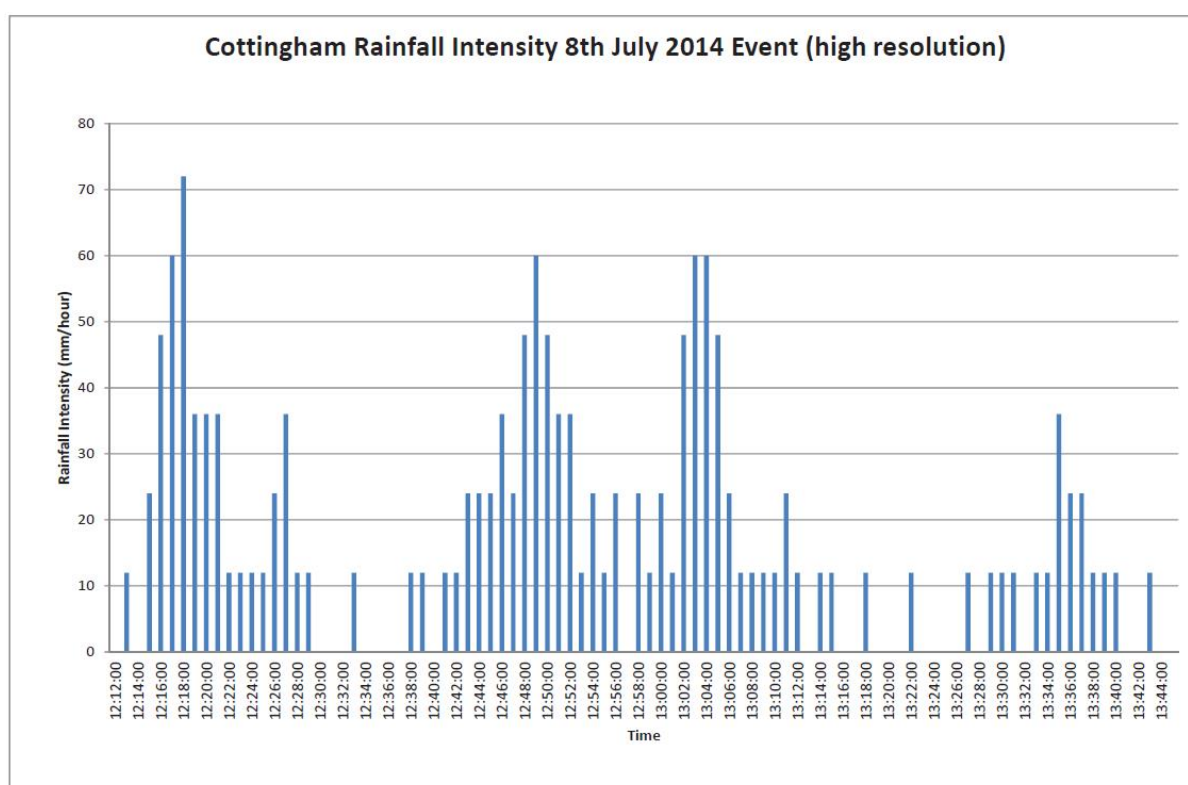
Data from the EA rain gauge at Mill House Woods Lane.

The EA rainfall data shows an initial peak intensity of over 70mm/hr declining quickly but then returning to 60mm/hr twice more during the following hour. The rainfall started just after 12:00 and lasted for 1 hour 45 minutes, a total depth of 26.6mm.

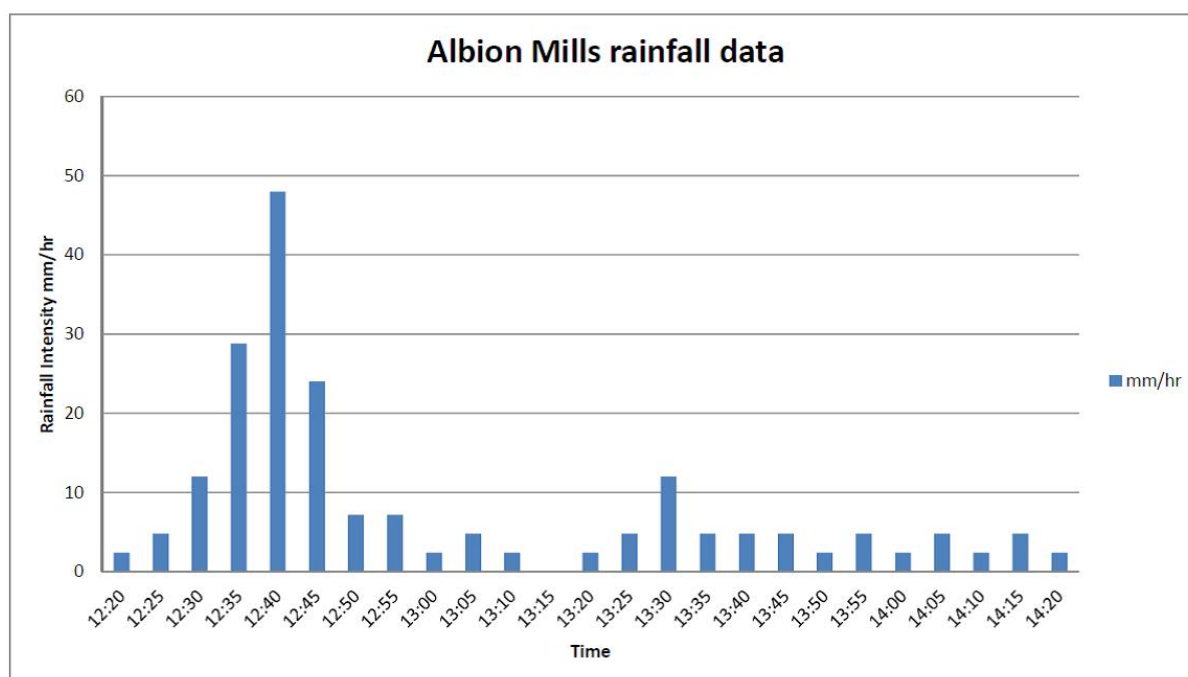
Data from ERYC rain gauge at Albion Mills

This is an ERYC rain gauge which shows a peak intensity of 48mm/hr at the beginning of the storm quickly declining to an average of 5mm/hr. The rain started at 12:20 and lasted for 2 hours, a total depth of 18.5mm.

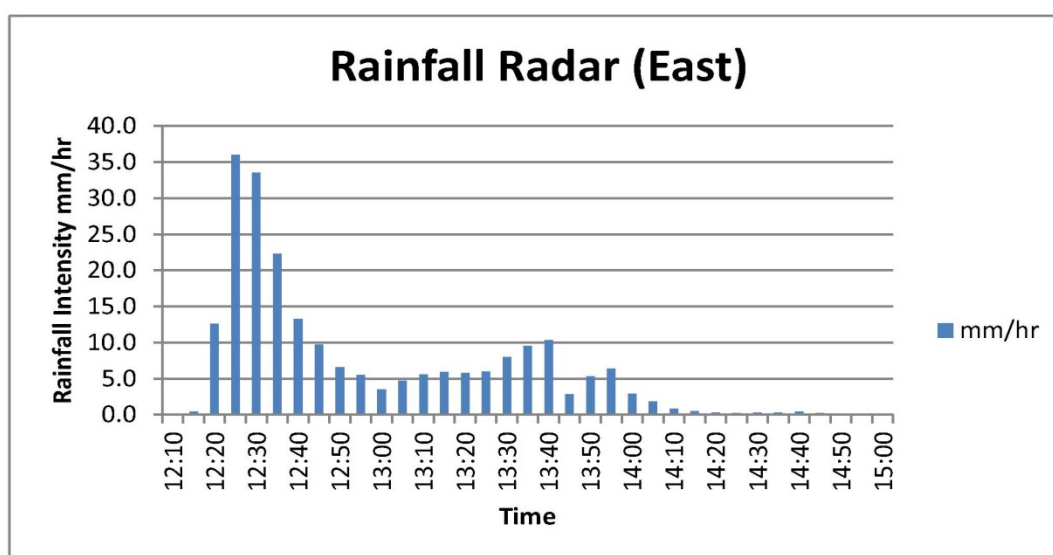
Met Office Rainfall Radar from the East end of the village.

This shows a peak intensity of 36mm/hr at the start of the storm which quickly declined to less than 10mm/hr. The rainfall started at 12:15 and lasted for 2 hours and 30 minutes, a total depth of 18.5mm.

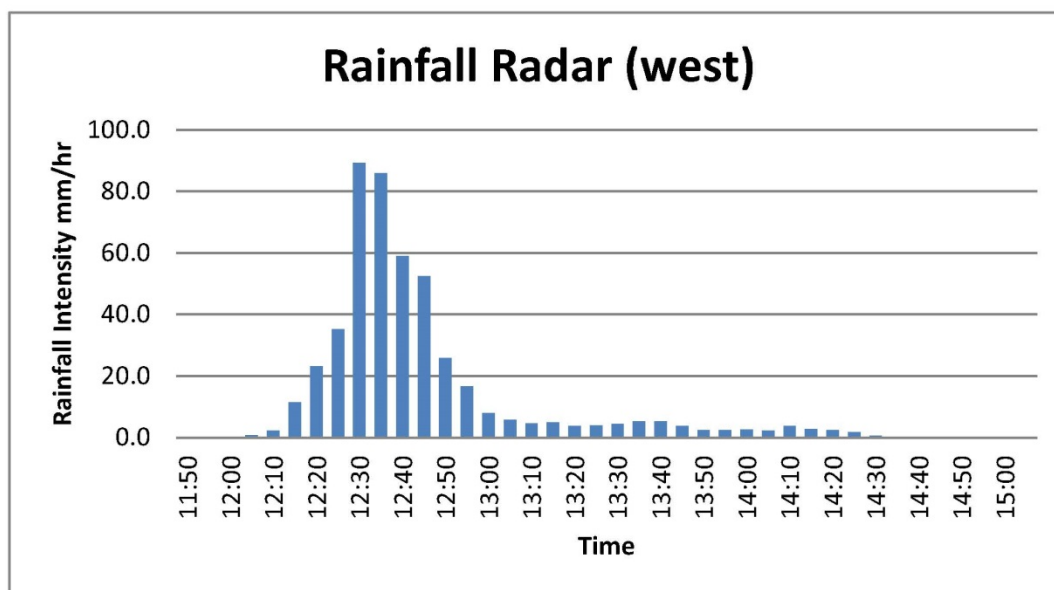
Met Office Rainfall Radar from the West end of the village

This data again shows an intense period of rainfall at the beginning of the storm, up to 89mm/hr again declining to less than 5 mm/hr. The rainfall started at 12:10 and lasted for 1 hour 30 minutes, resulting in a total depth of 39.5mm.

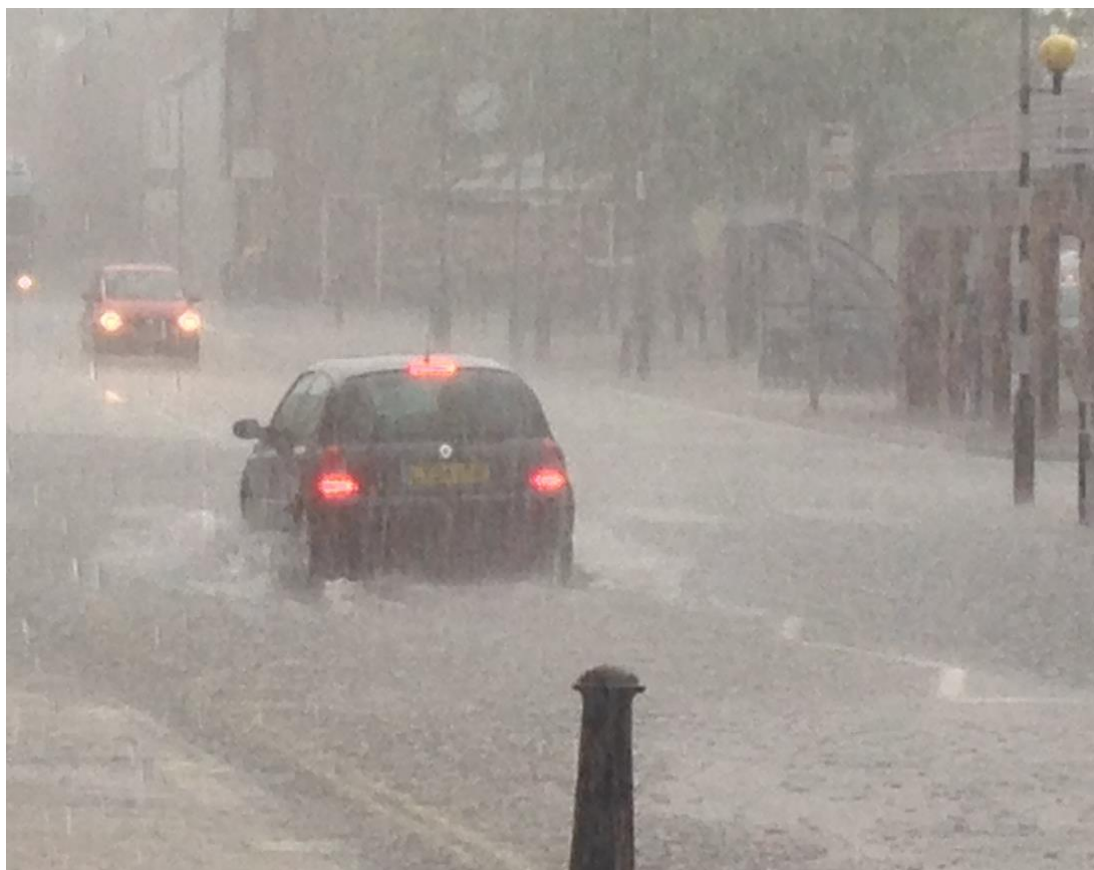
Photo 1: King Street

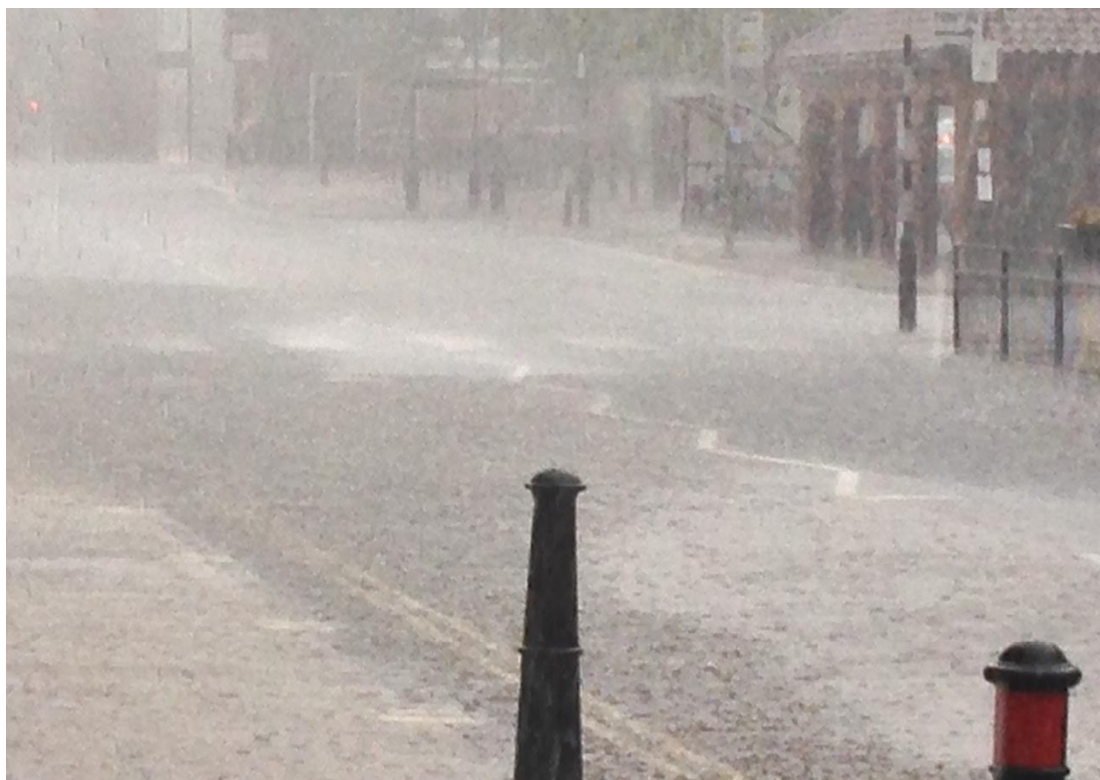
Photo 2: King Street during the storm

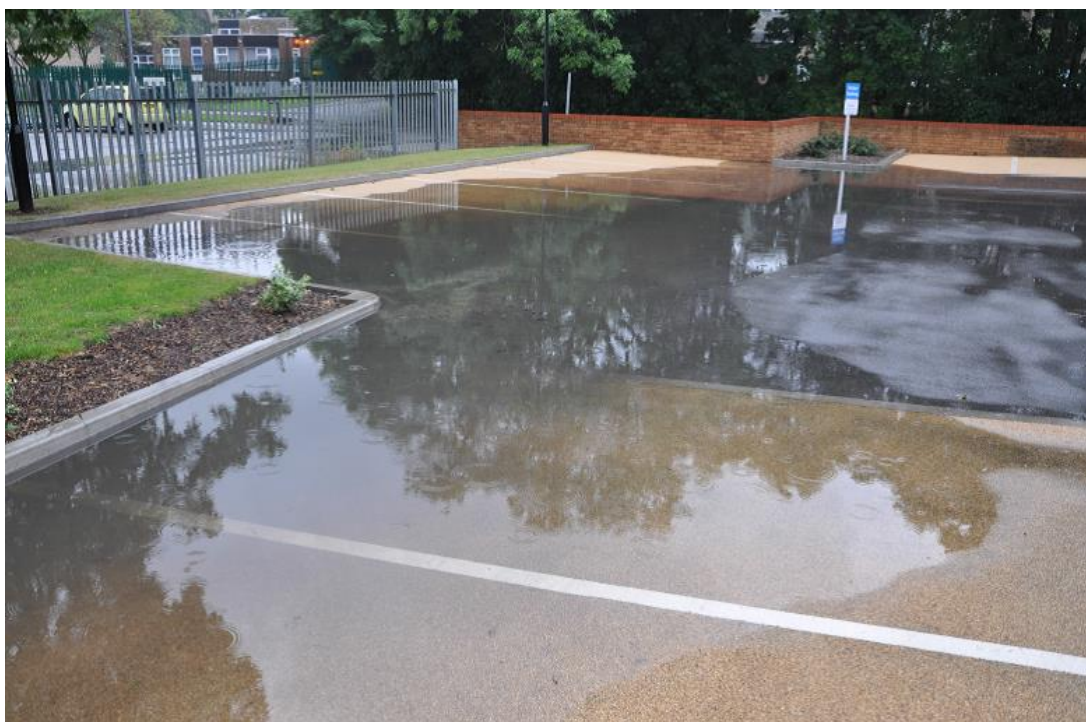
Photo 3: Cottingham Clinic on King Street car park flooded

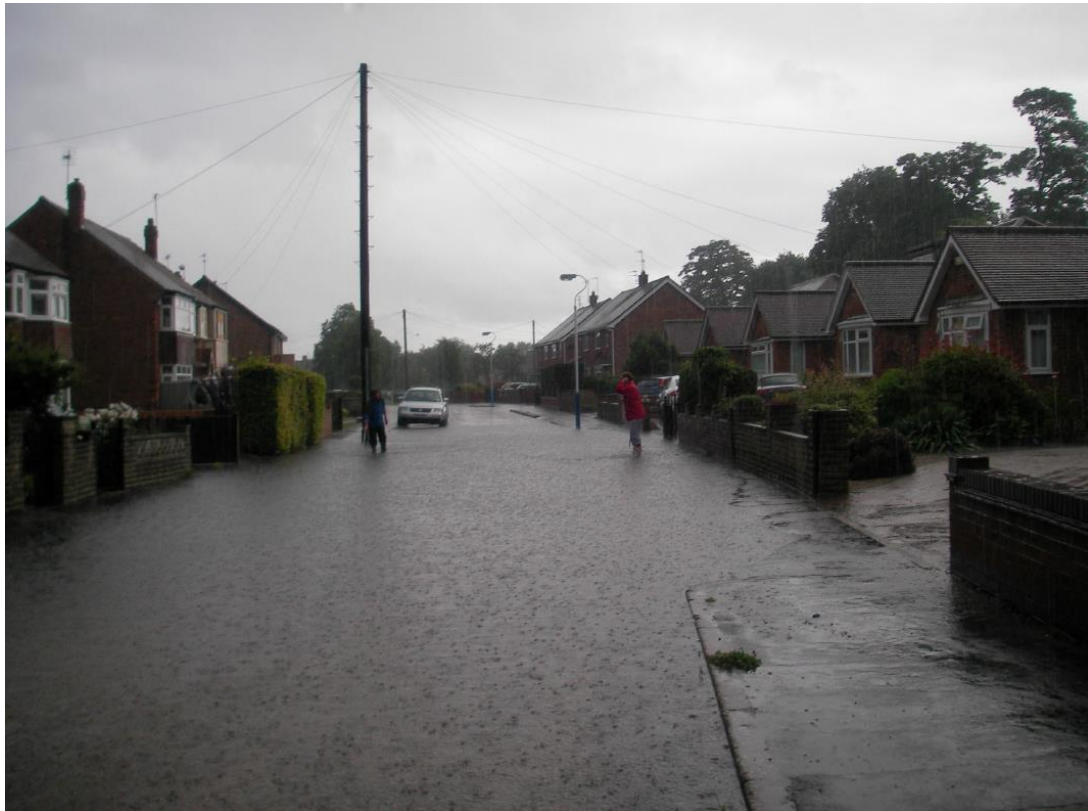
Photo 5: Oakdene showing highway flooded

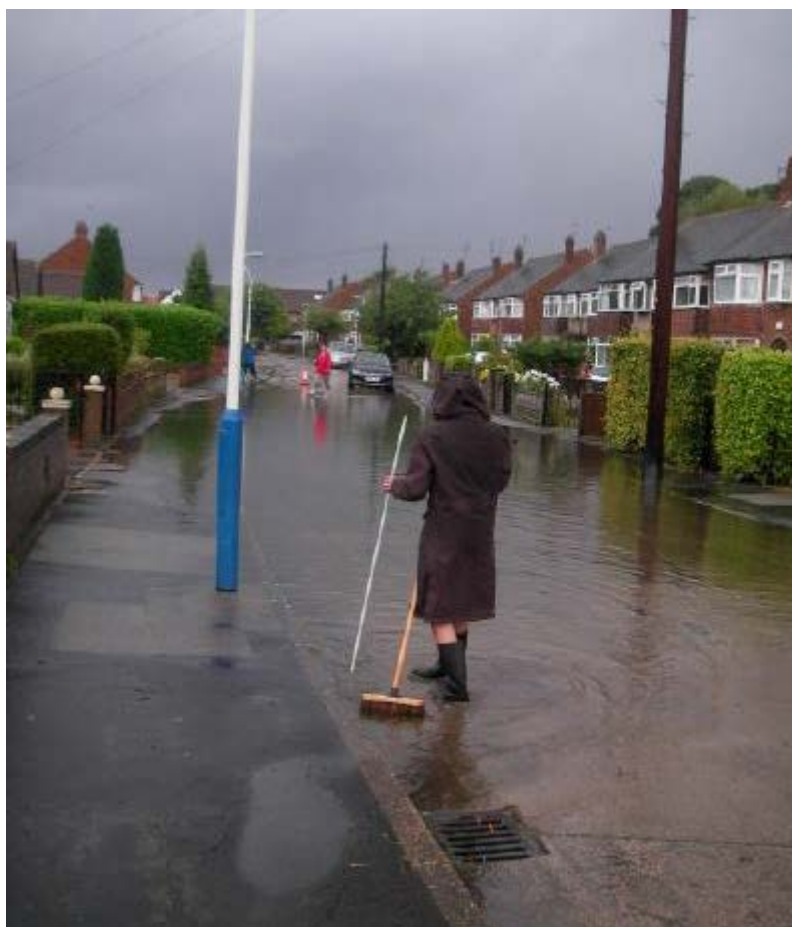
Photo 6: Oakdene showing highway gully drainage away

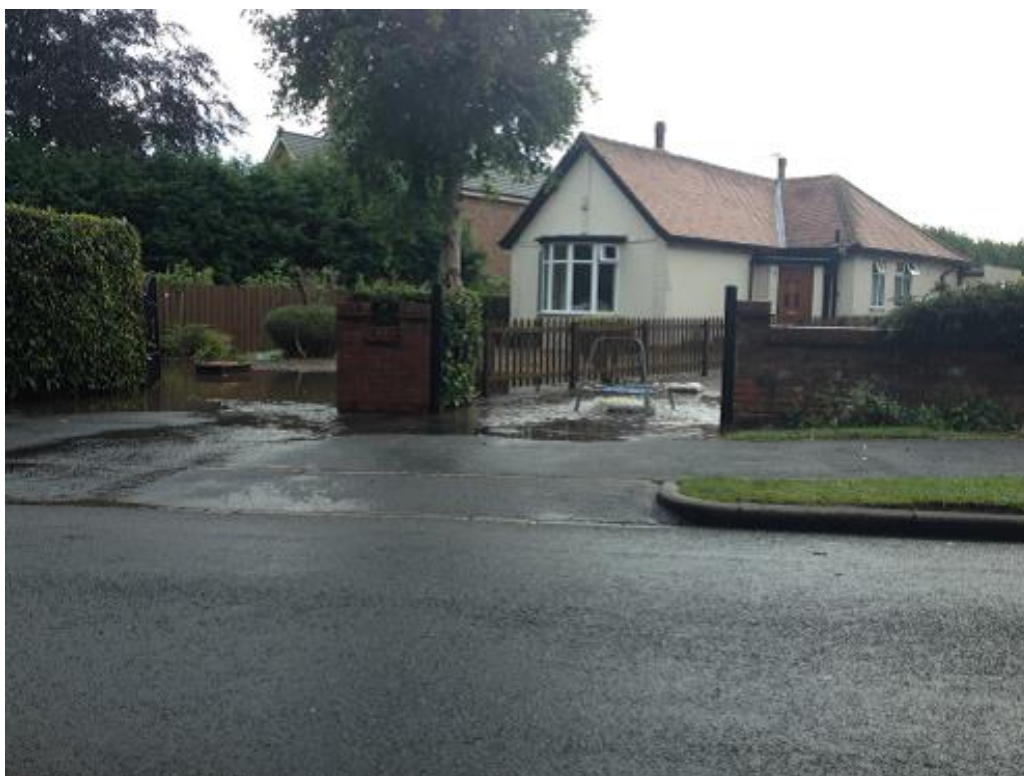
Photo 7: Harland Way sewer manhole after the storm

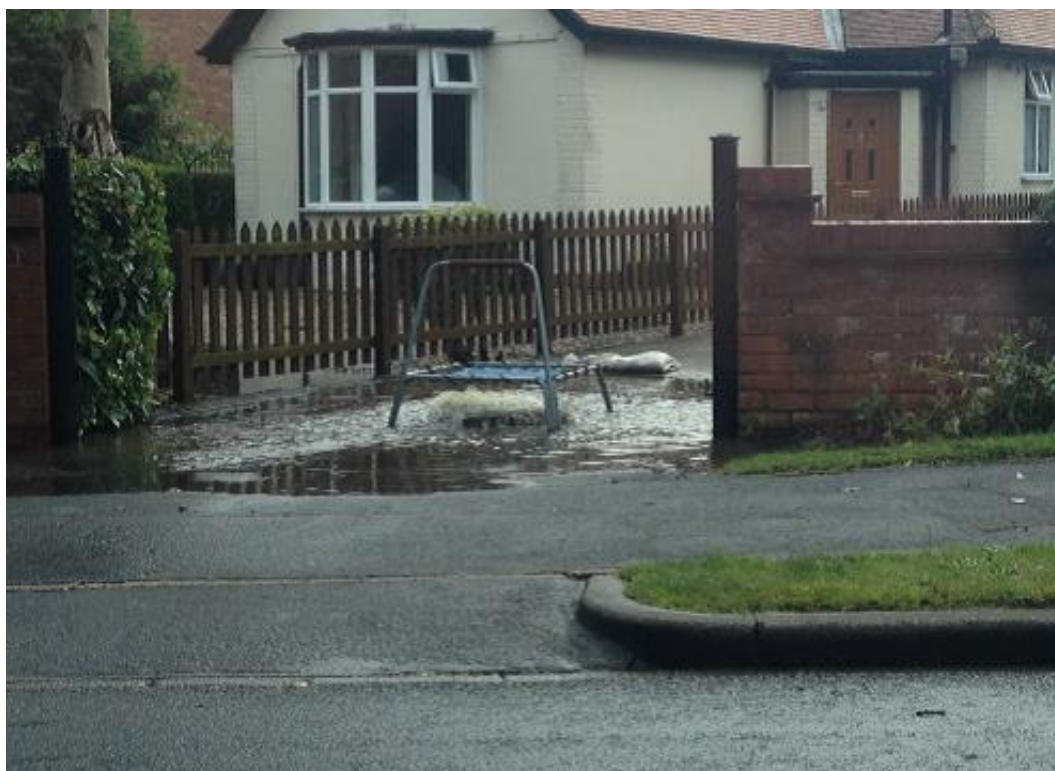
Photo 8: Sewer Manhole surcharging

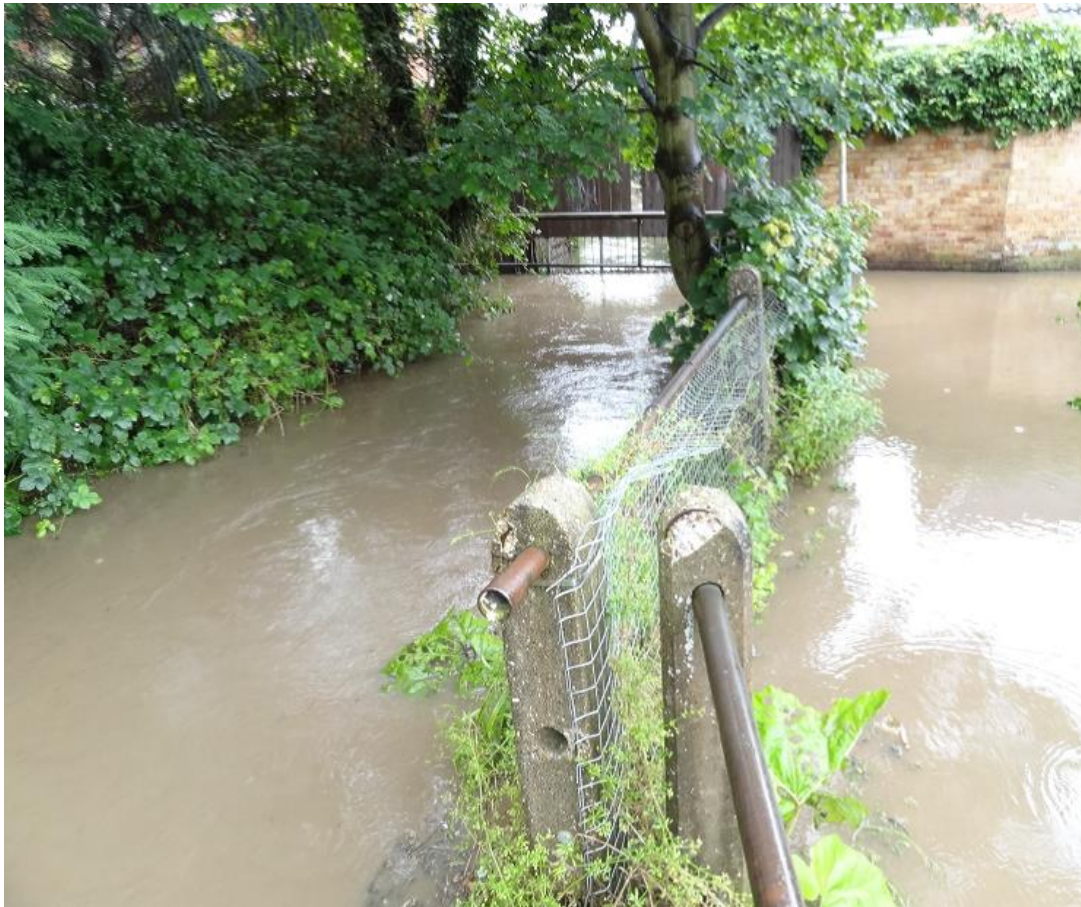
Photo 11: Mill Beck Bridge footpath between Hallgate and Broad lane Close

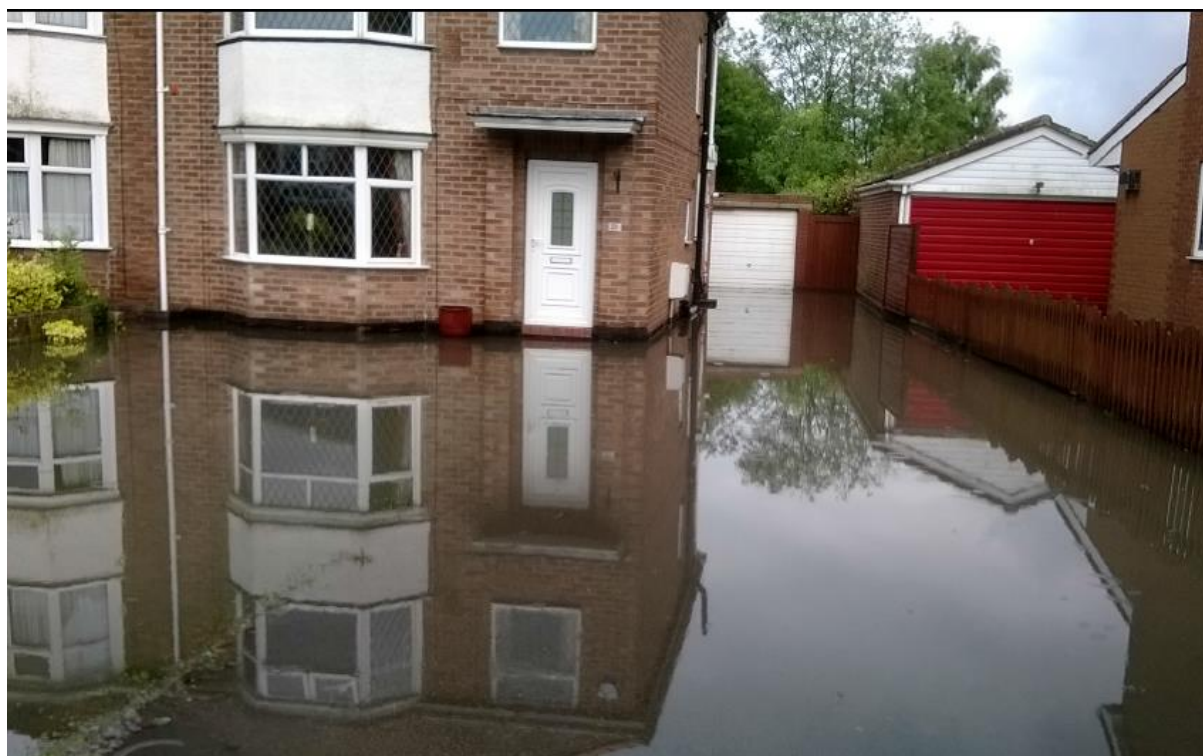
Photo 13: Property affected on New Village Road

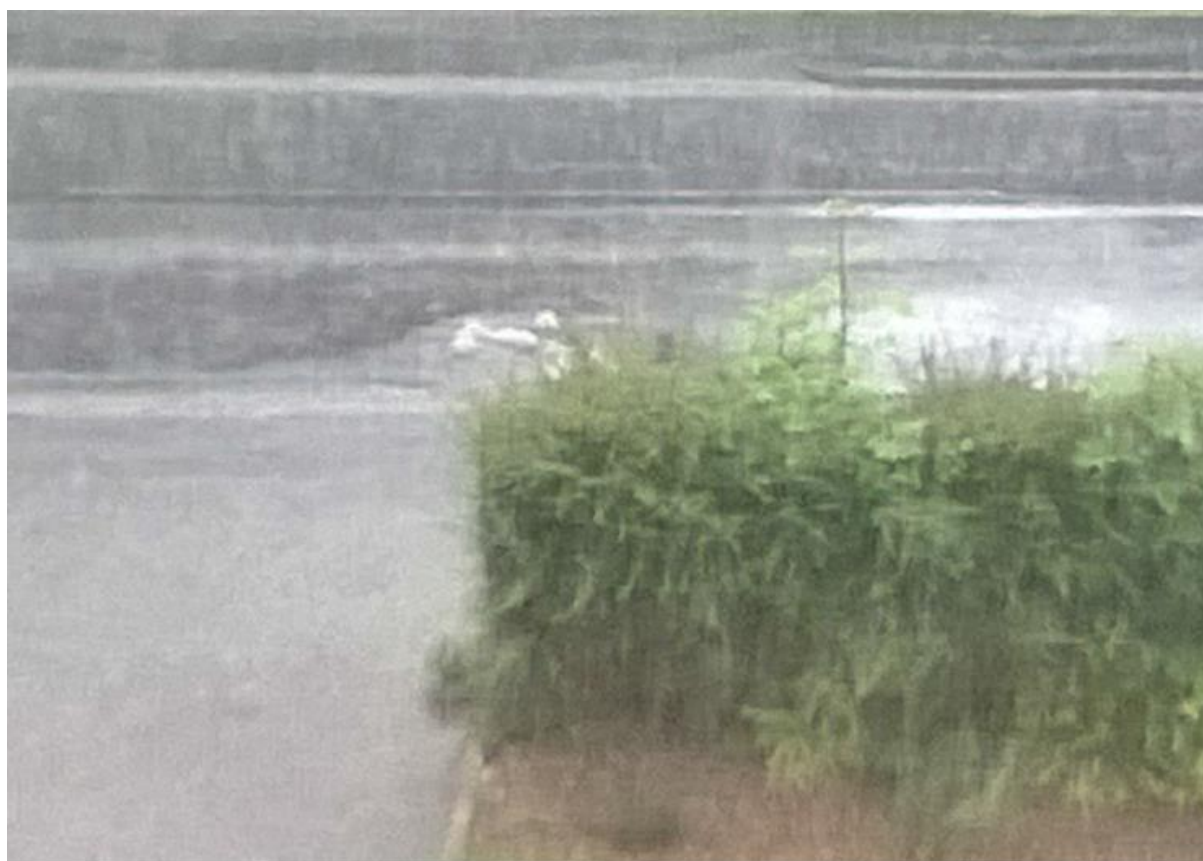
Photo 14: Water flooding from a sewer manhole on New Village Road

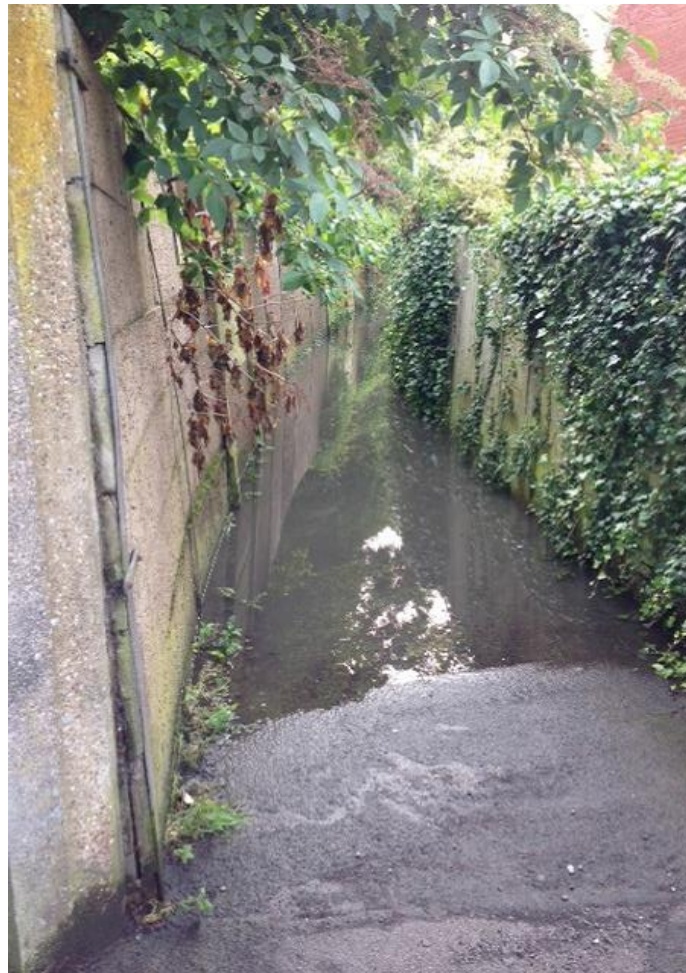
Photo 15: Thwaite Hall Snicket off New Village Road, flood water trapped

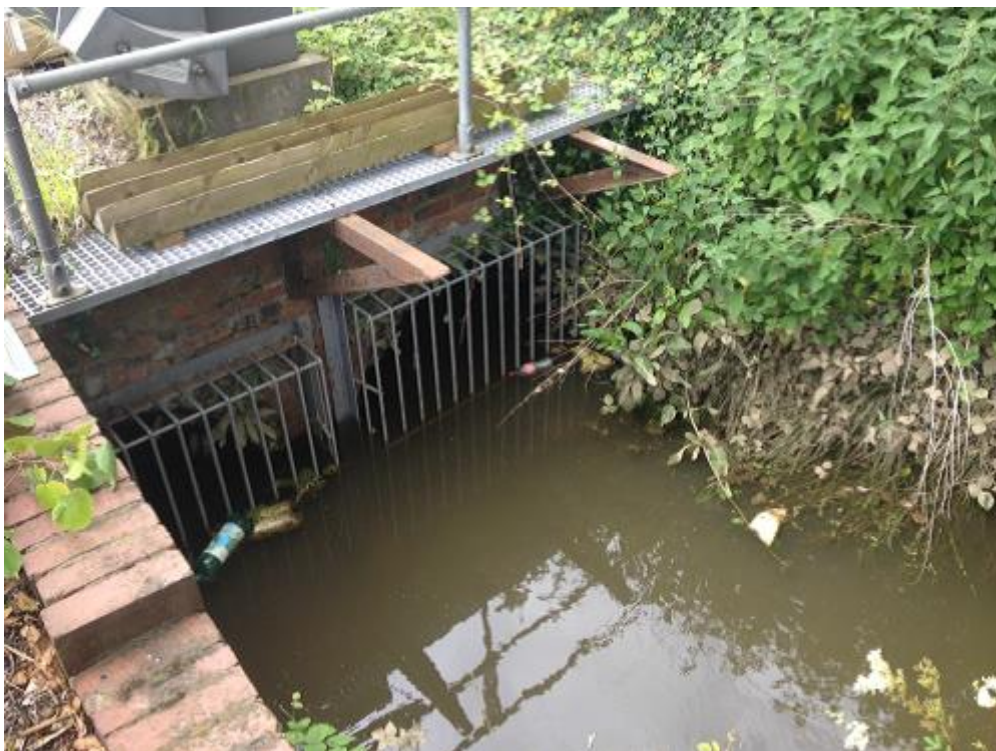
Photo 16: Creyke Beck showing the depth of flow on the bank side weeds

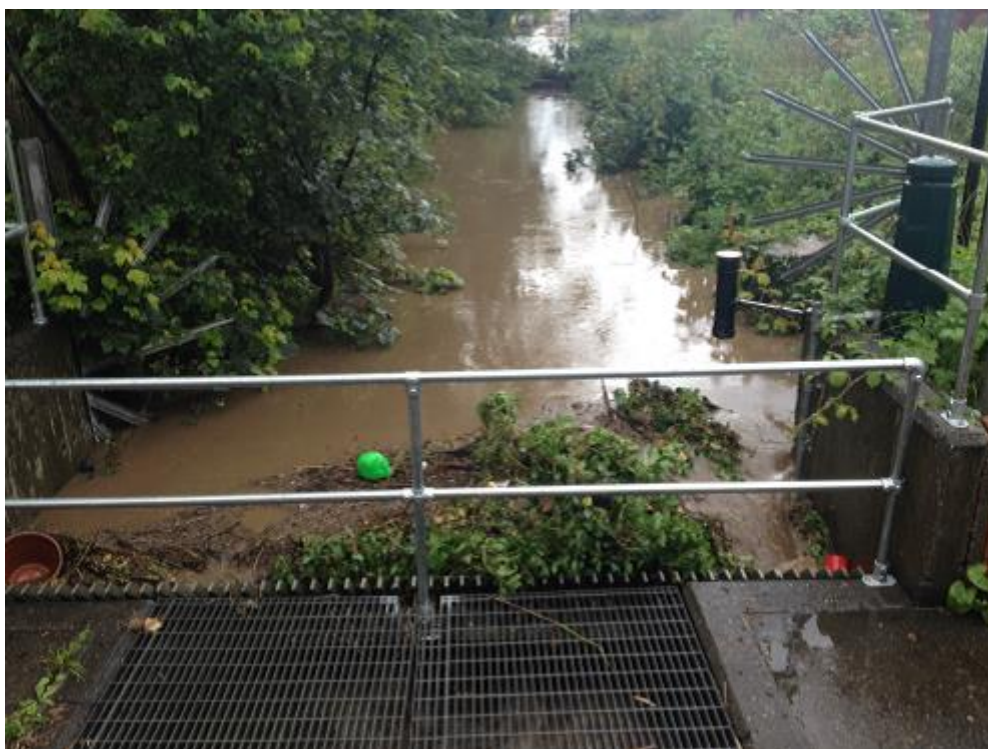
Photo 17: Victorias Way Screen, showing debris build up

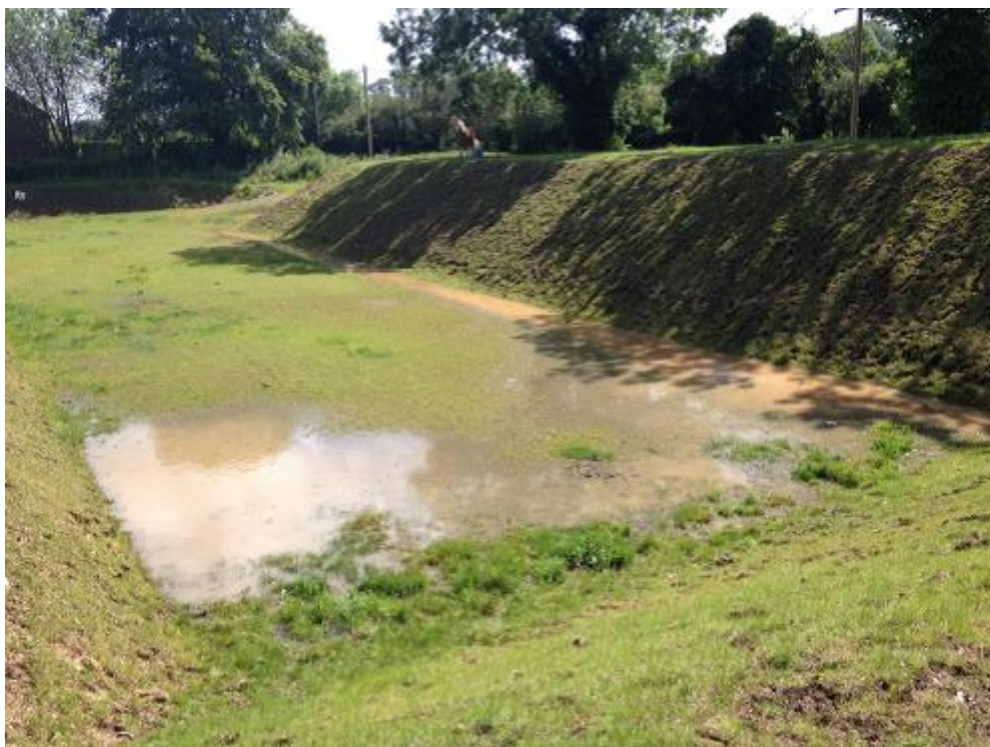
Photo 19: Raywell Valley Attenuation Lagoon after the storm

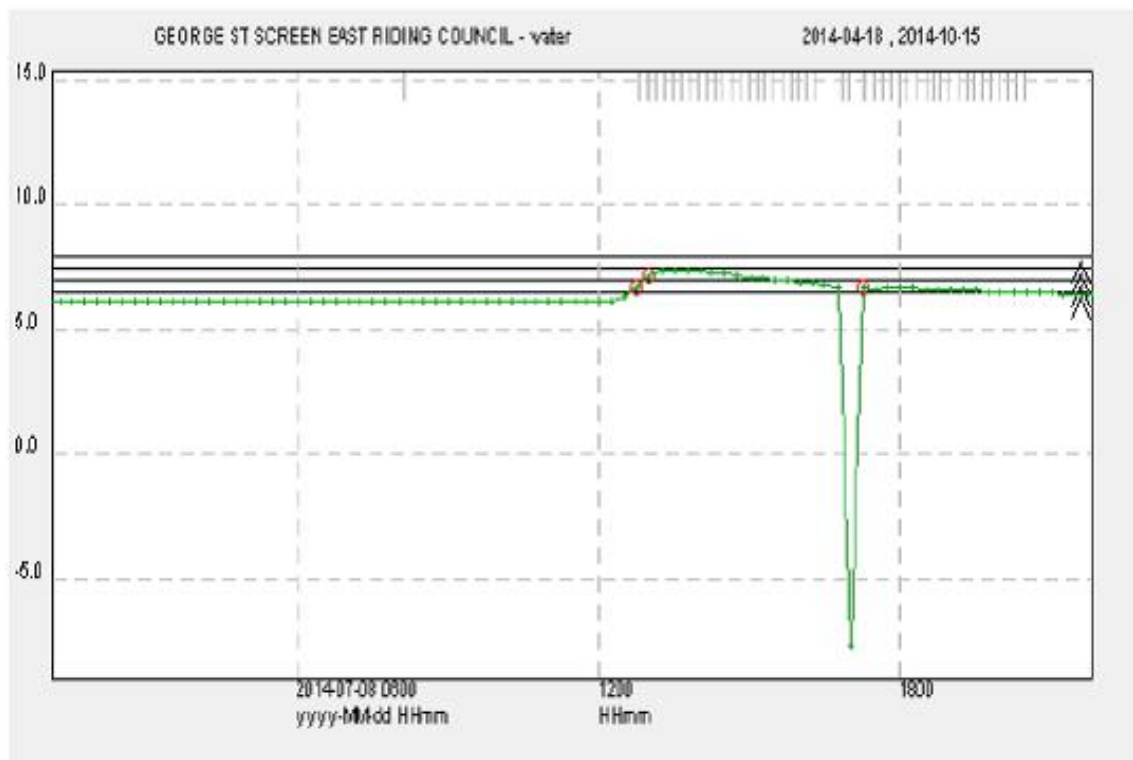
Telemetry data showing the water level in Broad Lane Beck at George Street screen on 8 July.

This shows that the level at the screen rose sharply at 12:15 and alarmed, then the level slowly returned to normal.

The spike at 17:00 shows a loss of echo, this is caused when the radar beam hits debris not water and does not return to the radar head. This is a normal occurrence and does not affect the overall effectiveness of the unit.

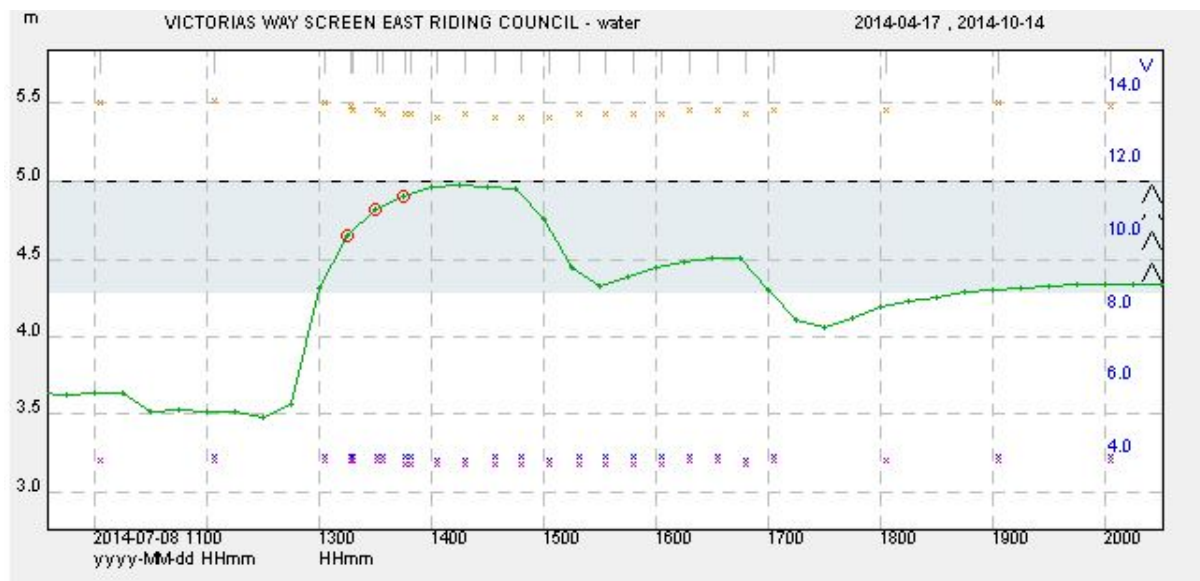
Telemetry data showing the water level in Mill Beck at Victoria's Way Screen on 8 July.

This shows that the level in Mill Beck rose sharply from 12:30, peaking at 14:30, before dropping slowly, but remaining at a higher level than before the storm.

Both screens were cleaned prior the event and during the event the Council's contractor attended site and removed debris washed onto the screens.
