Flood Investigation Report

Swinefleet, 5. and 6. July 2012

CES\D200\LDES\1464

East Riding of Yorkshire Council Flood Investigation Report

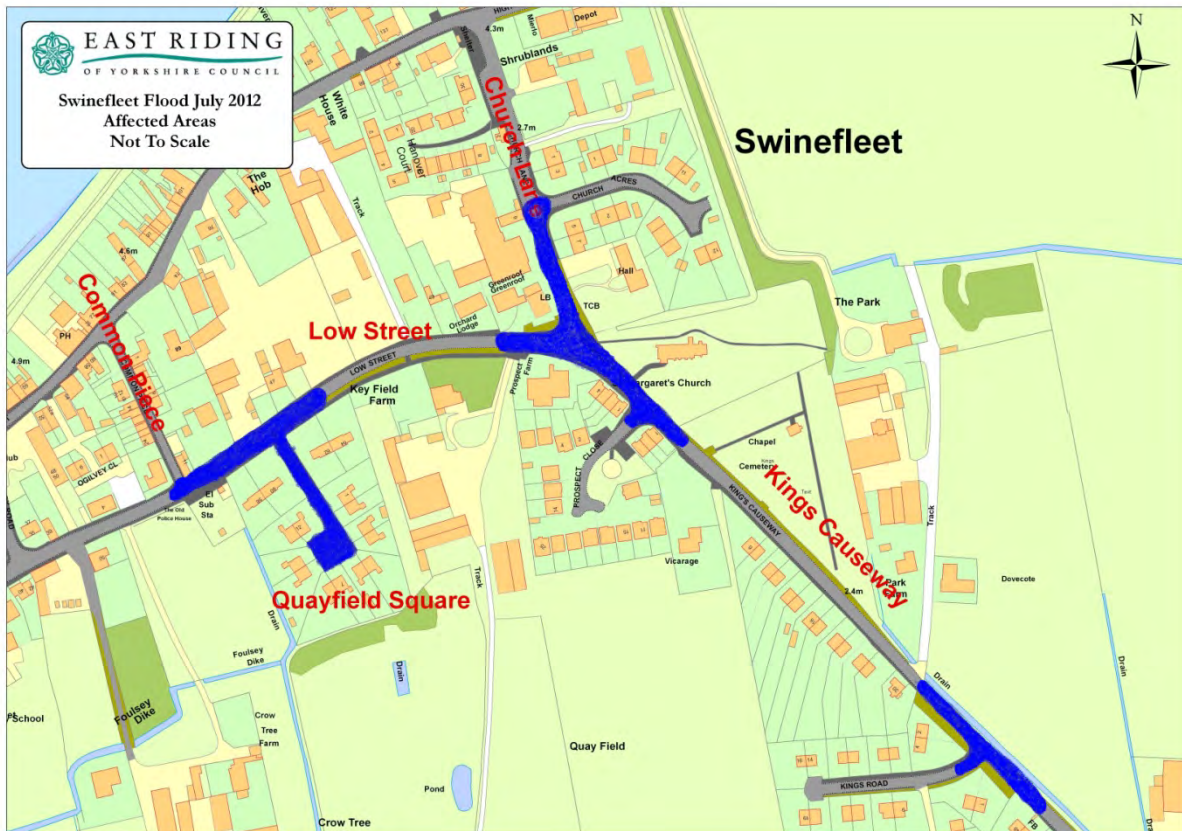
Figure 2 July 2012 Flooded Areas

On Friday 6th July the drainage system was overwhelmed and affected properties in Quayfield Square, Low Street and Kings Causeway. (see figure 2 and 3 on next page).

On Friday 6th July the subsequent rain led to increased surface flooding which eventually inundated the drainage system in the village and affected properties in Quayfield Square, Low Street and Kings Causeway.

Nevertheless water levels in the Quayfield Square area continued to rise and a number of properties flooded in the Quayfield Square. A number of properties on Low Street and Kings Road were also affected.

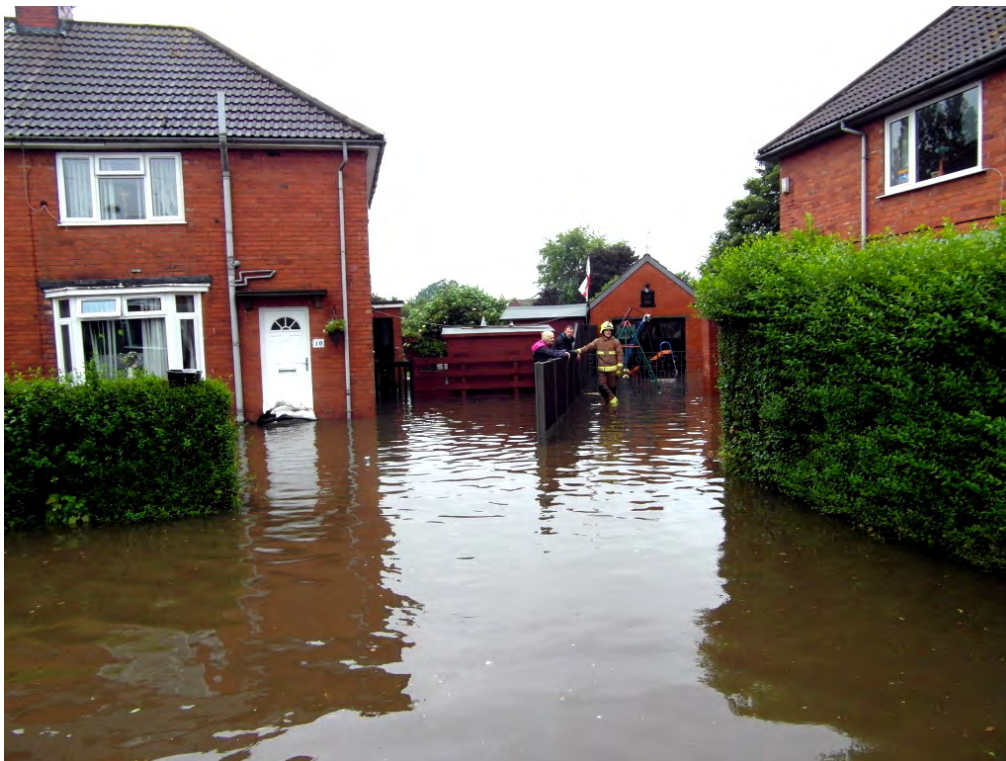
Figure 3 Photograph of Quayfield Square on 6th July

Kings Causeway is susceptible to flooding because of surface water run-off from agricultural land and highway drainage. Quayfield Square and adjacent properties on Low Street are located in a low spot in the village and as such the area is susceptible to flooding.

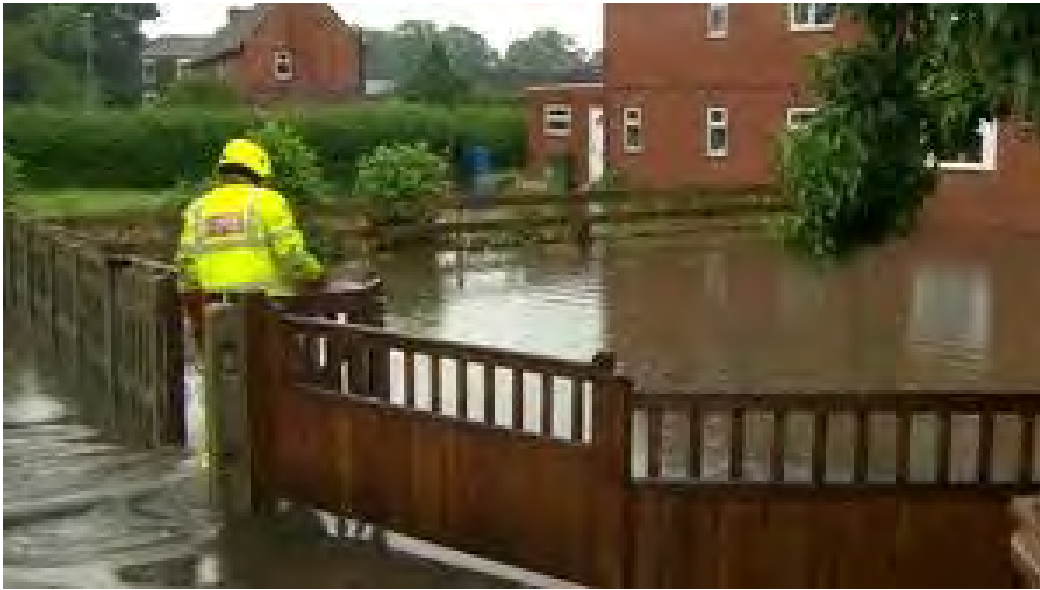
Figure 5 Photograph of Low Street on 6th July

The highway drainage outfall from Low Street was found to be partially obstructed by the level of the bed of the Foulsey Dike. The outfall was found to be in poor condition, at a low

level and this ditch had not been maintained for some time. . The investigation established that the outfall pipe and the outfall had subsided.

These circumstances will have restricted the discharge from the highway drainage outfall. The water levels in this ditch were also controlled by the elevated levels in the Warping Drain and the Black Dike.

- Installation of new separate highway drainage in Kings Causeway area, positively draining to the ditches on the east of the village.
- Removing the highway drainage discharge from the foul drainage system in the Quayfield Square and installation of a new highway drainage discharge point.
- Improvements to the highway drainage from the Church Lane area and providing an appropriate discharge point.
- Construction of a new outfall in Low Street or rebuilding of the existing outfall and headwall.
- Provide additional road gullies in Low Street at the Junction with Common Piece.

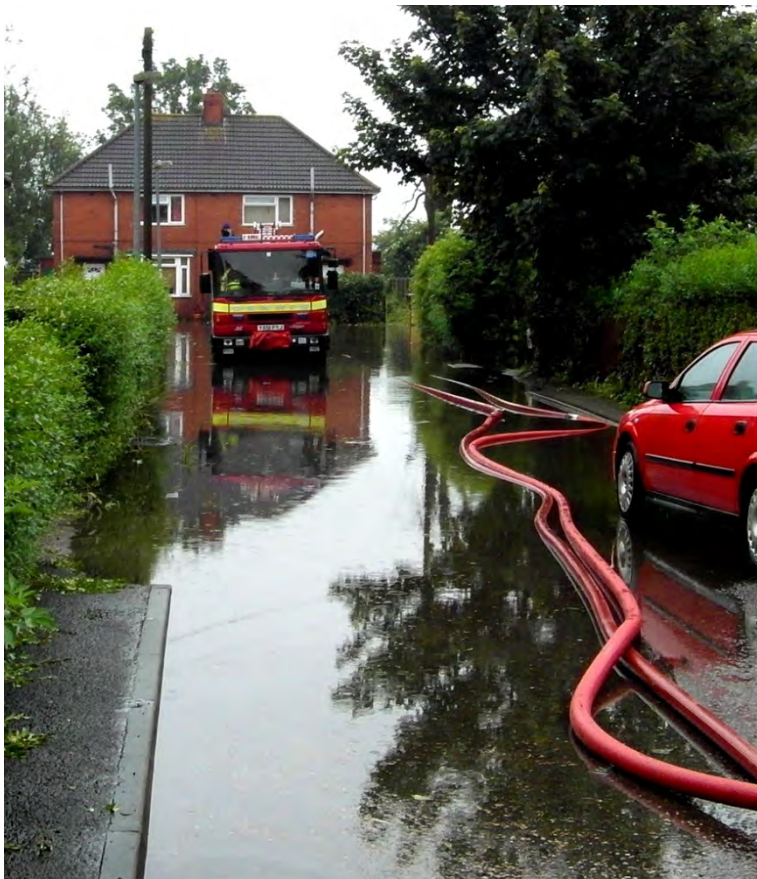
Figure 6 - HF&RS in attendance at Quayfield Square

During this time a unit from Humberside Fire and Rescue Service attended and pumped water away from the at-risk areas. Flood water was also pumped from the Kings Causeway area towards the Reedness Drain.
