Flood Investigation Report

Market Weighton Flooding Event

on 20 July 2014

EAST RIDING
OF YORKSHIRE COUNCIL

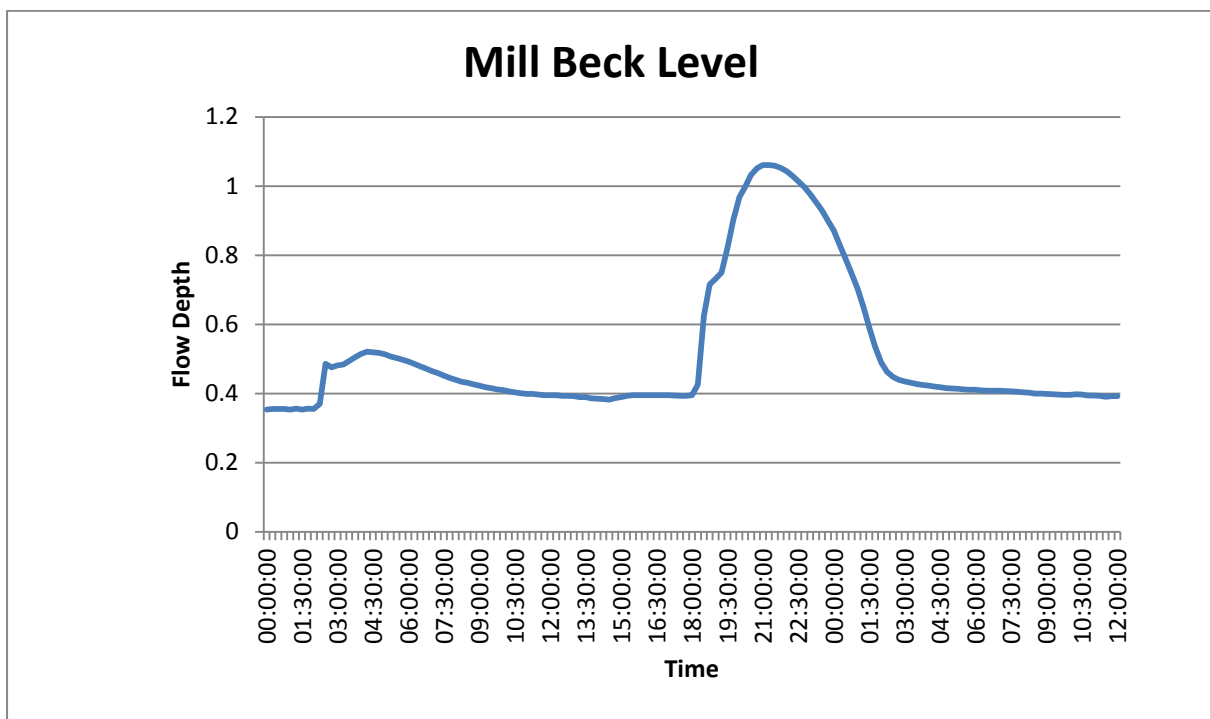
Mill Beck water levels through 20 July and up to 12:00 noon on the 21 July. (EA data)

This shows the Beck levels rose sharply at 02:30 in the morning on 20 July, peaked at 04:30 and slowly dropped back to the previous level by 12:00, then rose sharply again at 18:00, peaked at 21:00 then dropped back to a normal level by 03:00 on 21 July. This corresponds with the timing of the intense rainfall and reports of flooding in the town. It should be noted that there were no reports of water flowing out of the Beck, however it is believed that many drains which discharge directly into the Beck will have been held back by the high flows in the Beck itself.

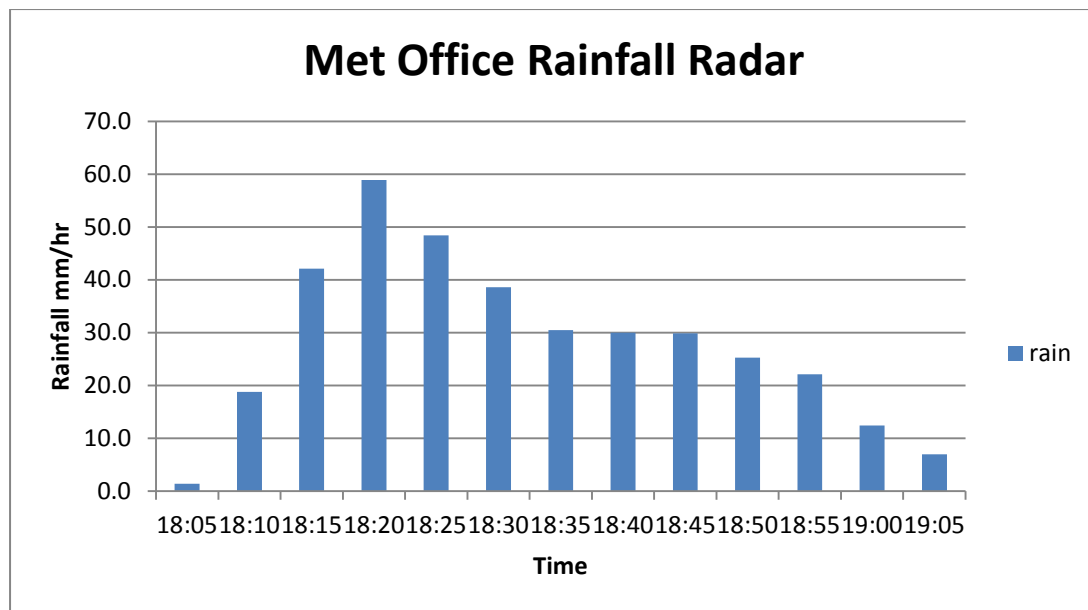
Rainfall Radar from the Met Office for Market Weighton.

This shows the peak rainfall rate of 59mm/hr in a 5 minute period, and a total of 30mm in an hour.

The Met Office Rainfall Radar for Market Weighton indicated a peak rainfall rate of 59mm/hr in a 5 minute period, and a total of 30mm in an hour.

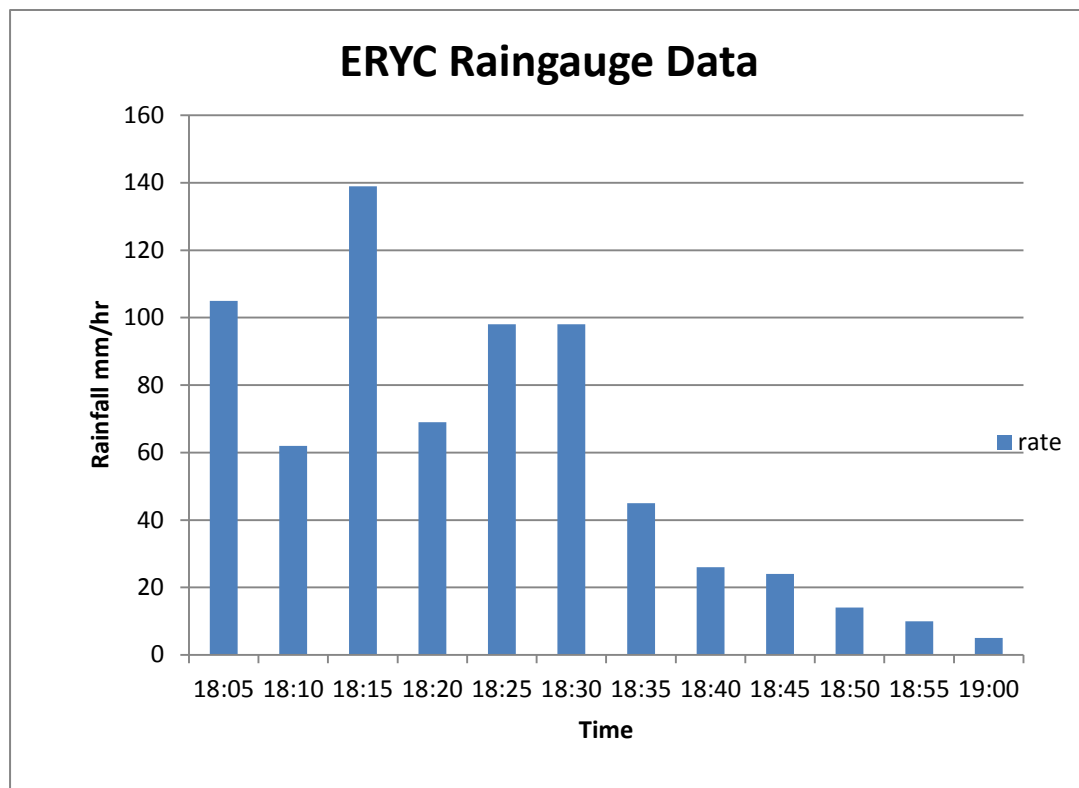
The council rainfall gauge in Market Weighton

This shows the peak rainfall rate of 139mm/hr in a 5 minute period, with 60mm falling in one hour, with some 50mm of rain in 30 minutes.

The long term average rainfall for the whole of July is 74mm.

The Council rainfall gauge in Market Weighton recorded a peak rate of 139mm/hr in a 5 minute period, with 60mm falling in one hour, and some 50mm in 30 minutes.

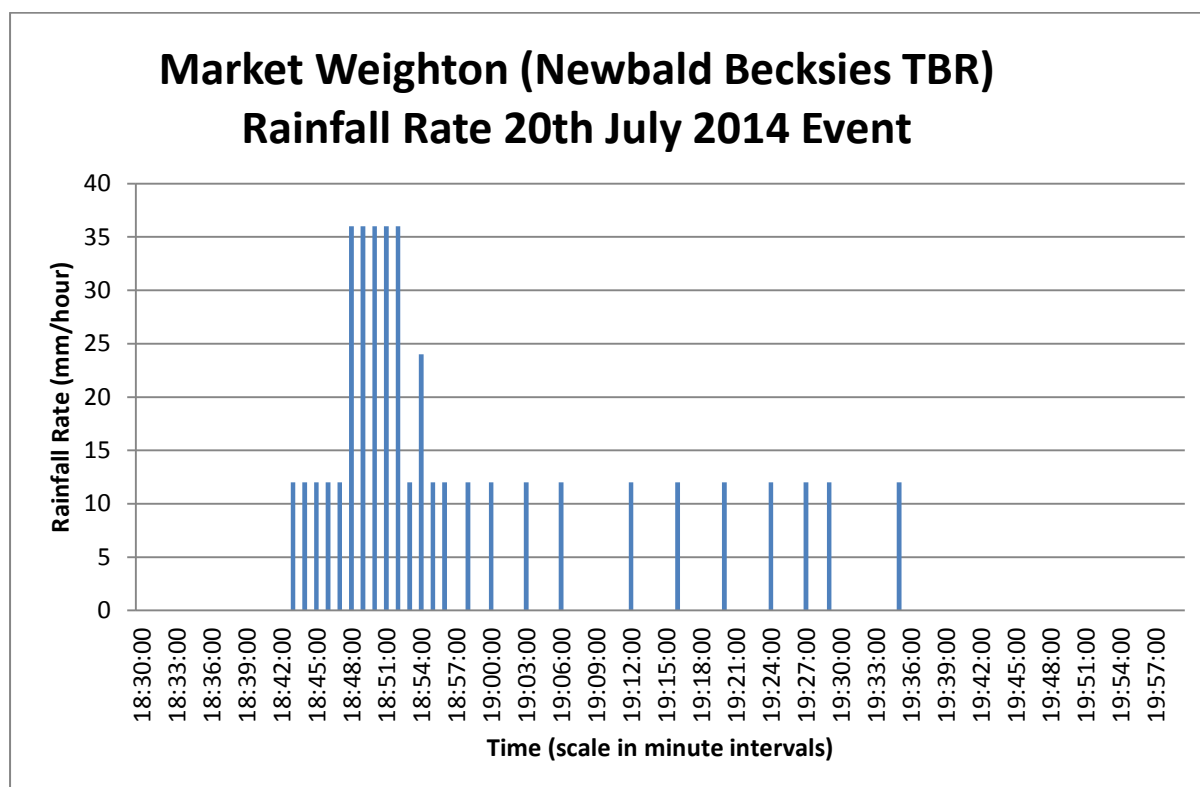
EA rainfall data from the rain gauge at North Newbald

This shows the peak rainfall rate of 36mm/hr in a 5 minute period, with 7.2mm falling in one hour.

Although the rain gauge is only 6km (3.5 miles) to the south of Market Weighton the recorded rainfall was much less than the estimated rainfall. This is consistent with the nature of summer storms, which often result in very localised intense rainfall such as has been experienced during the summer of 2014.

The EA rain gauge at North Newbald recorded a peak rainfall rate of 36mm/hr in a 5 minute period, with 7.2mm falling in one hour.

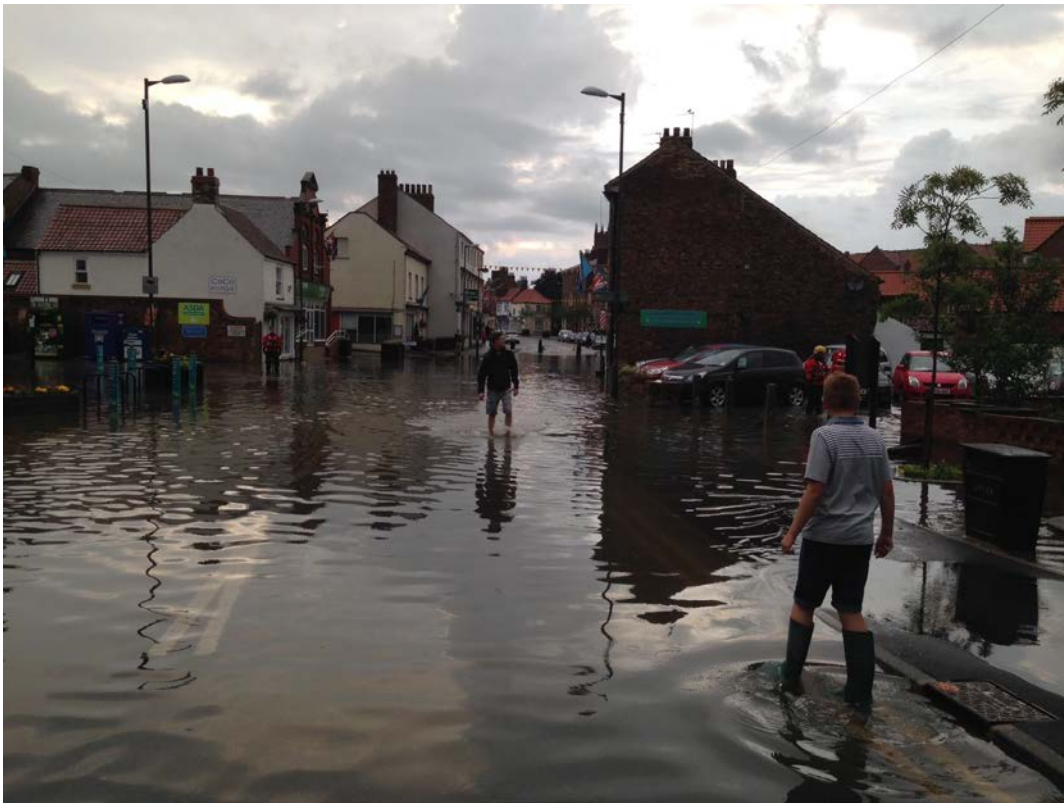
Photo 1: High Street and the Archway from Chapel Corner.

With surface run-off from the A1079, and the A1034 Sancton Road running overland into Southgate, the watercourses and drainage systems were overwhelmed. With run-off from Cliff Road also flowing into Southgate, running along Southgate into Hawling Road (see photo 7) and Scotts Croft following the natural contours of the land flowing towards the line of the Beck, surface flows also ran into Chapel Corner (see photos 1 to 4)

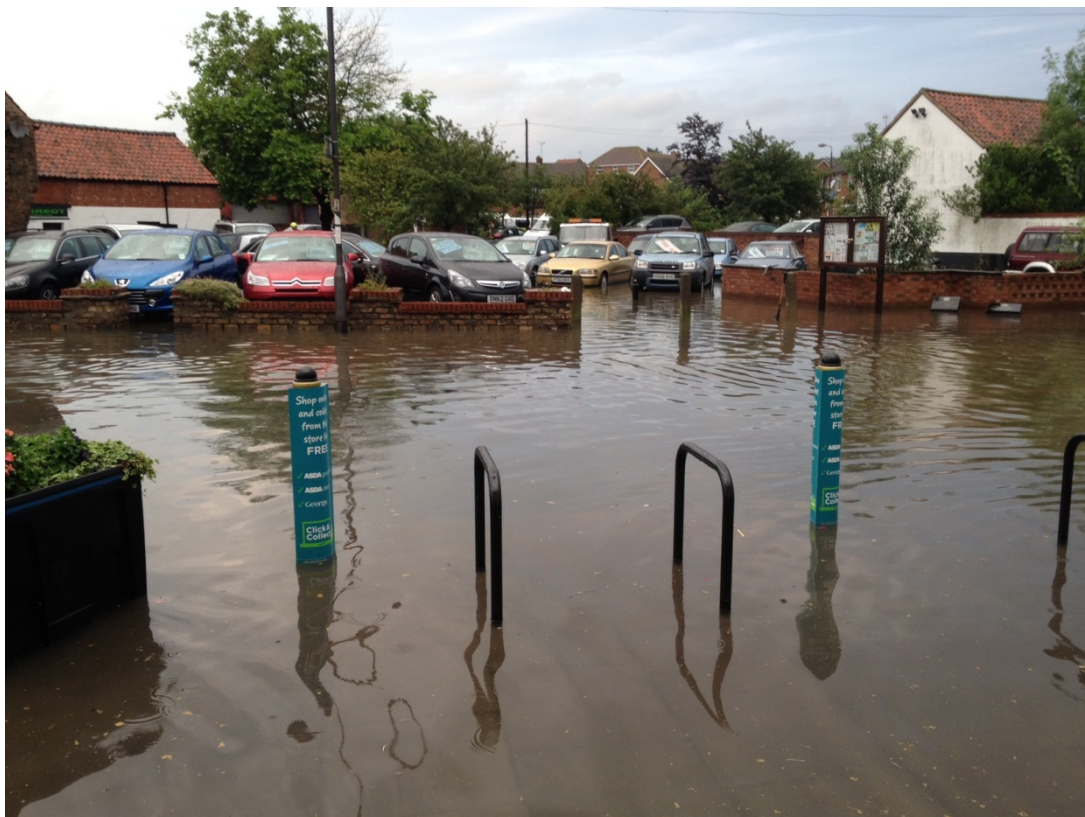
Photo 2: The Archway, as levels subsided

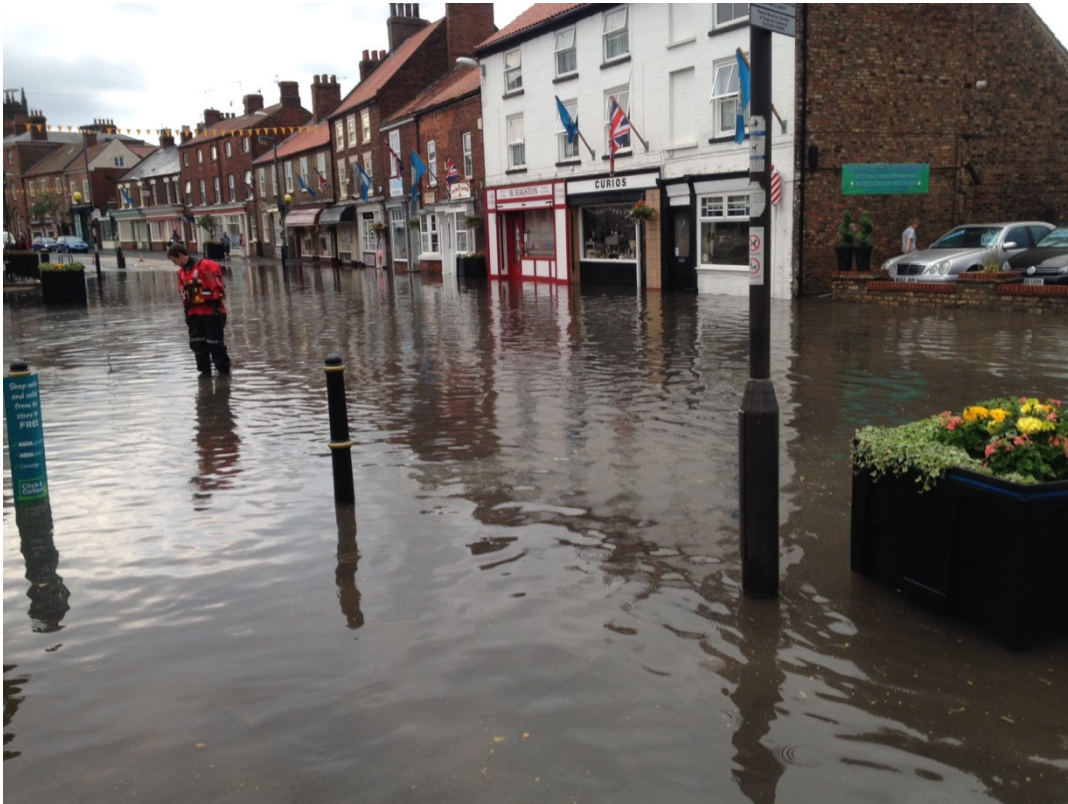
Photo 3: High Street looking west, from Chapel Corner.

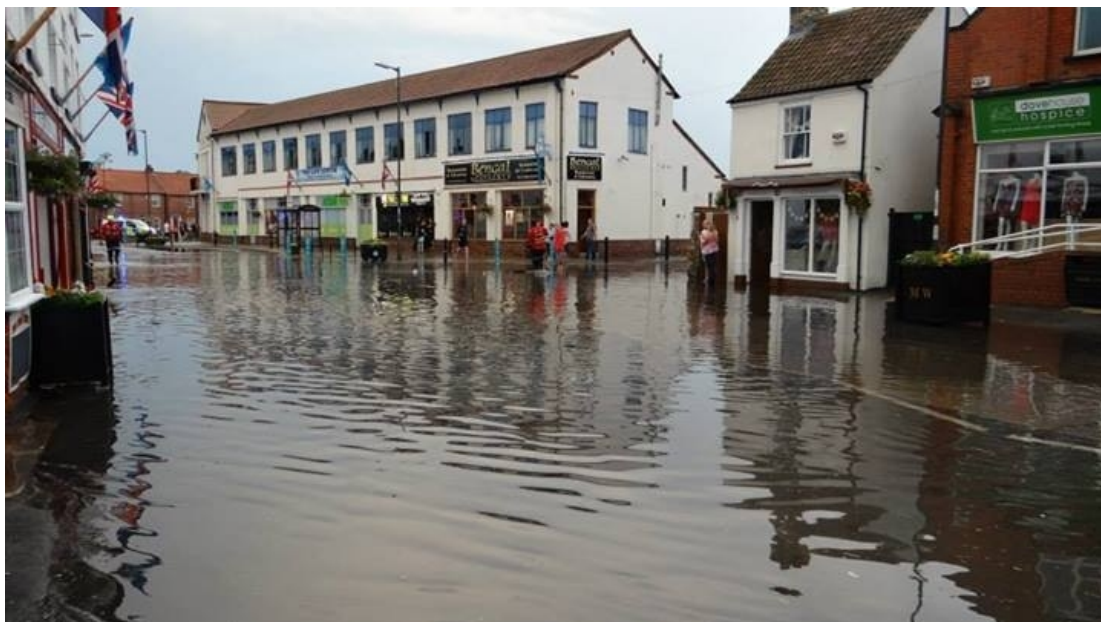
Photo 4: High Street looking east, from Market Place.

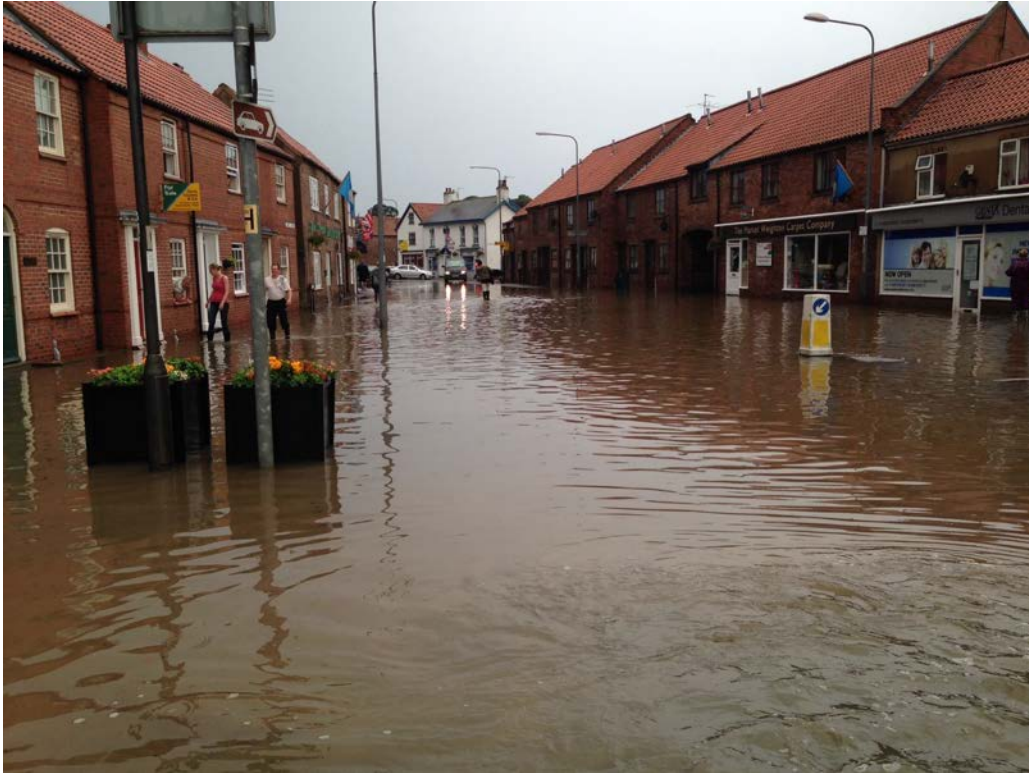
Photo 5: Southgate from Chapel Corner

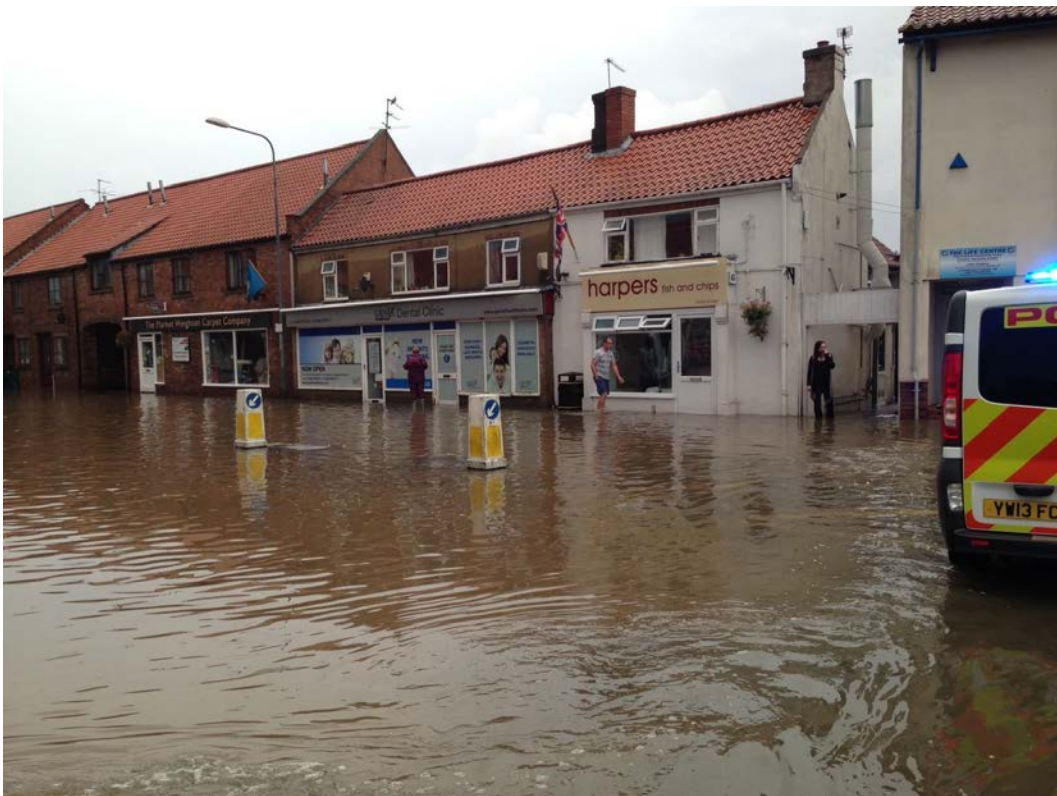
Photo 6: Southgate at Chapel Corner

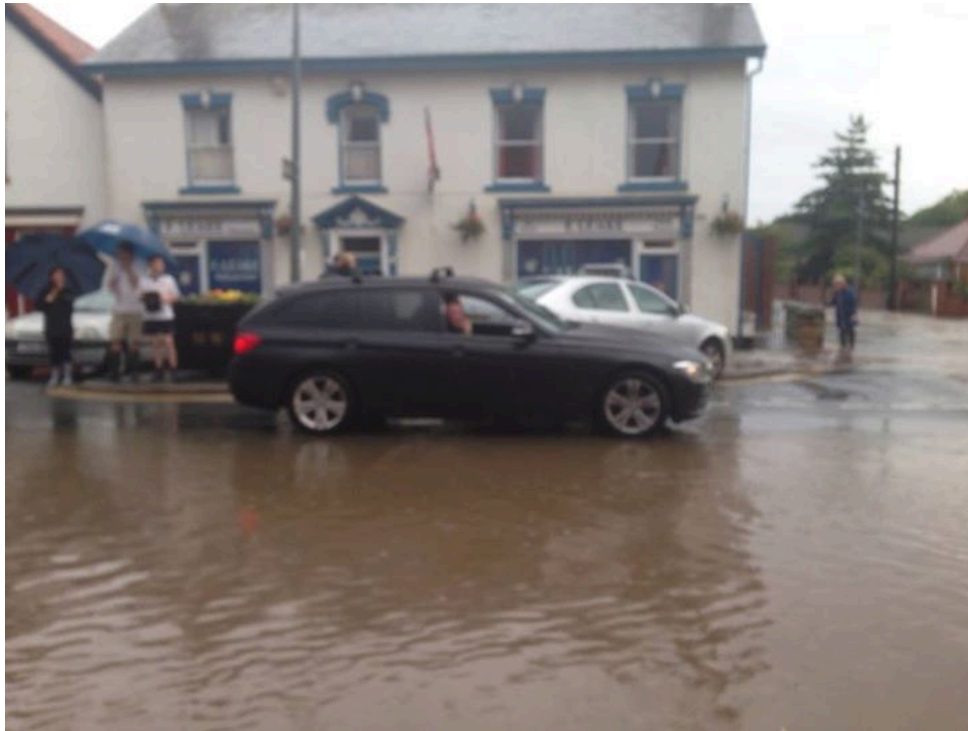
Photo 7: Southgate, showing water flowing down Hawling Road

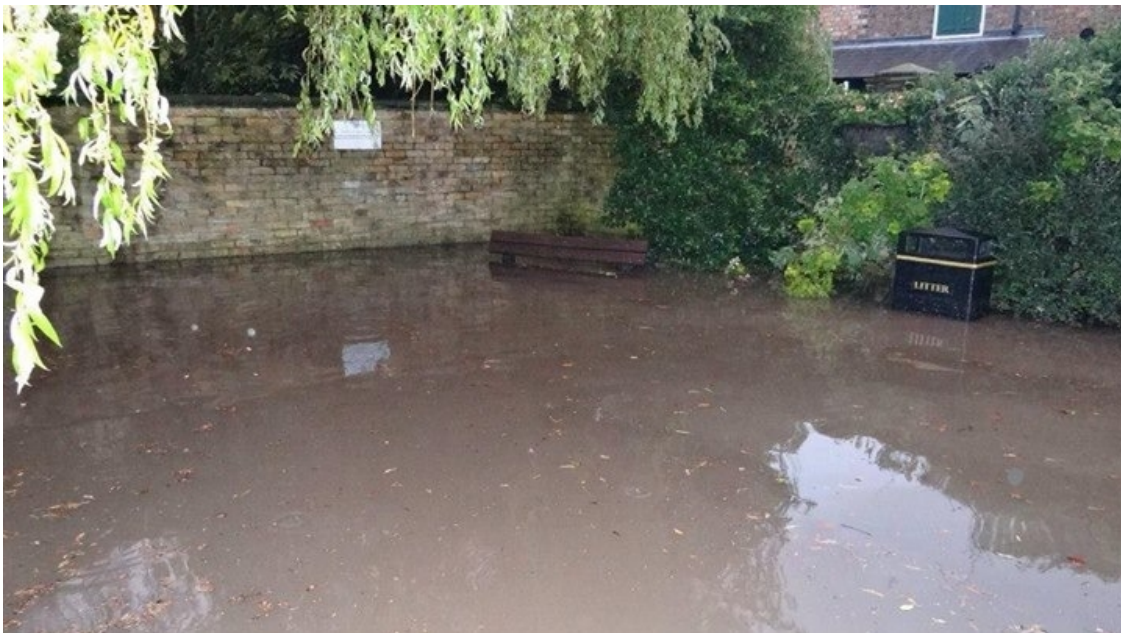
Photo 8: The Green, pond where the beck enters the culvert

It has been reported that water flowed down The Archway from the St Helen's Square/The Green area and into High Street. (see photos 8 to 10).

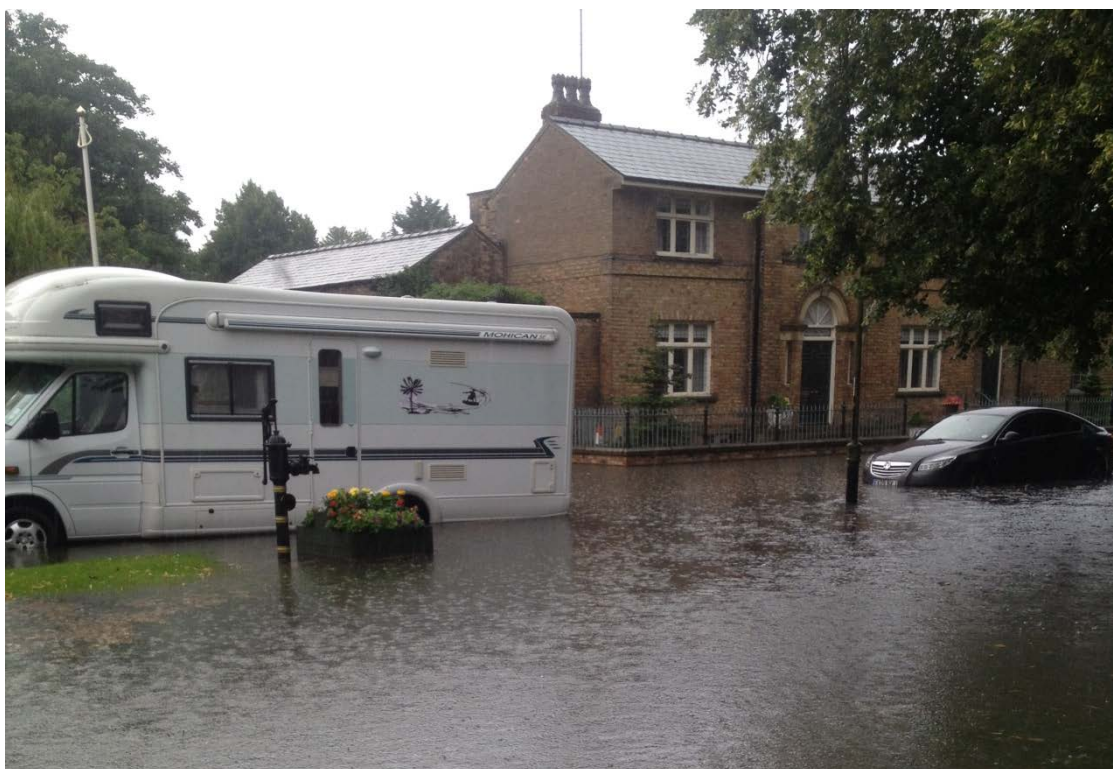
Photo 9: The Green/St Helens Square area

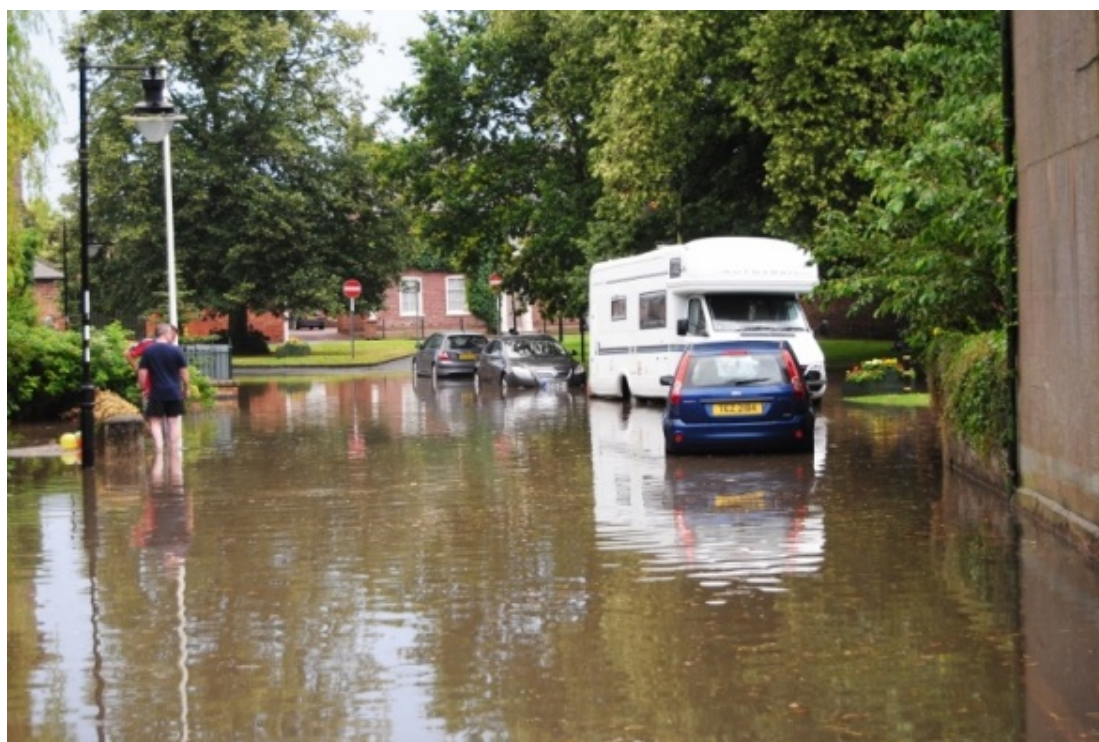
Photo 10: The Green/St Helens Square area after the rain

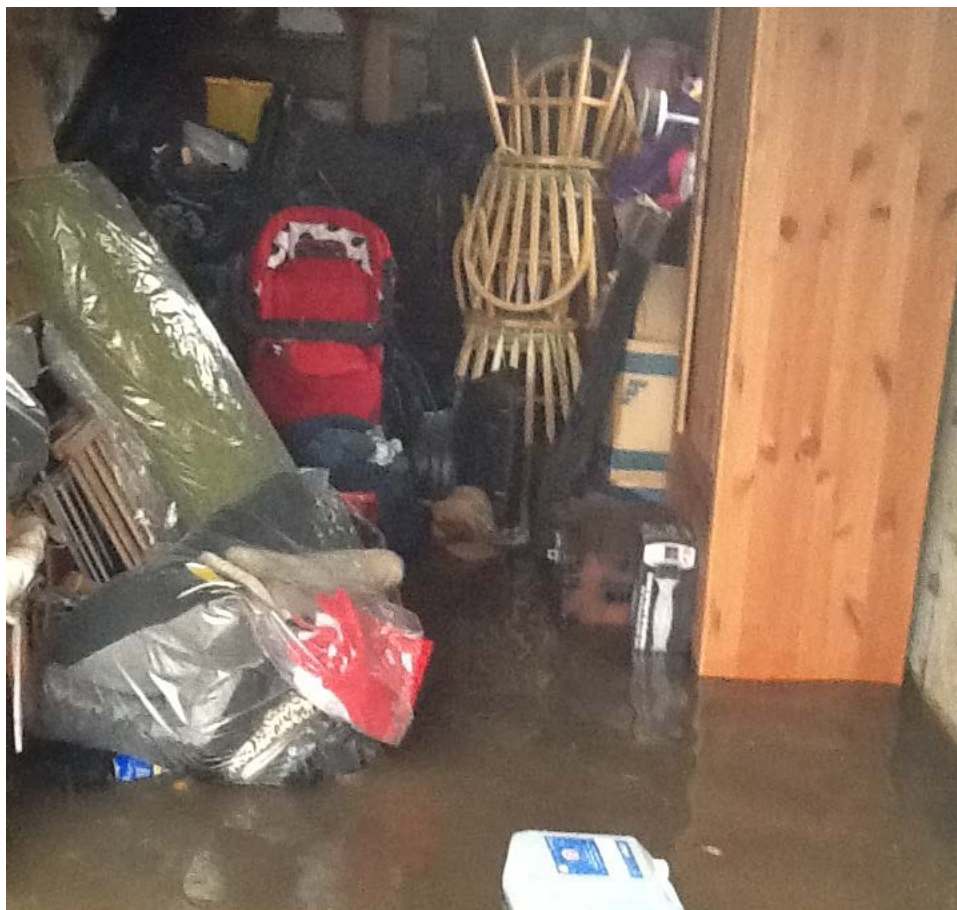
Photo 11: Flooded garage in Croft Close

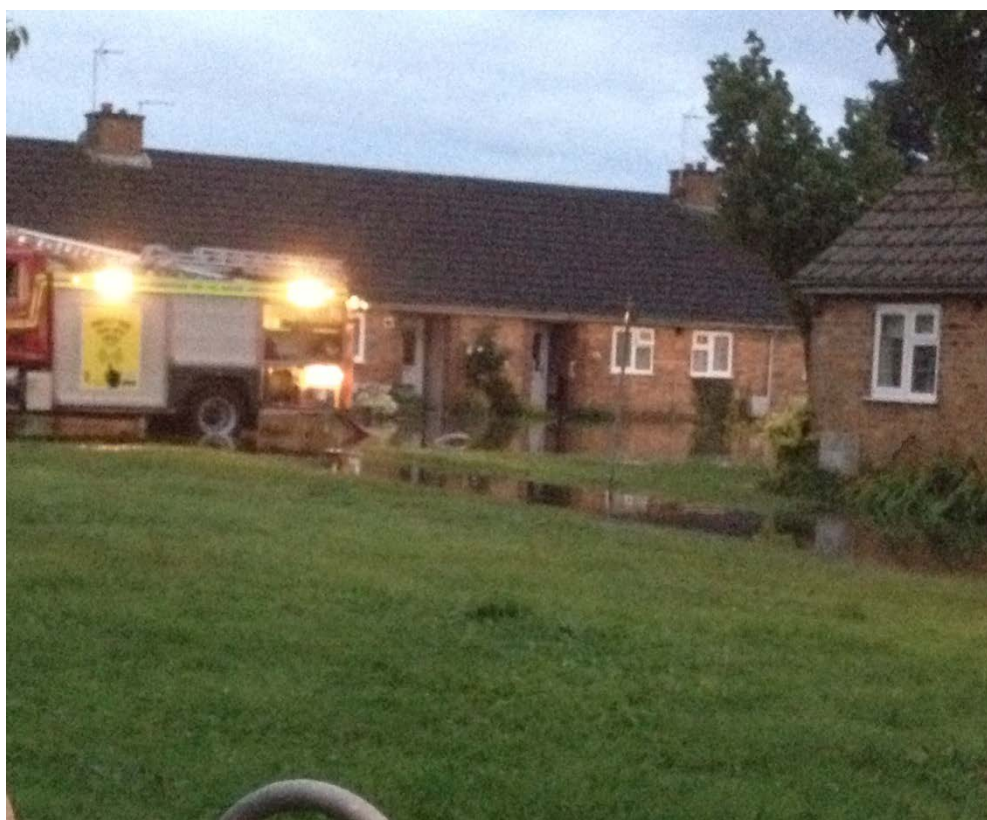
Photo 12: Croft Close with Fire Brigade in attendance

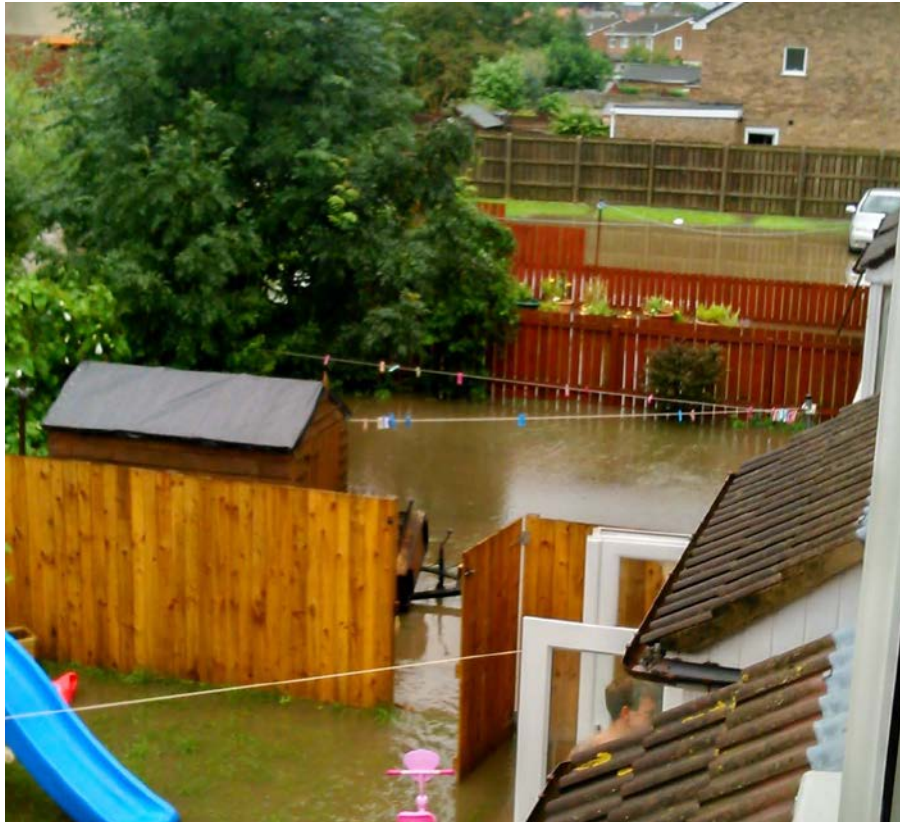
Photo 13: Gardens to rear of Wicstun Way

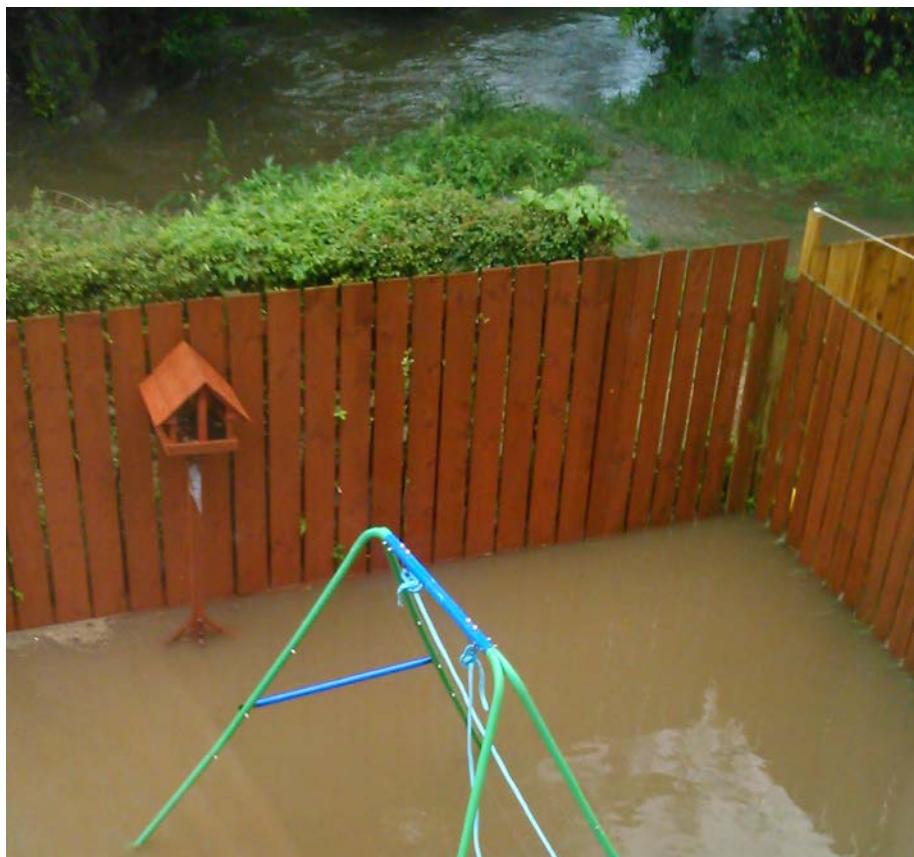
Photo 14: Gardens at Rear of Wicstun Way showing the beck

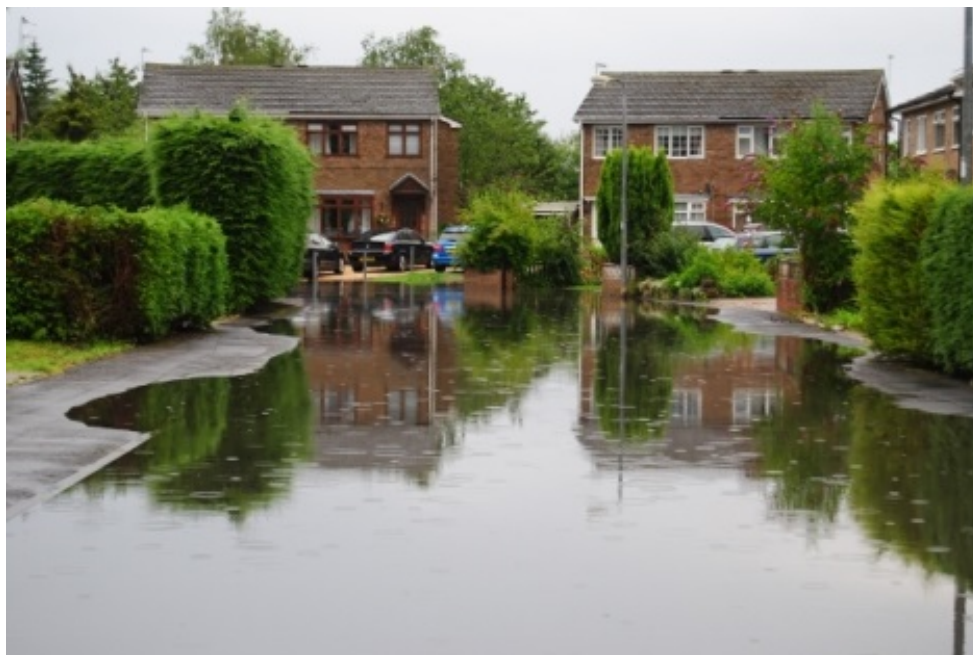
Photo 15: Northgate Vale, off York Road

Northgate Vale (see photo 15) which drains into the combined sewer network, suffered extensive highway flooding when the rainfall overwhelmed the drainage system. In the on-going development in Medforth Street the new health centre which was due to be opening imminently was flooded, it is believed from the buildings own drainage system, and this delayed the opening by several weeks.

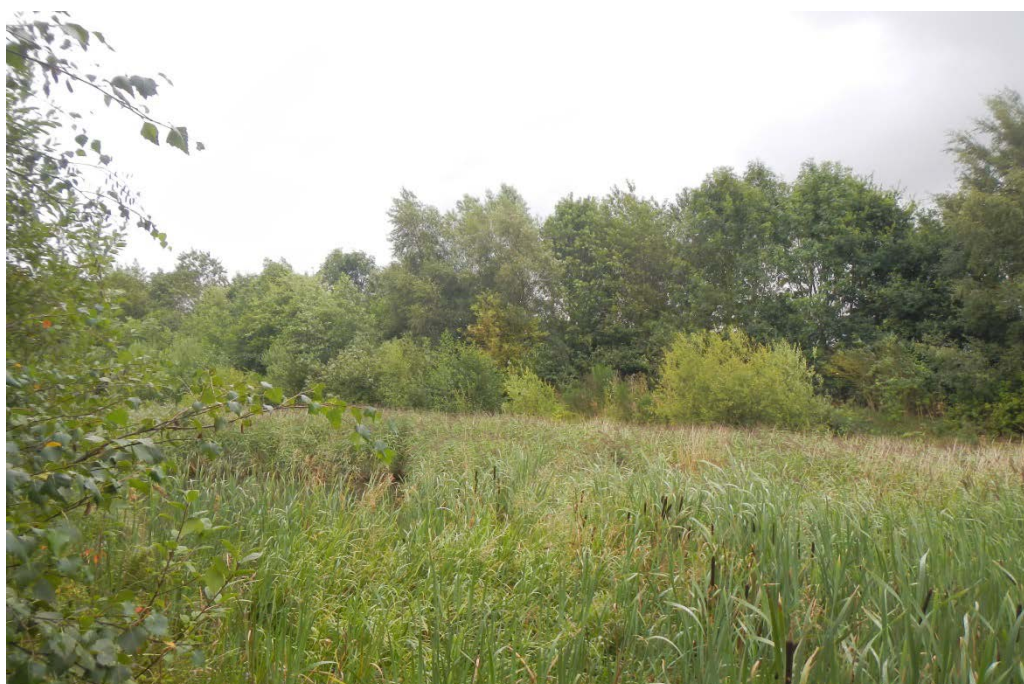
Photo 16: Storage lagoon off A1079/A1034
