Flood Investigation Report

Goole Floods 5th and 6th July 2012

December 2013

EAST RIDING
OF YORKSHIRE COUNCIL

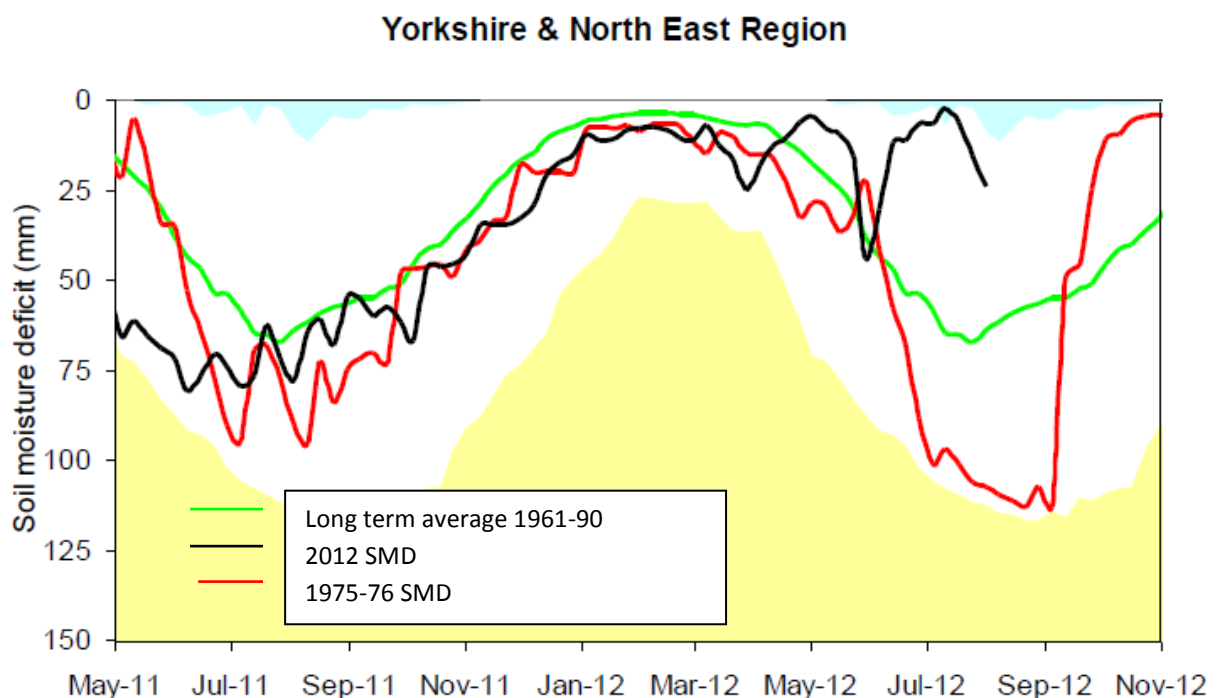
Figure 2: Soil Moisture Deficit prior to July 2012

The WSR shows that the SMD in Goole before the event was less than 10mm, indicating a wet catchment with little capacity to accept more rainfall. As such land drained by the Goole & Airmyn IDB drains would have been wet and responsive to rainfall. Despite this the IDB drains were operating normally prior to the event and maintaining normal water levels.

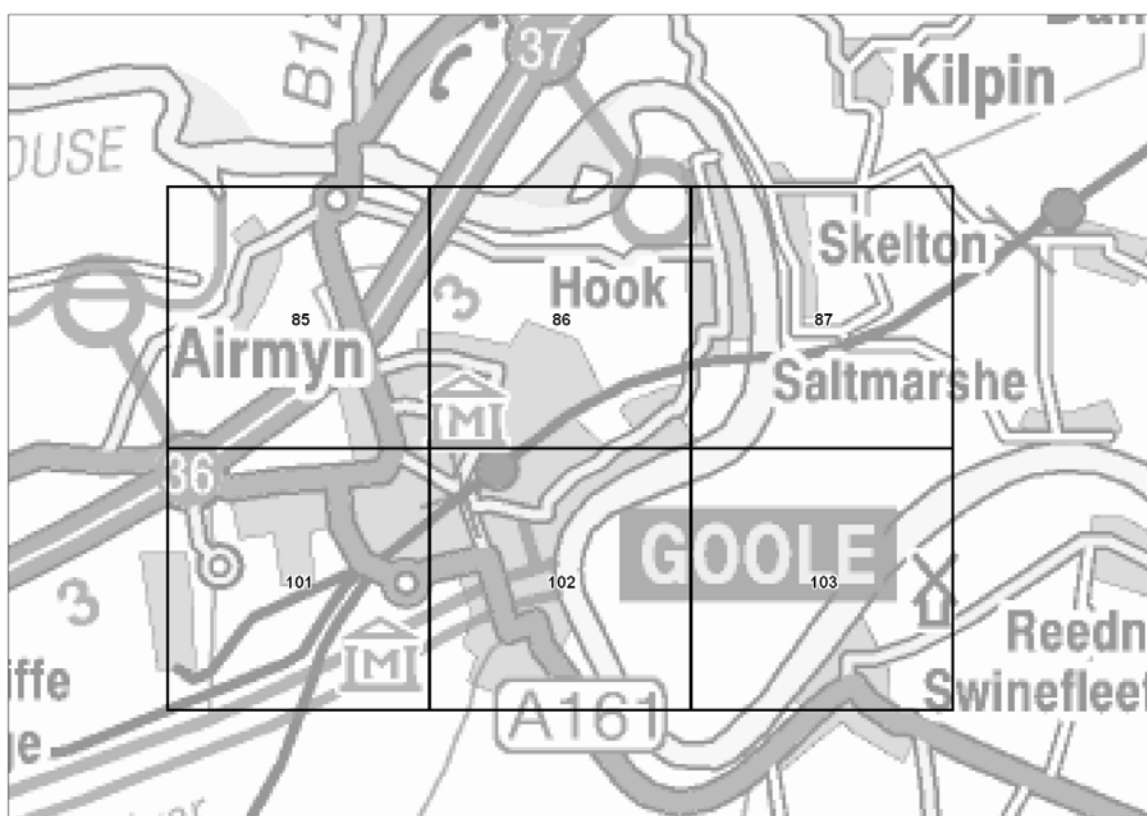
Figure 3: Met Office radar 2km grid coverage at Goole

Four radar grid cells cover Goole town. Cells 85, 86 cover Airmyn and Hook respectively and Cells 101 and 102 cover the south west and south east of Goole as shown in Figure 3: Met Office radar 2km grid coverage at Goole.

The nearest Met Office radar to Goole is at Ingham, to the south. The type of radar data available is Nimrod Corrected Single Site data, which has had appropriate corrections applied to it to compensate for atmospheric conditions. The Met Office also correlated the radar data with observations from rain gauges to further improve accuracy. This Nimrod corrected data provides the best estimation of rainfall using radar techniques.

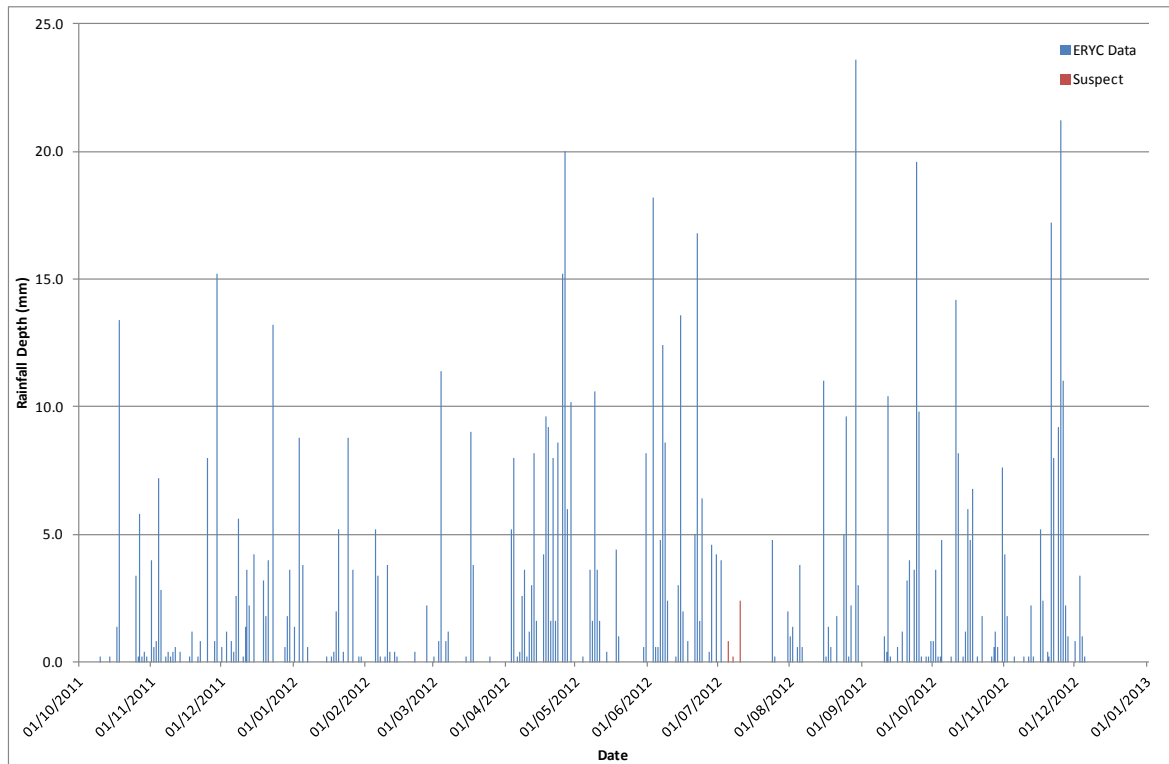
Figure 4 : Goole Rain Gauge daily observed rainfall

The Goole rain gauge was struck by lightning at 12:41 on 5th July. Data from this point up to its replacement on 24th July is not reliable. Figure 4 below shows a combined plot of all the rain gauge data that is available, with the unreliable data highlighted in red.

Key statistics recorded by the Goole rain gauge are as follows:

- The most significant event (in terms of volume) recorded in Goole since the installation of the rain gauge was an 80mm rainfall event covering a 10 day period starting on 17th April 2012. The estimated annual probability of this event is 1 in 7.4 years; and
- The most intensive rainfall event recorded was a 15-minute period during which 11.2mm (equivalent to 44.8mm/hr) was observed on the morning of 18th October 2012. The estimated annual probability of this event is 1 in 4.0 years.
- The Goole rain gauge station was struck by lightning at the start of the event and as a consequence, high resolution, localised data is not available for analysis.

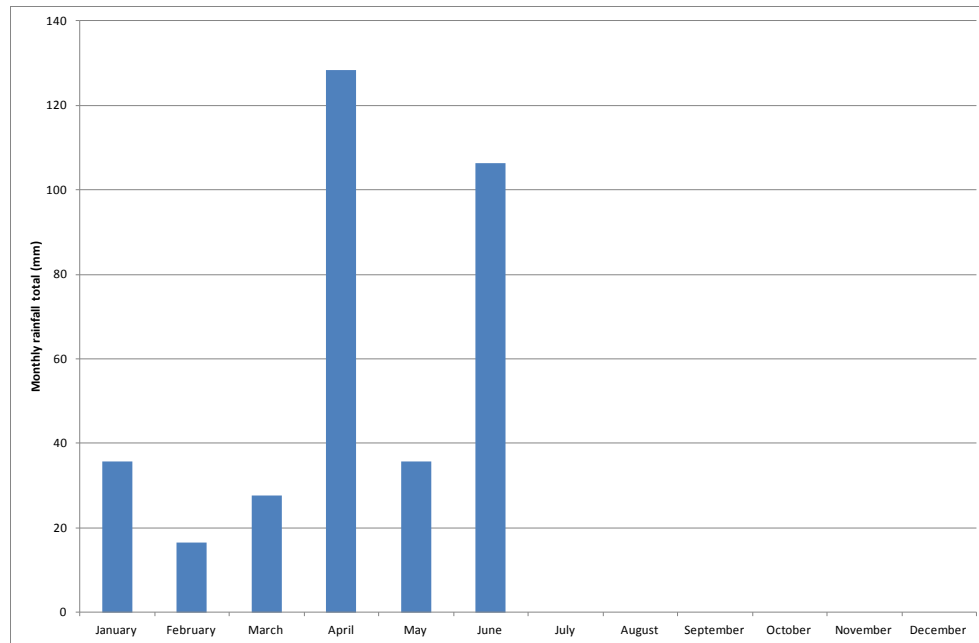
Figure 5 : 2012 Monthly rainfall totals at Goole rain gauge

During 2012 in the months before the flooding event, the Goole rain gauge recorded a total of 350.2mm of rain, as shown in Figure 5 below.

The Flood Estimation Handbook v3 (2011)⁴ indicates that Average Annual Rainfall for this location is 595mm. Unfortunately a full 12 months data is not available at the Goole rain gauge site, but from the 6 months data shown in Figure 5 it does suggest that Goole had received more than the average January to June rainfall prior to the flooding.

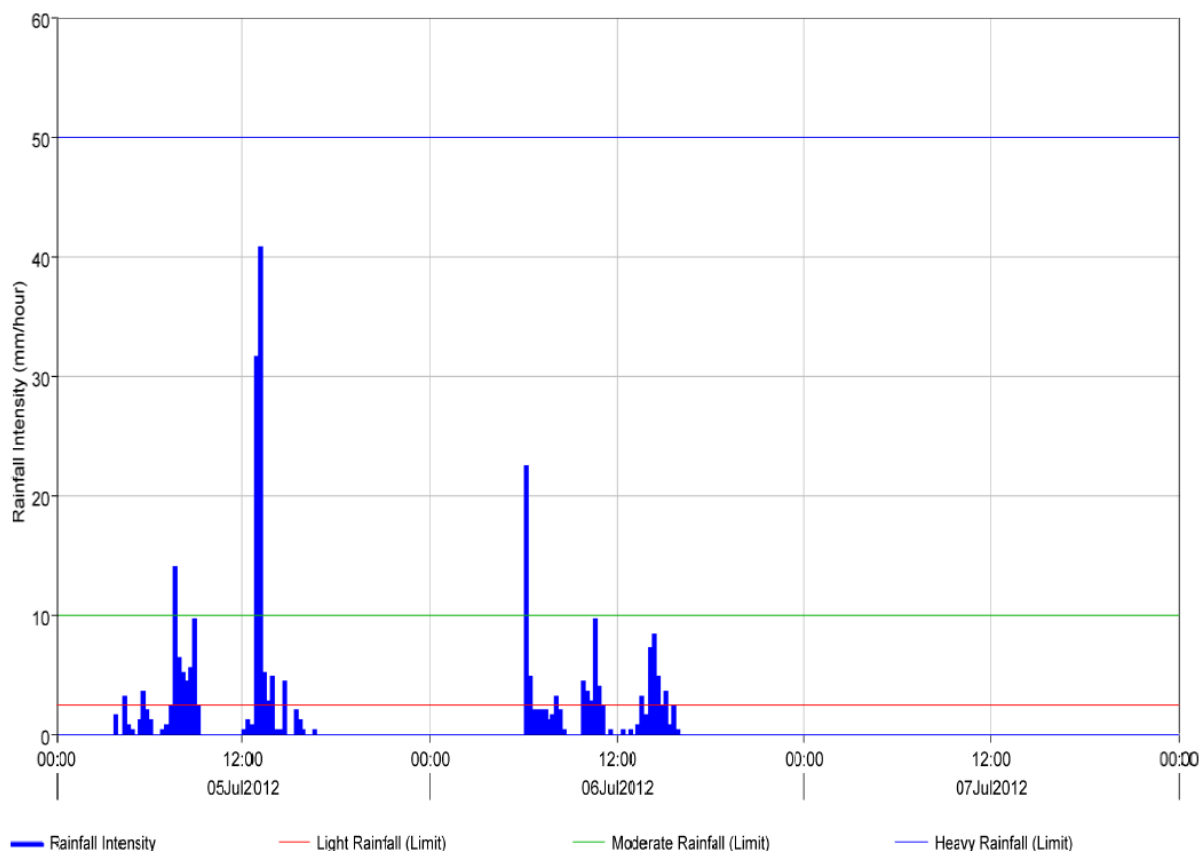
Figure 6 : Rainfall Event

The sub-daily data from the Met Office radar record for Cell 86 indicates that light rainfall on 5th July commenced at 04:00, briefly increasing to moderate rainfall at 04:30 and again at 05:45 until 07:45 when the intensity of rainfall briefly increased to heavy rainfall of 13.8mm/hr before falling back to moderate rainfall that lasted for over an hour before tailing off.

This first period of rainfall stopped at 09:45 and at no point did the rainfall in any 15-minute period exceed that expected from a 1 in 1 year return period event. Considering the cumulative rainfall that fell during this 5.75 hour period the event only marginally exceeded a 1 in 1 year event.

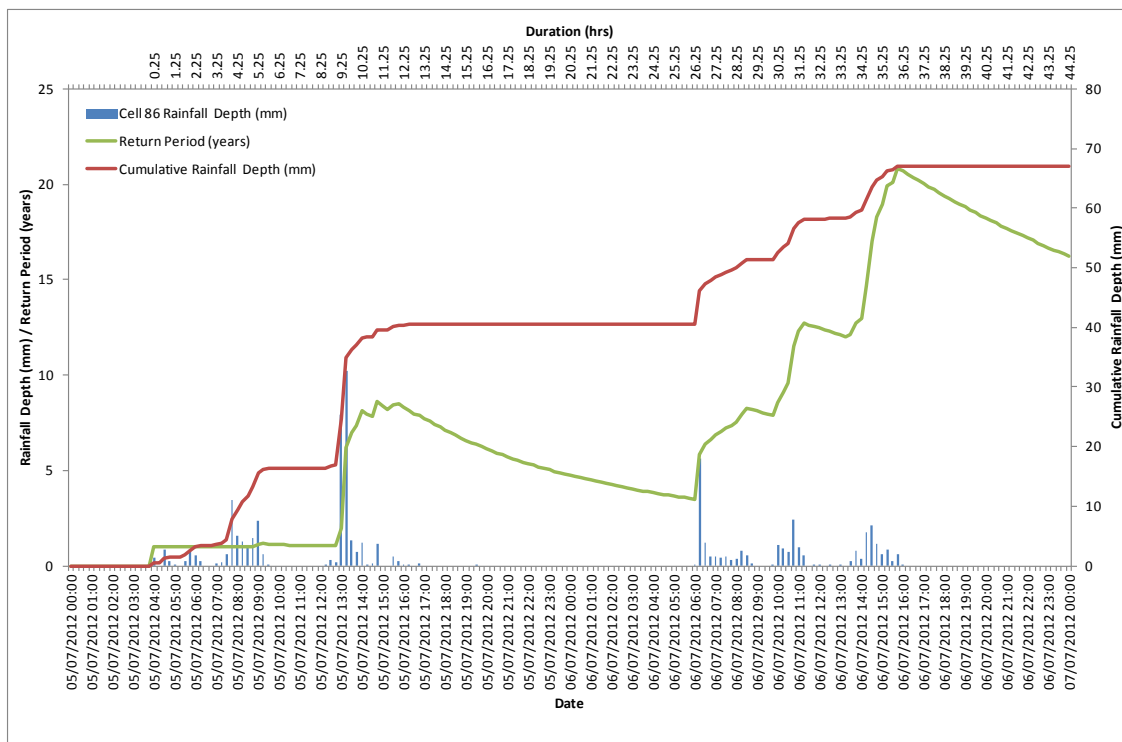
Figure 7 : Cell 86 rainfall depth, cumulative depth and return period

At its heaviest, the intensity of the rainfall on 6th July was only 22.4mm/hr. This equates to a 1 in 1 year event and is considerably less than that experienced in Goole on 5th July. Cumulatively, the rainfall on 6th July was not itself significant, with a return period of only marginally above 1 in 1 year. However, the cumulative rainfall that fell on Goole during the 36 hours spanning the two days of the floods has a calculated return period of 1 in 20.8 years.

Figure 7, shows a plot of the rainfall depth versus time from the radar data in radar Cell 86. The figure also shows the cumulative rainfall depth and the calculated return period on the same time axis.

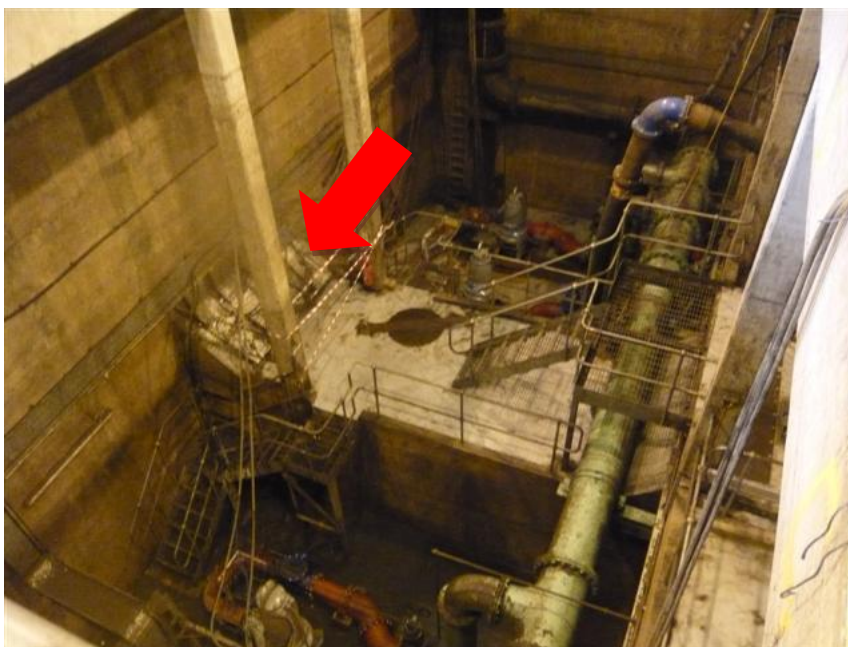
Figure 8 : Normal location FFT pumpsets junction boxes.

The telemetry data shows the two FFT pumpsets operating appropriately until just after the flooding of the dry well on 5th July after which they both stopped or failed in succession. These failures are understood to have been due to water ingress into the main junction boxes, where the power cables from each of the FFT pumpsets connect to the main power cables. These junction boxes were located within the dry well area as shown on the Figure 8.

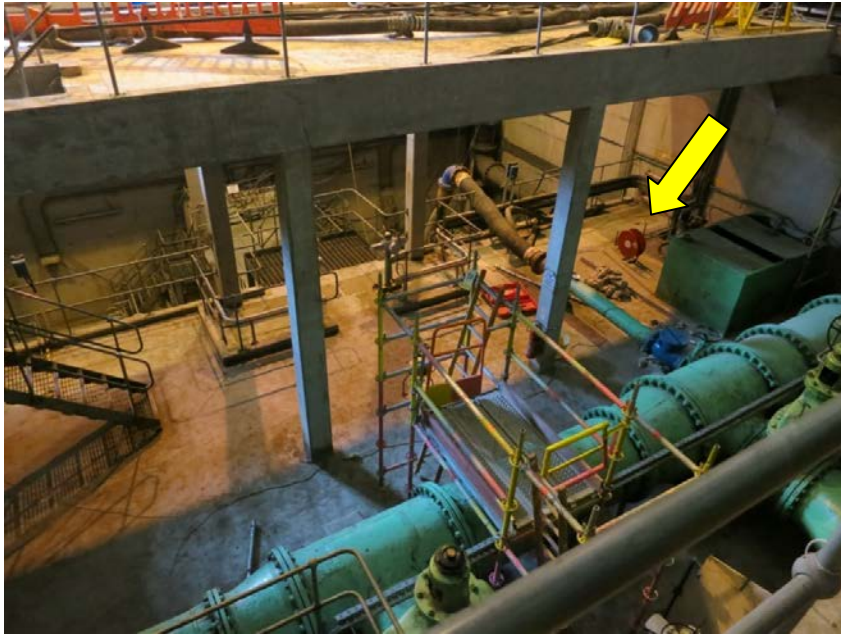
Figure 9 : Location of Manhole Cover B

At around 14:15 on 5th July a “bang” was heard by the contractors on site from within the dry well at Carr Lane PS. This “bang” was the sound of the cover over manhole B either coming out of its frame or the falling to the slab level within the dry well. Thereafter the contractors observed wastewater surcharging from the storm pump wet well into the main dry well through this manhole.

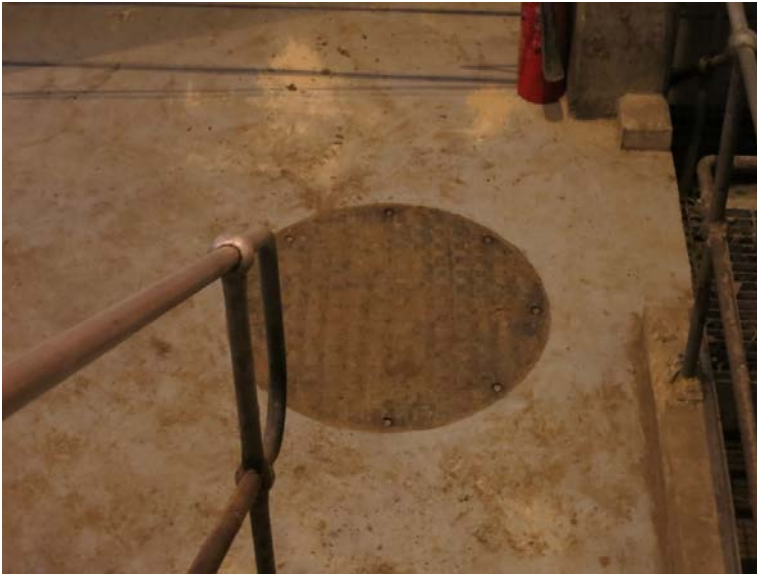
Figure 10: Typical manhole cover detail within Carr Lane PS

Figure 10 below shows a typical manhole cover within Carr Lane PS, but not manhole cover B. The cover in the photograph has 8 holding down bolts correctly installed.

- 1) That there was no visible damage to manhole cover B after it was subsequently found in the dry well when the pumping station was eventually pumped out.
 - 2) There was no evidence of any corrosion on the cover or the cover frame associated with manhole B,
 - 3) There were no stripping of the threaded holes within the frame (or the manhole cover) of manhole B,
 - 4) That there was no evidence of any sheared bolts as a result of the failure of manhole B.
- YWS and their contractors have confirmed that there was no evidence of any bolts having been in the cover at the time.

Based on the available evidence the most probable failure mechanism is that manhole cover B was not bolted into its frame when the inflow of waters passed into the storm pump wet well and surcharged it to soffit level.

At this time it would have been possible to replace and bolt down the manhole cover that had come off.

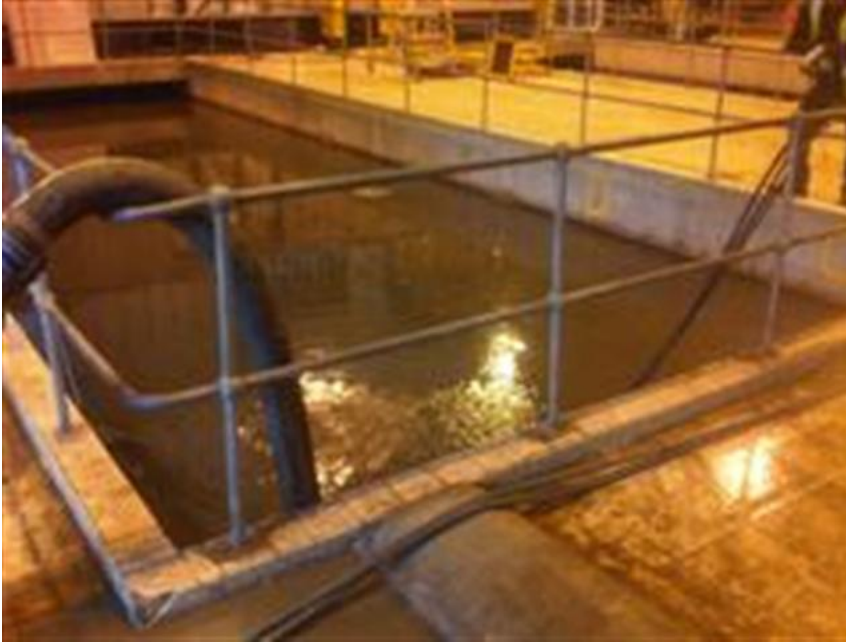
Figure 11 : Dry Well at Carr Lane PS flooded

At 14:21 a storm pumpset failed as flood water levels continued to rise in the dry well. A second storm pumpset failed at 14:39 on 5th July and the third failed at 15:09 whilst the dry well was over 80% flooded.

The failure of each of the storm pumpsets reduced the outflow capacity of the pumping station, decreasing its ability to remove water from the Goole sewer system. It is this mechanism that resulted in water levels rising sufficiently high to add to the flooding in some areas of the Goole catchment.

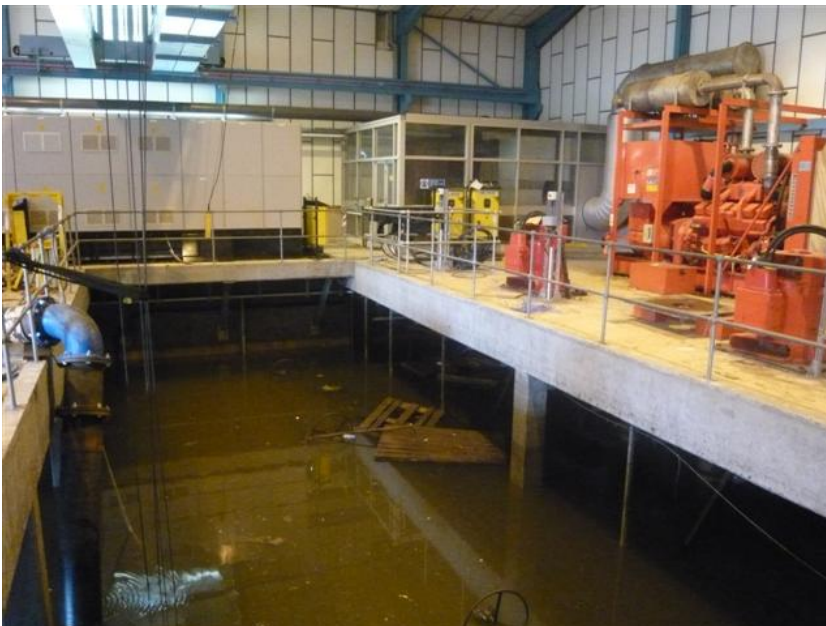
Figure 12 : Overpumping operations of the Carr Lane PS dry well

At around 19:20 on the 5th July YWS started tankering operations to extract flood water from Carr Lane PS dry well.

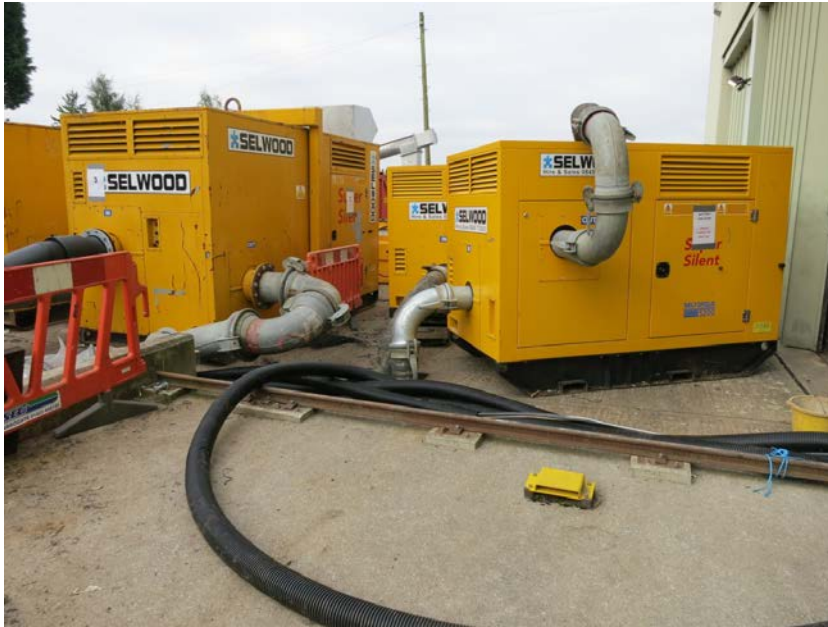
Figure 13 : Temporary
Selwood S200 pumpset

Following the initial flooding of the dry well, YWS arranged for two 8" temporary diesel pumpsets to be brought to the Carr Lane PS. These pumps were located at the front of the pumping station (see Figure 13) and commenced over pumping operations at 00.25 on the 6th July. Overpumping using the two 8" temporary diesel pumpsets continued as required until approximately 14:00 on the 7th July.

These pumps were fitted with 8" flexible pipe discharging into the field some 20m west of the pumping station. This operation was done following YWS's confirmation to the EA.

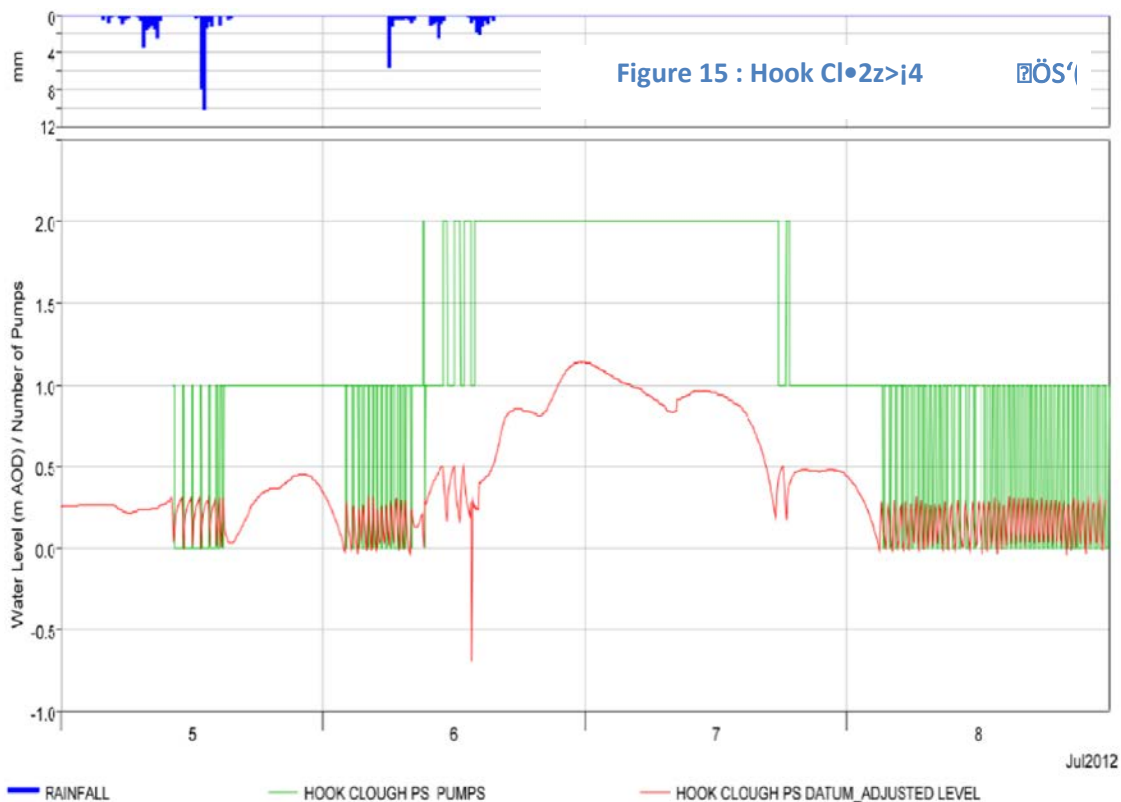
IDB telemetry data for Hook Clough PS (see Figure 15) shows that a pumpset started operating from around 09:45 on the morning of 5th July to manage water levels from the rainfall. The pumpset operated normally (i.e. oscillating on and off to maintain levels at 0.5m AOD or lower) except for a steady on period between 14:45 and 02:00 on the morning of 6th July.

At about 08:00 on 6th July a pumpset switched on in response to water levels that would not drop below the initial 0.3m AOD cut off point. This pumpset stayed operational until 09:15 when the two pumpsets swapped duty rotation.

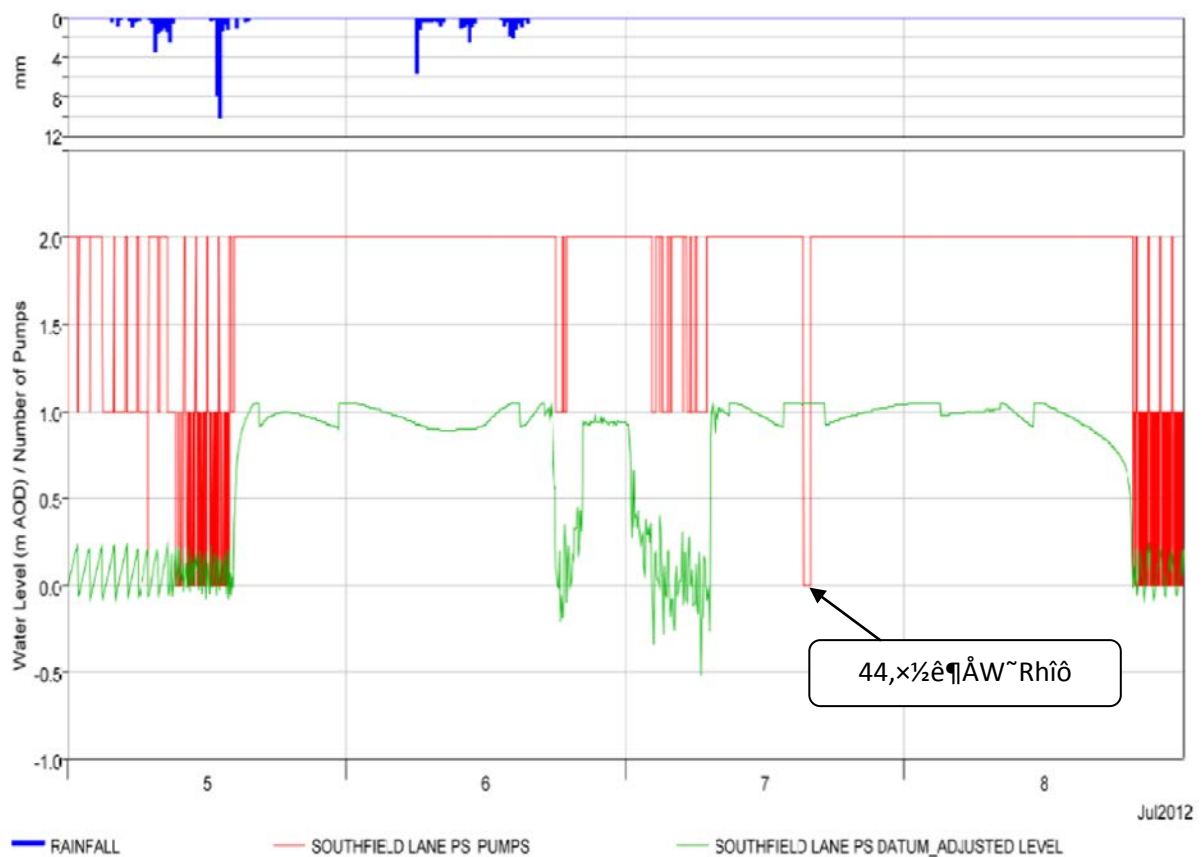
Figure 16: Southfield Lane PS data

IDB telemetry data for Southfield PS (see Figure 16) shows that the pair of 26 l/s pumpsets were operating normally in a regular saw-tooth pattern prior to the event.

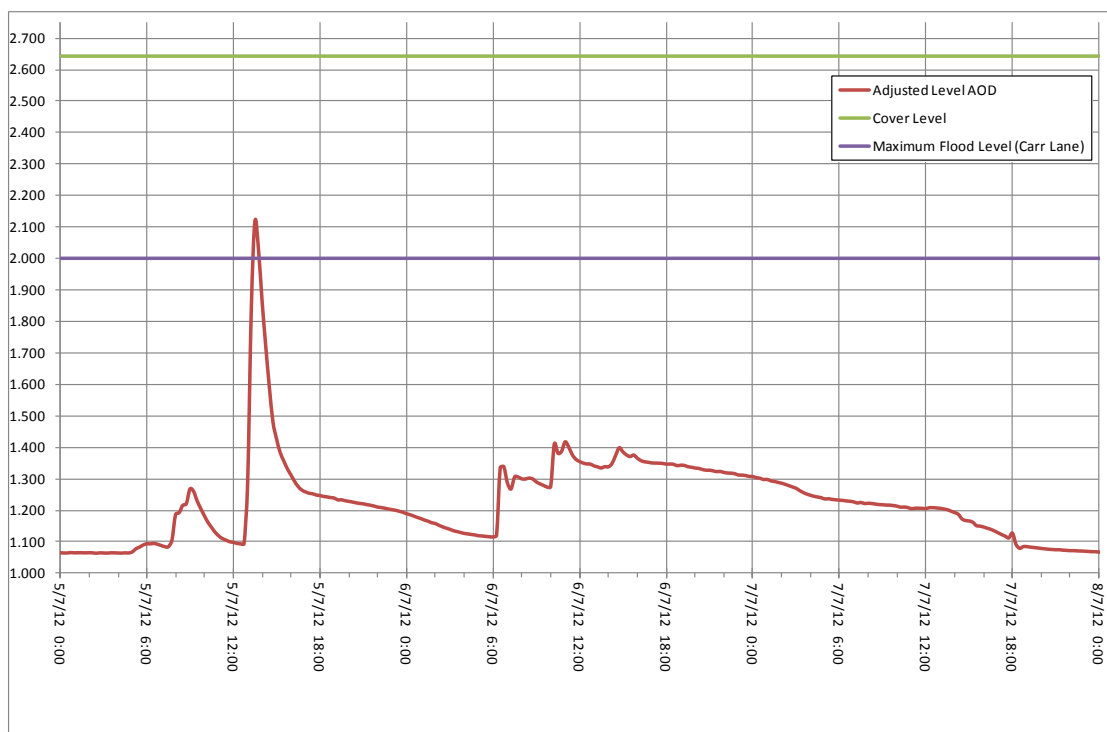
Figure 17 : Hook Drain telemetry data

ERYC maintains a water level telemetry monitoring system in Hook Drain near Marlborough Avenue. The relevant data is shown in Figure 17 below.

The level records are from the southern extent of the culverted watercourse, in the centre of Goole, and in an area where it receives predominantly overland flow.

The records for Hook Drain following the rainfall experienced on the 6th July again show a short response period typical of a highly urban run-off. Levels however only dropped back to normal gradually over an extended period. This is indicative of surcharge in the downstream system. The levels only drop to normal once the Hook Clough PS has cleared significant volumes by late afternoon on the 7th July.

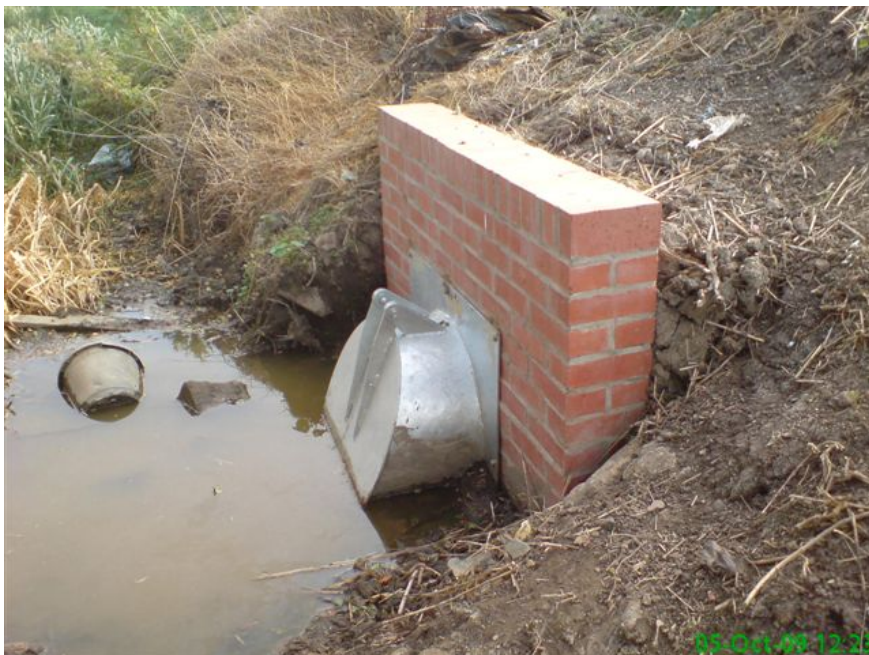
Figure 18 : Flap valve installation at the northern end of Hook Drain

The impact of downstream water levels and flow restrictions affects surcharging and flooding throughout the various drainage systems in the town.
