Flood Investigation Report

Section 19, Flood & Water Management Act (2010)

Upper Calder Valley – 6-9th July & 25th August 2012

Document Title: Upper Calder Valley – 6-9th July & 25th August 2012 Flood
Investigation Report

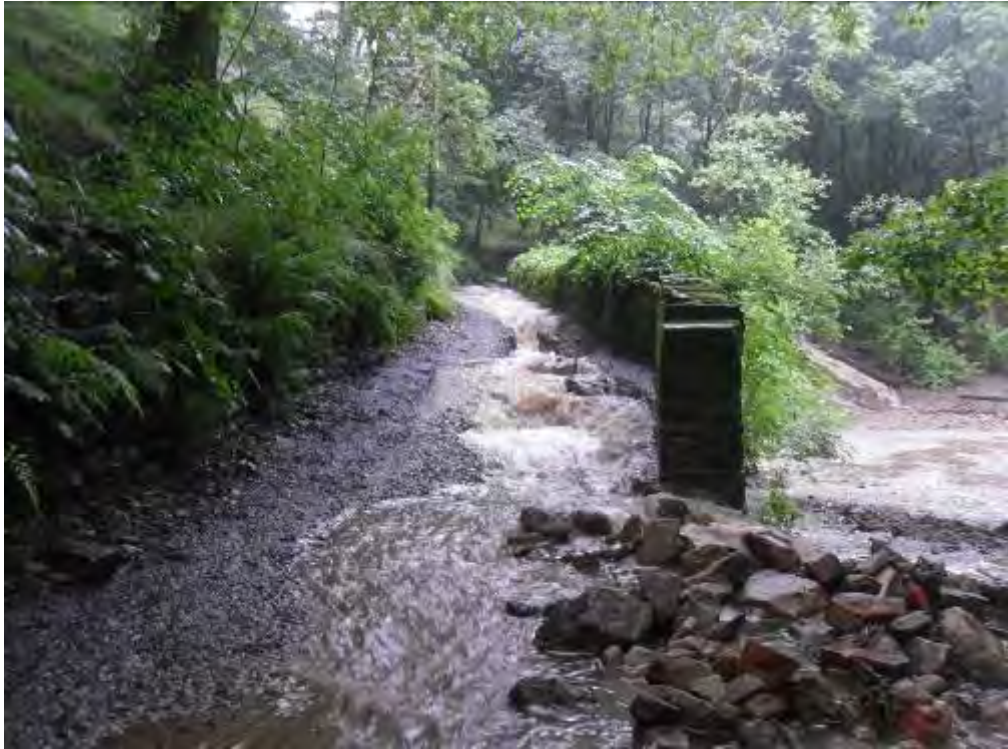
The reservoir spillway and overflow was unable to contain the flood water, which eventually split, part flowing down the adjacent access track (see Figure 2).

Figure 2 - The access track adjacent to Nutclough Reservoir being eroded by floodwaters from the spillway, which flowed onto the A6033.

Nutclough Reservoir is under review and awaiting further repairs to the reservoir spillway and culverts. A more detailed study of the flood mechanisms and reservoir structure in this location is being discussed

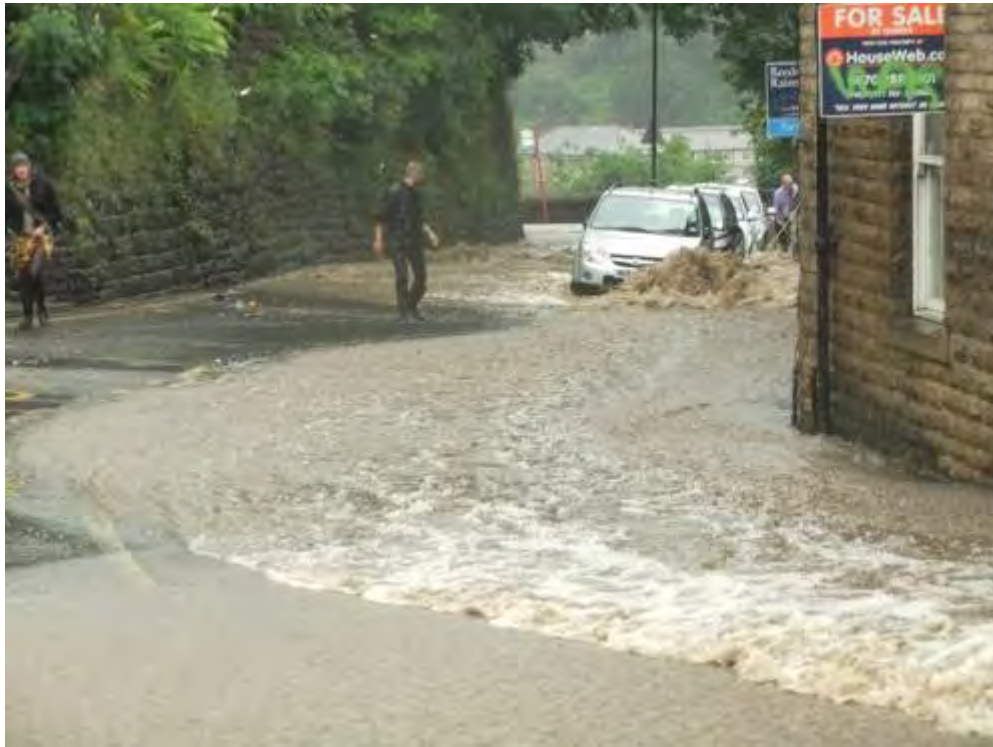
The surface water from Nutclough reservoir spilled onto Nutclough Road and onto the A6033 at approximately 2.30pm. The surface water carried a mixture of stone and tree debris, onto the A6033. Depth of water was estimated to be 200-300mm across the carriageway. Properties along the A6033 and Foster Lane at the junction with Nutclough Road required sandbag protection at doorways as flood waters reached threshold level of the properties. Approximately 11 properties and 1 commercial property were affected at the discharge point onto the A6033 (see Figure 3).

Figure 3 - Flood waters and debris from a combination of Nutclough Reservoir overflowing and Keighley Road.

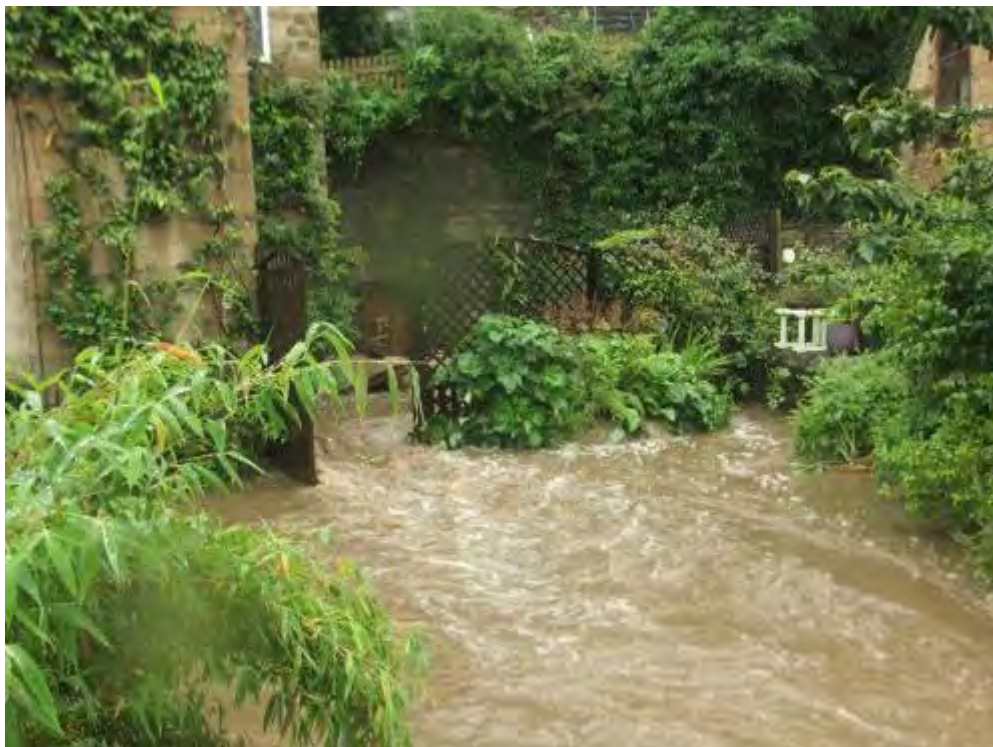
Figure 4 - Flood waters from Nutclough Reservoir overflowed a retaining wall behind residential properties, flooding the properties and spilled onto the A6033. Depth of water in photograph is approximately 300-400mm.

The culvert discharging water from Nutclough Reservoir to the Hebden Water, became blocked and flood waters built up against the retaining wall behind

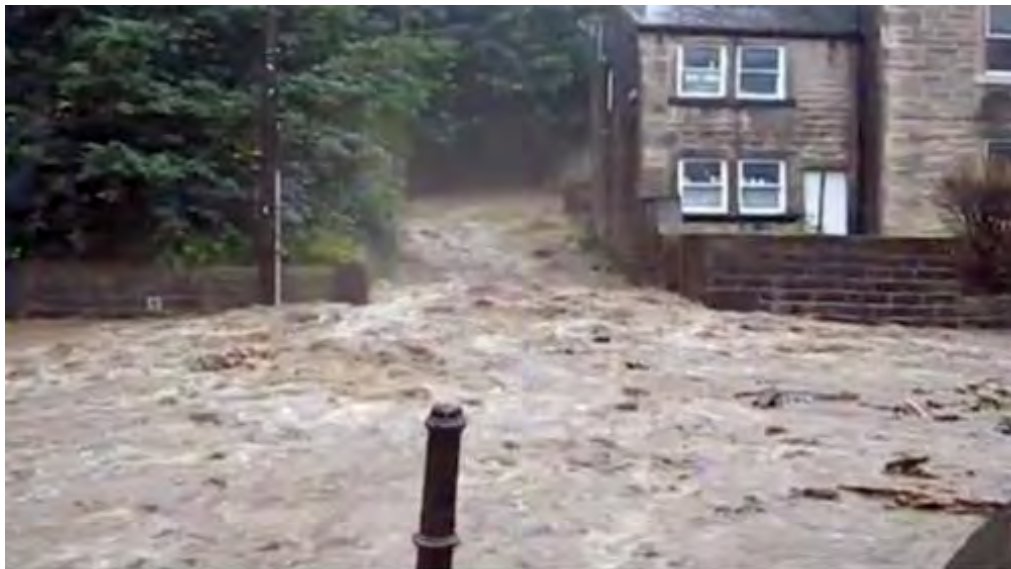
A small watercourse adjacent to the junction of the A646 and Station Road, became blocked and spilled onto both these roads. Excess rainfall on this small, flashy catchment had resulted in a significant amount of flow, which mobilised a large volume of debris in the watercourse (see Figure 5). The watercourse feeds into a drainage system, which flows under the A646. The entrance to the culvert became blocked with debris, which resulted in the majority of the flow bypassing the culvert entrance and flowing onto the A646, across Princess Bridge and onto Station Road.

Figure 5 – Watercourse opposite Station Road overtopping flooding Burnley Road and depositing a significant volume of debris on to the highway.

There was severe damage to several culverts across the borough. These were assessed and prioritised. The unnamed watercourse opposite Station Road, Hebden Bridge was cleared. The culvert entrance at White Lee Clough and at Nutclough reservoir has been cleaned of debris. The White Lee Clough culvert collapse was repaired. All other works to culverts identified for repair in the aftermath of the flooding has been completed.

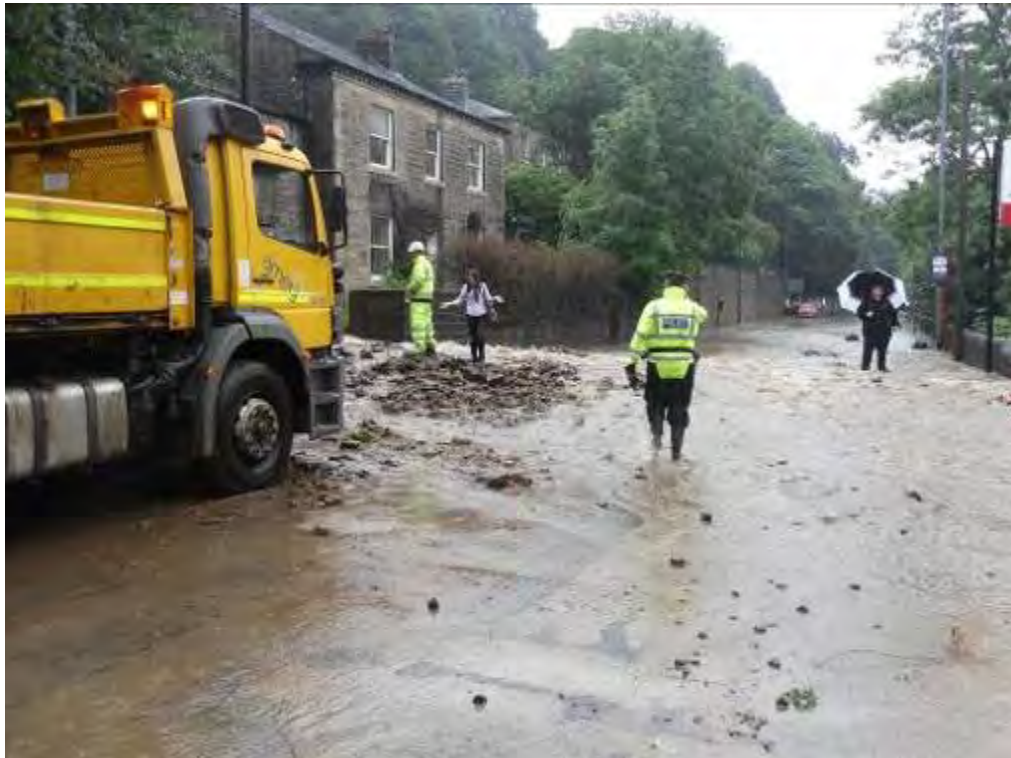
Figure 6 – Police, Amey LG and Calderdale Council cleaning up the debris and repairing the damage after the peak of the rainfall on the 9th July.

A significant amount of debris was transported and deposited onto the highway resulting in the road being closed (see Figure 6). The excess surface water flowed onto the two adjoining roads, onto the playing fields and alongside Mayroyd Cottage. Flood waters also directly entered the canal. Highway drainage systems along the A646 towards Mytholmroyd discharge surface water to the Rochdale Canal. The excess surface water from the small watercourse on A646 in part flowed back into the Rochdale canal putting pressure on the capacity of the adjacent pound.

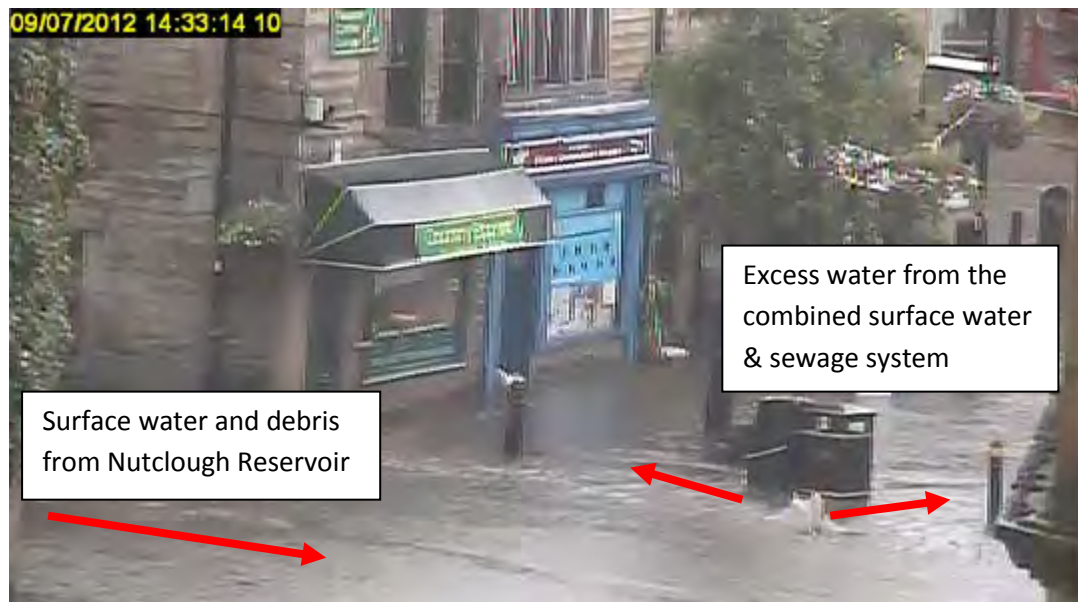
The high intensity rainfall and the overtopping of Nutclough Reservoir caused localised flooding on St Georges Square and New Road. Figure 7 below shows that the drainage system on the corner of St Georges square was unable to cope with the heavy downpour.

Surface water and debris from Nutclough Reservoir started to enter the square at approximately 3pm exacerbating the flooding in this location. The two separate sources of surface water flooded St Georges Square and adjoining roads flooding property and businesses.

Figure 7 - Picture taken from Camera 84 at the corner of St Georges Square, Hebden Bridge.

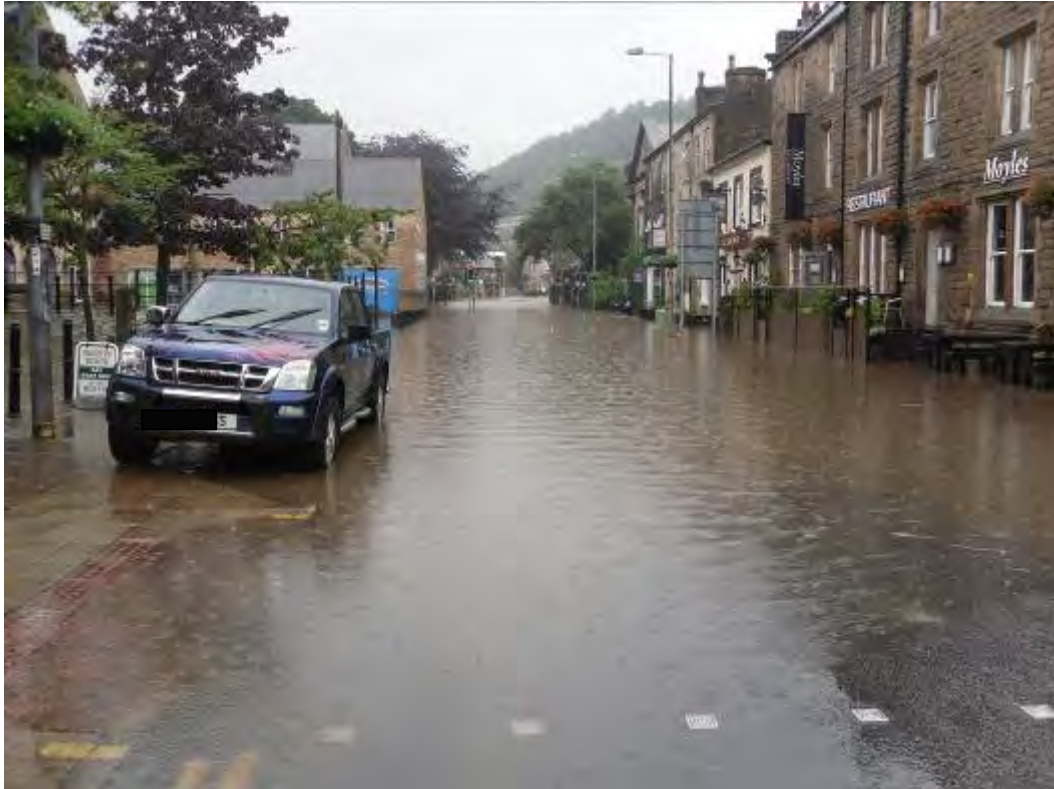
High intensity rainfall overwhelmed drainage systems along New Road resulting in the build up of surface water on the highway. The Rochdale Canal adjacent to the Hebden Bridge Visitor and Canal Centre and Marina overtopped the towpath and flowed onto New Road. A significant volume of flow spilled onto the highway contributing to the flooding in this location. New Road was flooded to a depth of approximately 600-700mm in places. Properties and businesses along New Road were flooded and subsequently closed (See Figure 8).

Figure 8 - Extent of flooding on New Road

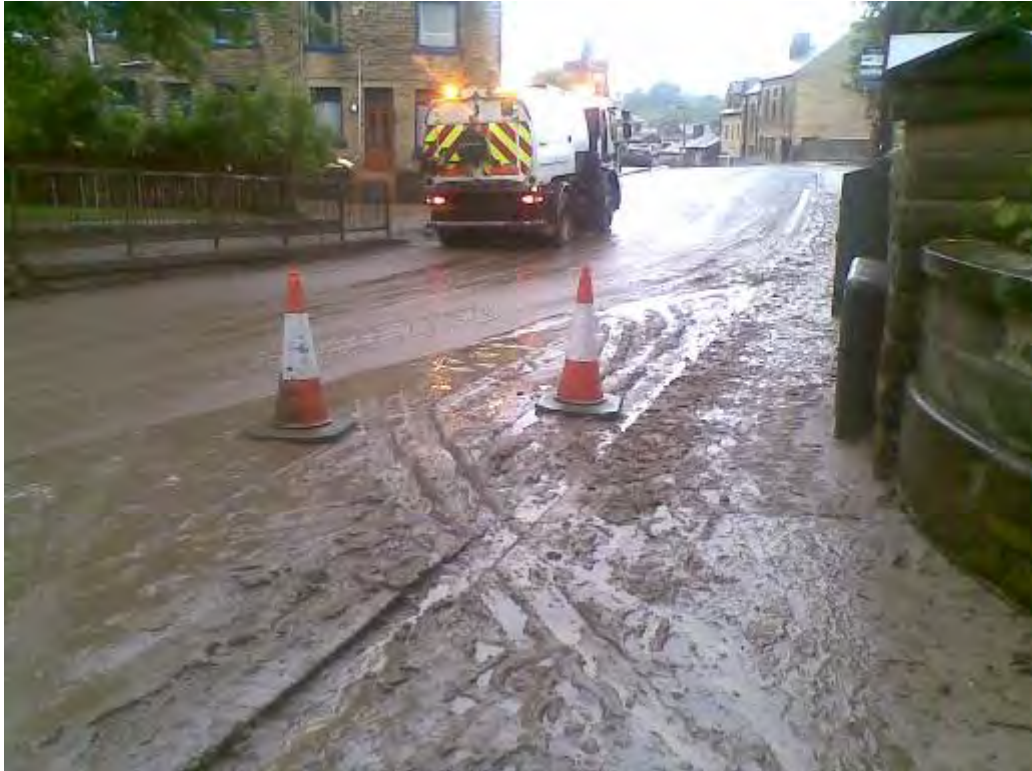
The culvert at the top of White Lee Clough on Midgley Road blocked again and spilled surface water down Midgley Road and ponded at White Lee Bridge.

Figure 10 - Shows the aftermath of the flooding at White Lee Bridge.

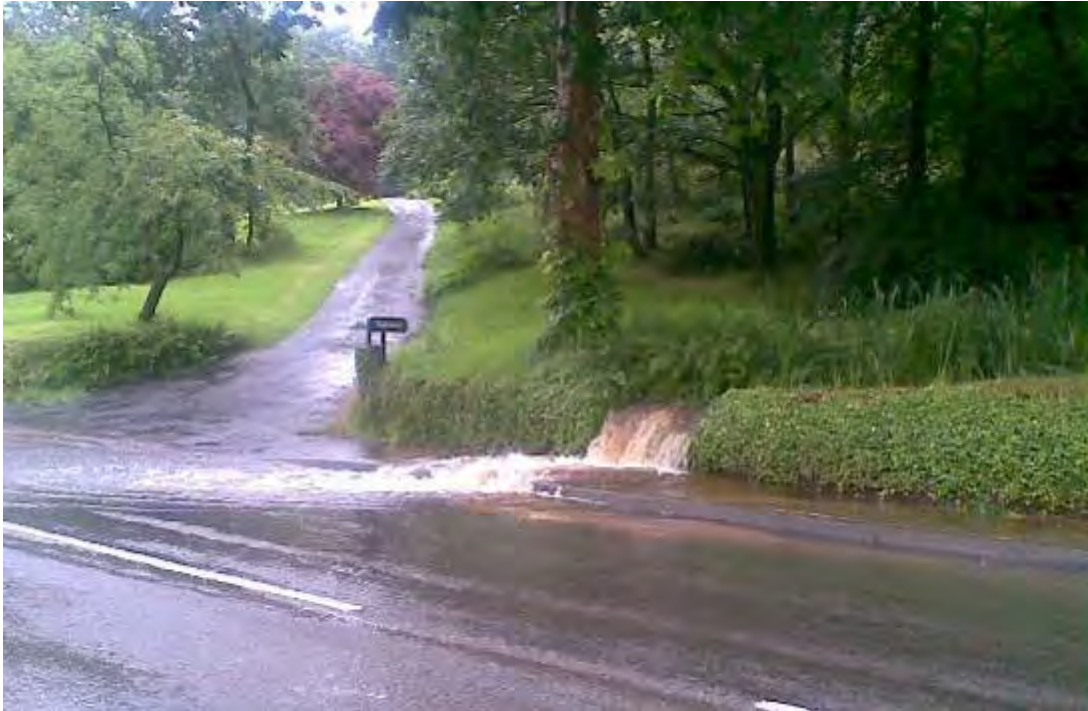
Flooding occurred on the highway at several points along Cragg Vale on the 6th & 9th July. Several watercourses flowing from moorland areas intersect the highway and pass under the highway through culverts. Many of these systems became blocked or were overwhelmed with debris and flood waters, which spilled onto the highway (see Figure 11).

Figure 11 - A typical example of a watercourse in Cragg Vale bypassing the drainage system flooding the highway.

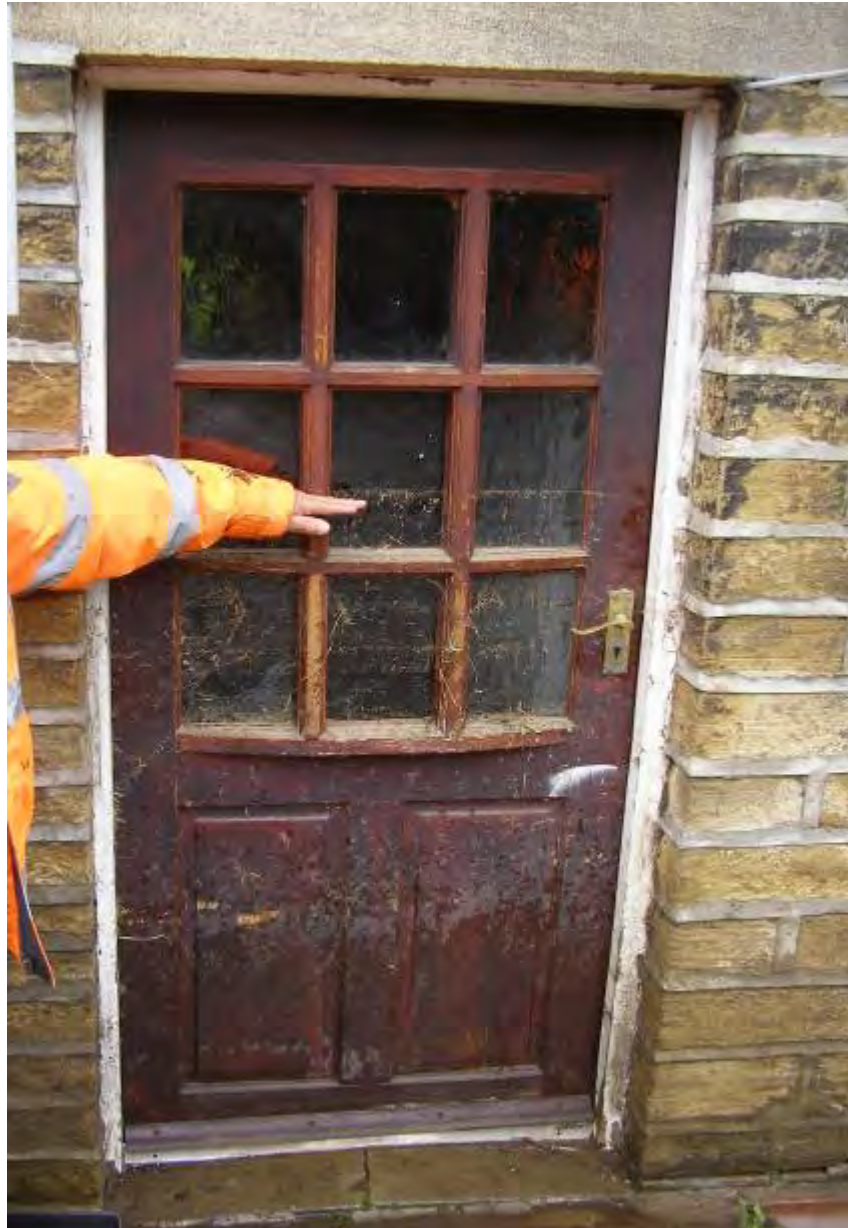
A land slip on Jumble Hole Clough mobilised a significant amount of debris into the watercourse. The intense rainfall was greater than the capacity of the watercourse, which resulted in flood waters spilling onto Jumble Hole Road. The flood waters also damaged a retaining wall upstream of the railway underpass. The flood waters and debris flowed down Jumble Hole Road and

flooded Halifax Road. A significant volume of water, mud and debris was deposited on Halifax Road, in the gardens of adjacent properties and into a commercial property on Jumble Hole Road (see Figure 12).

Figure 12 – The rack mark on the property door shows the height the flood waters reached at the peak of the rainfall event.

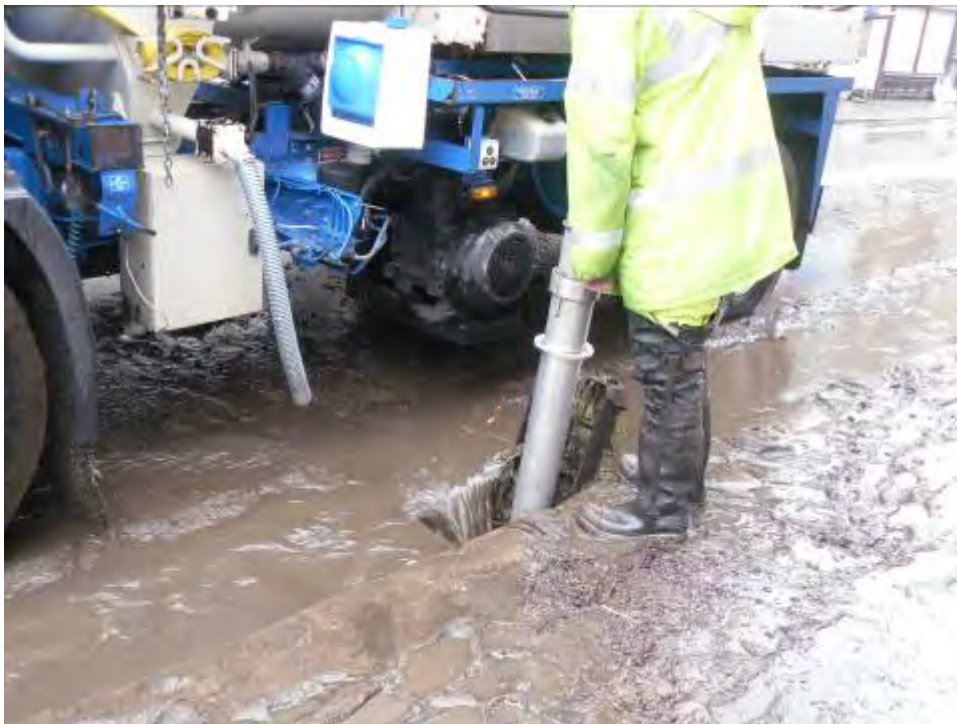
During and after the flood event Amey LG and other local drainage contractors undertook gully cleaning and repairs to the highway drainage system where possible.

Figure 12 - Drainage contractor unblocking the highway drains in Hebden Bridge.

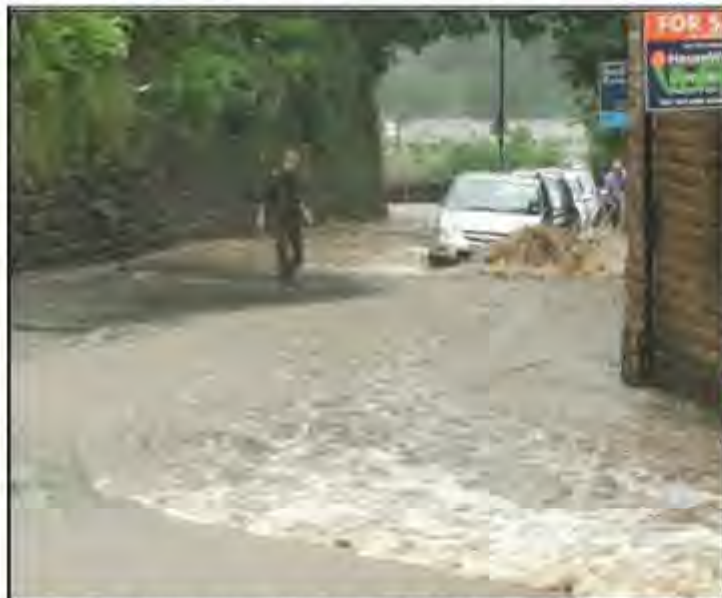
Photograph 1 - Flood waters from Nutclough Reservoir overflowing onto Keighley Road

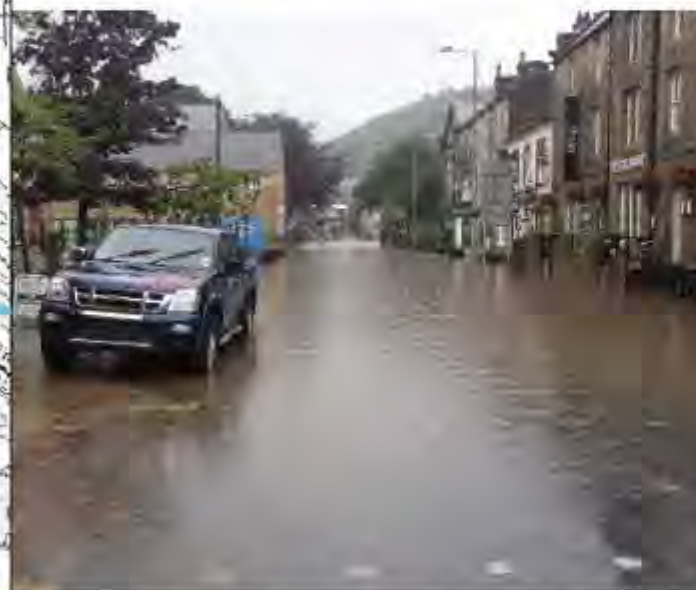
Photograph 2 - New Road in Hebden Bridge flooded from a number of sources
