Flood Investigation Report Section 19, Flood & Water Management Act (2010)

Upper Calder Valley – 22nd June 2012 Flood Incident

Document Title: Upper Calder Valley - Section 19 Flood Investigation Report

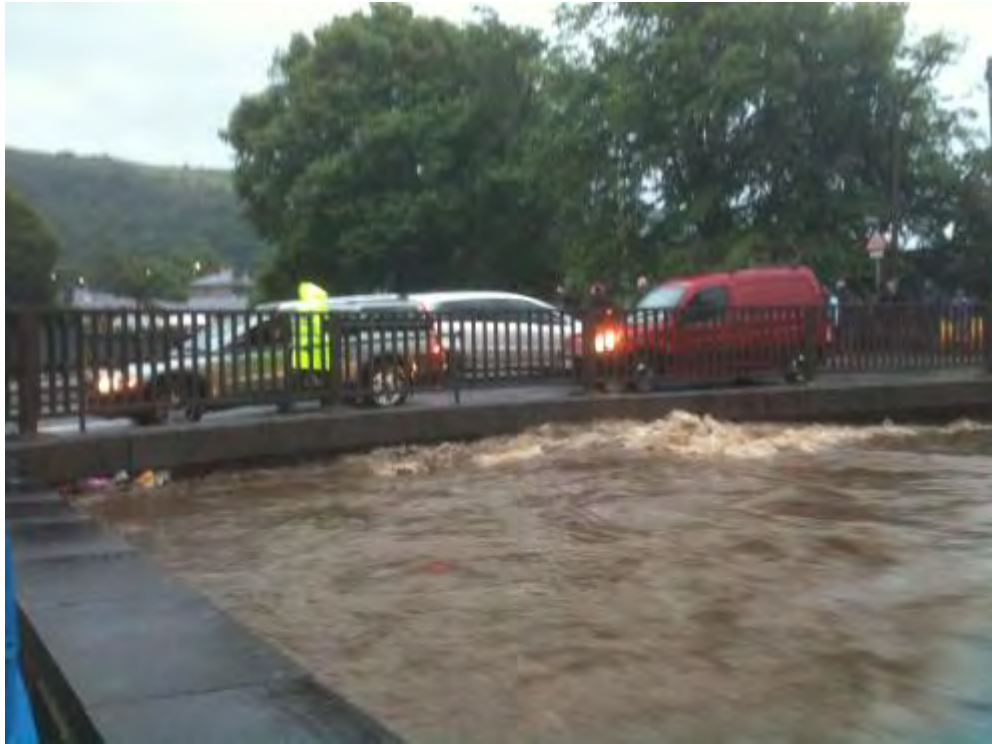
Figure 2 - River Calder close to reaching overspill point on Caldene bridge (Source: CMBC)

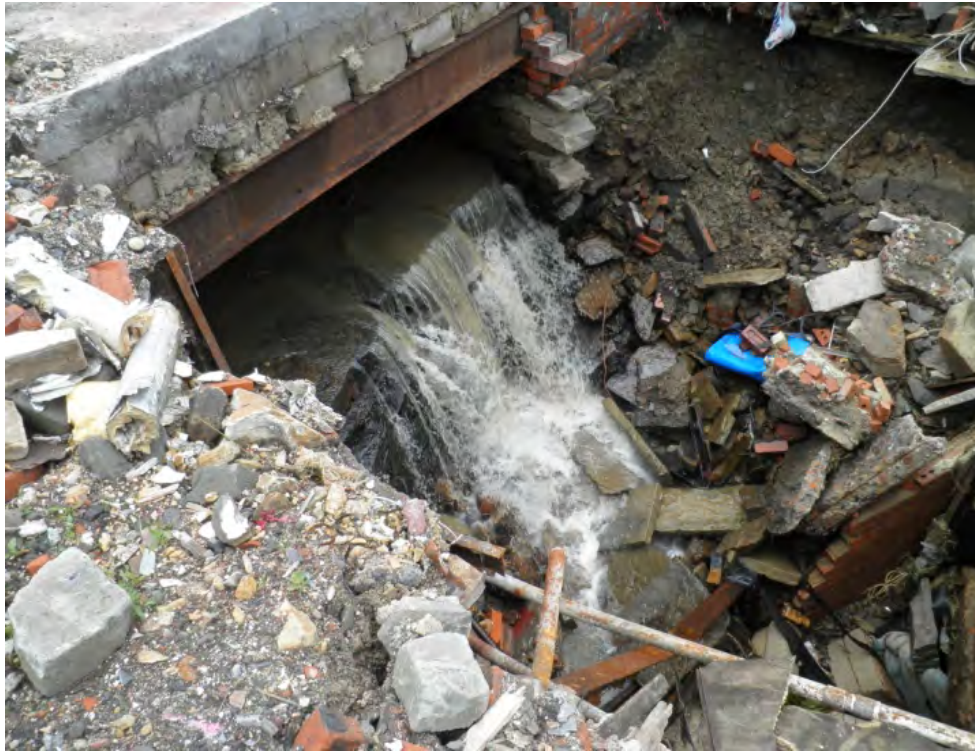
In Cornholme, there was a culvert collapse on the Red Water Clough close to the confluence with the River Calder, as Figure 3 illustrates. The EA and CMBC removed debris from the watercourse and surrounding area and the EA took steps to stabilise the culvert.

Figure 3 – The collapsed culvert on Red Water Clough, Cornholme (Source: EA)

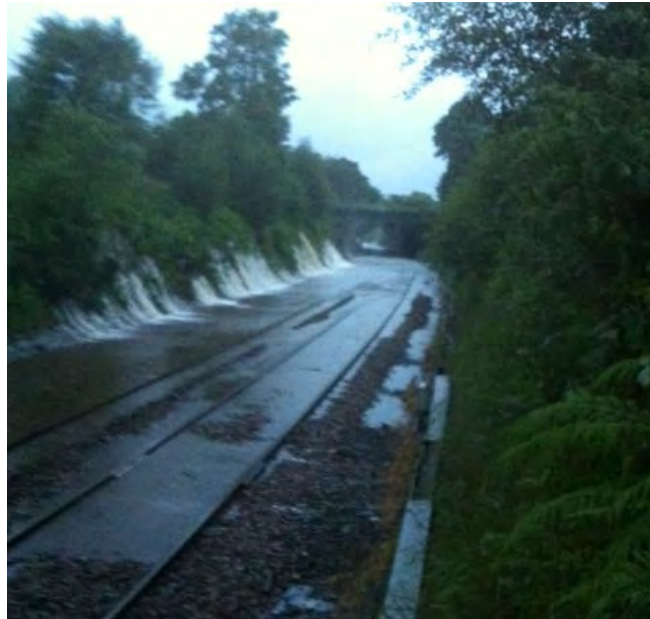
The Walsden Water and Bottomly Clough overtopped their banks and flooded a 150m section of Network Rail track at Dean Royd Road. The main flooding mechanism is reported to come from Walsden Water as shown in Figure 4. The floodwaters built up to a significant depth above the line and contributed to extensive travel disruption.

Figure 4 – Flood waters spilling onto the rail track downstream of Dean Royd Road (Source: Network Rail)

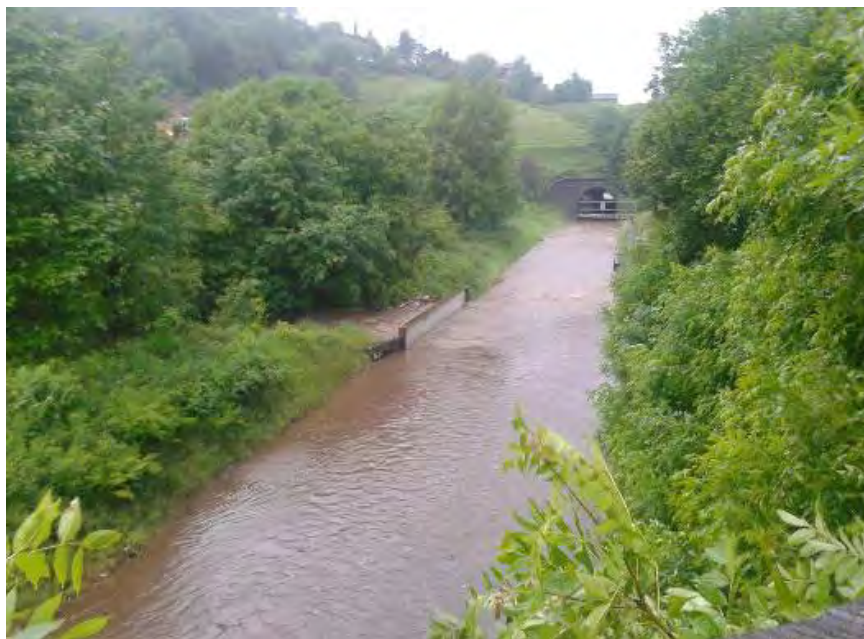
Walsden Water overtopped Network Rail Bridge 96 and flooded approximately 600m of the track as far as Walsden Station (as shown in Figure 5). The floodwaters spilled over the rail embankment between Walsden station footbridge and the property at 554 Rochdale Road, flooding a significant area of Rochdale Road and nearby properties. The floodwaters continued to flow along the highway towards Todmorden. It is reported that the highway drainage was overwhelmed in this location.

Figure 5 - Flooding of Network Rail track at bridge 96, Walsden (Source: EA)

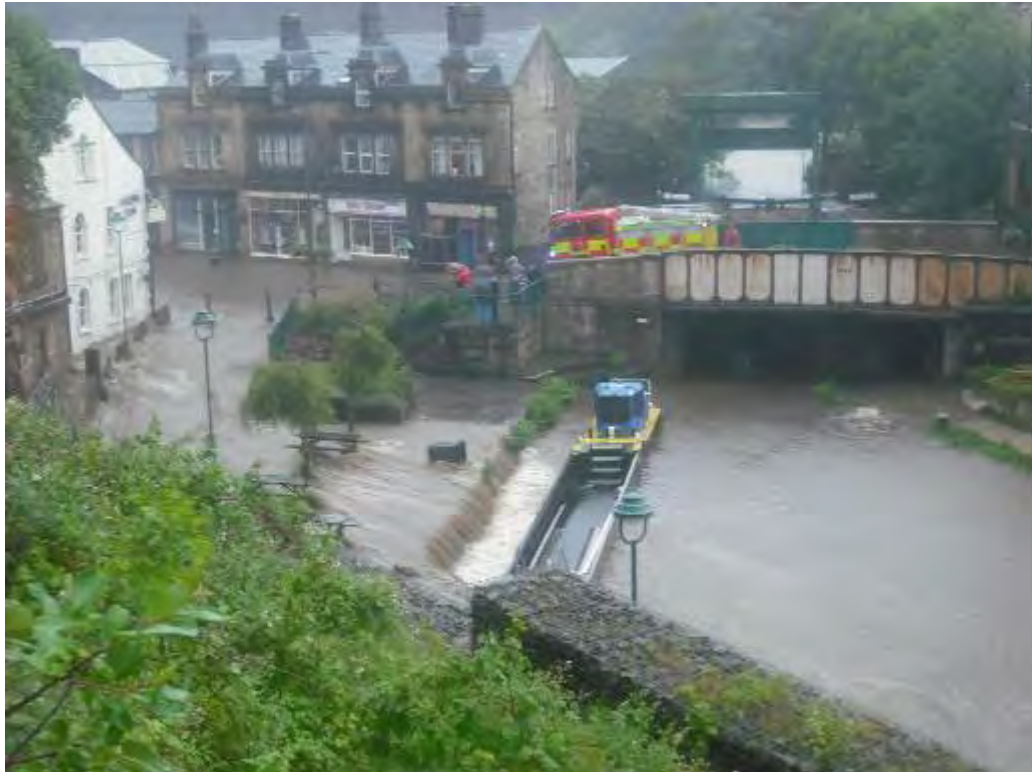
The sloping topography between the Golden Lion pub and the Rochdale Canal allowed the floodwaters to enter the Rochdale Canal at a rate that overwhelmed the capacity of the downstream lock (Lock 18). The canal overtopped in this location and flooded the streets and car parks adjacent (Lever Street and Union Street) via a pedestrian access ramp and steps. The

additional water discharging into the Rochdale Canal resulted in the locks immediately downstream overtopping the canal towpath and flooding the waste ground (SD 94089, 24130).

Figure 6 - Flood waters from Rochdale Road spilling into the Rochdale Canal immediately below Lock 19 (Source: EA).

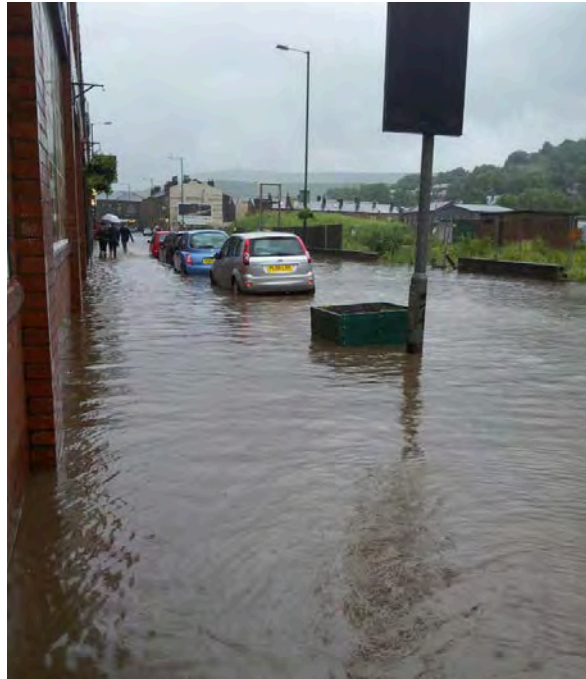
The combination of floodwaters from Lever Street and Union Street and the floodwaters from the wasteland further downstream overwhelmed the drainage system along Halifax Road adjacent to the Health Centre. A 430m section of highway and several adjacent properties flooded to a depth of approximately 400mm, as shown in Figure 7.

Figure 7 – Halifax Road flooded in the centre of Todmorden (Source: EA)

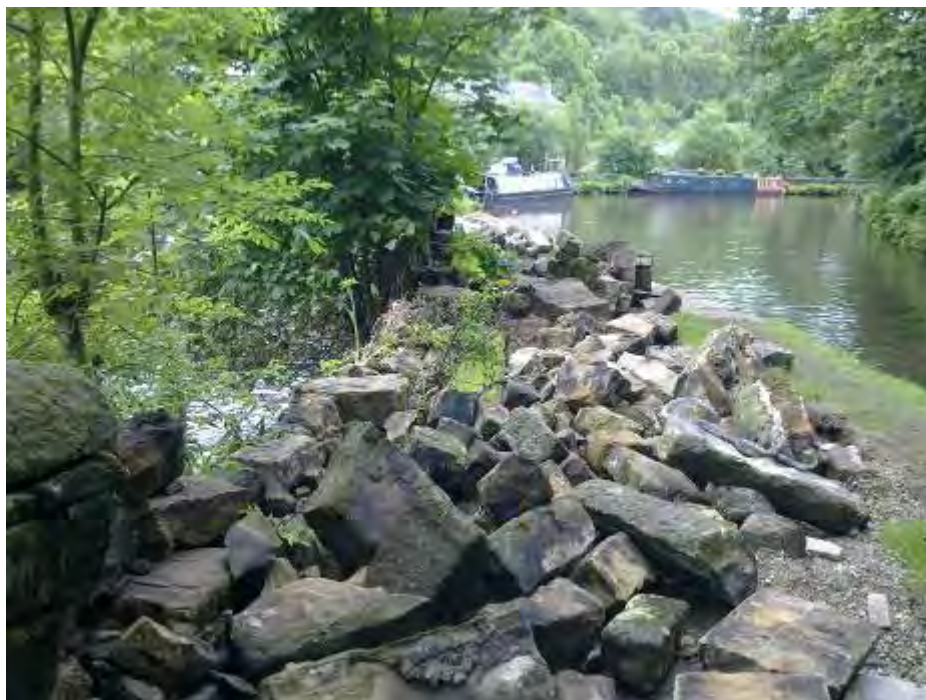
At several locations between Todmorden and Hebden Bridge there was flooding between the River Calder and Rochdale Canal. Figure 8 is an example of where the River Calder has spilled into the Rochdale Canal. Equally, there have been reported cases where the Rochdale Canal has spilled into the River Calder.

Figure 8: River Calder river wall breached and flowed into canal (Source: EA & CRT)

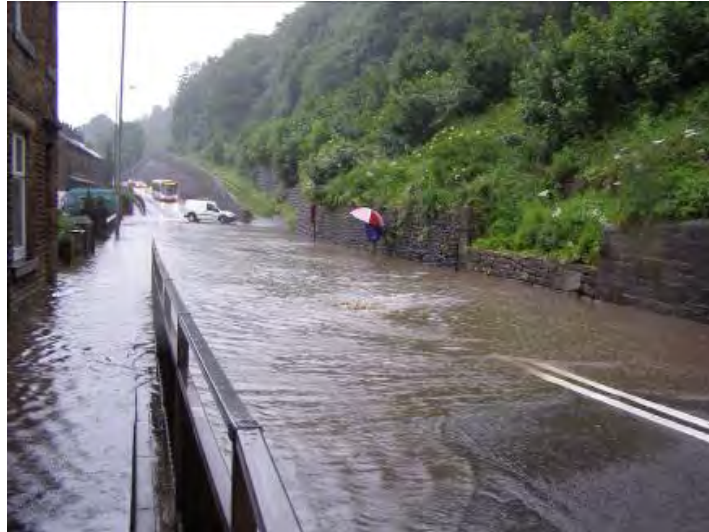
Properties and highway were flooded between 706 to 730 Halifax Road. Surface water accumulated on the highway and in property gardens from heavy rainfall and the main sewer. This subsequently entered the properties. Several cellars were also affected from ground water flooding.

Figure 9 - Flooding of the highway and properties along Halifax Road (Source: CMBC)

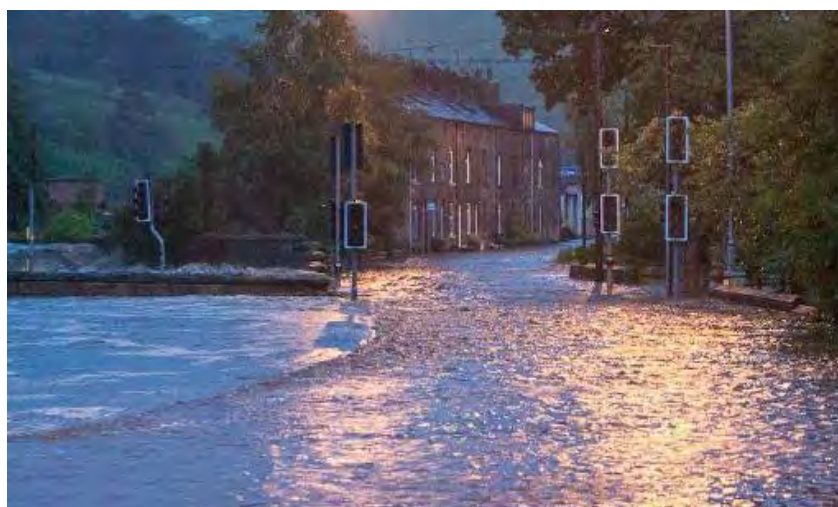
Properties and highway between Callis Bridge and Woodland View were affected by floodwaters from sewer, the River Calder and a small watercourse. The sewer surcharged and flooded the highway initially, however, the main flood mechanism came from the River Calder overtopping the river wall to a depth of approximately 1m. In addition, properties at Woodland View were affected by excess surface water spilling from Knott Wood culvert.

Figure 10 - River Calder overtopping the river wall at Callis Bridge, Eastwood (Source: CMBC).

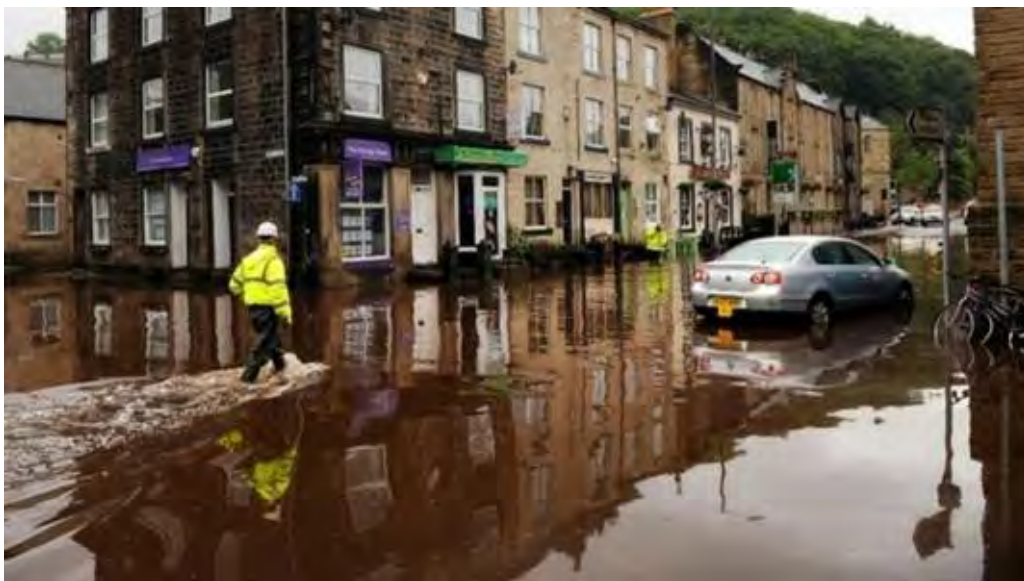
Figure 11 – Flooding in the centre of Hebden Bridge (Source: ITV)

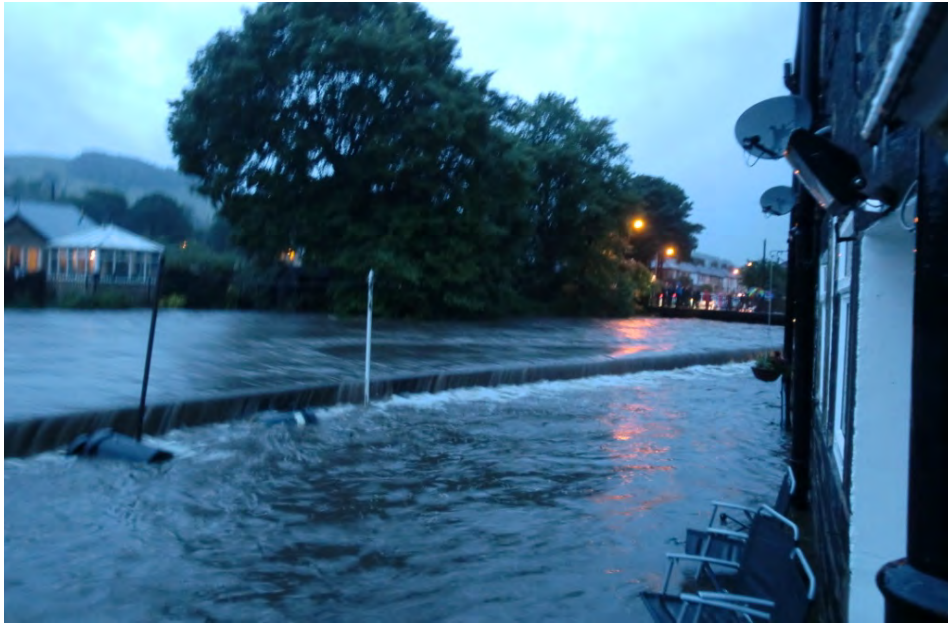
Floodwater was observed seeping through apertures in the floodwall at Caldene Bridge at 8pm. Between 9.45pm and 10.15pm, the river overtopped the river walls upstream and downstream of Mytholmroyd Bridge flooding nearby property (as shown on Figure 12) and contributing to the flood waters accumulating on Burnley Road.

Figure 12 - Flood waters overtopping river wall downstream of Caldene Bridge (Source: CMBC).
