# Flood Investigation Report

Pocklington, 19 April 2012

CES\D200\LDES\1394

### East Riding of Yorkshire Council Flood Investigation Report

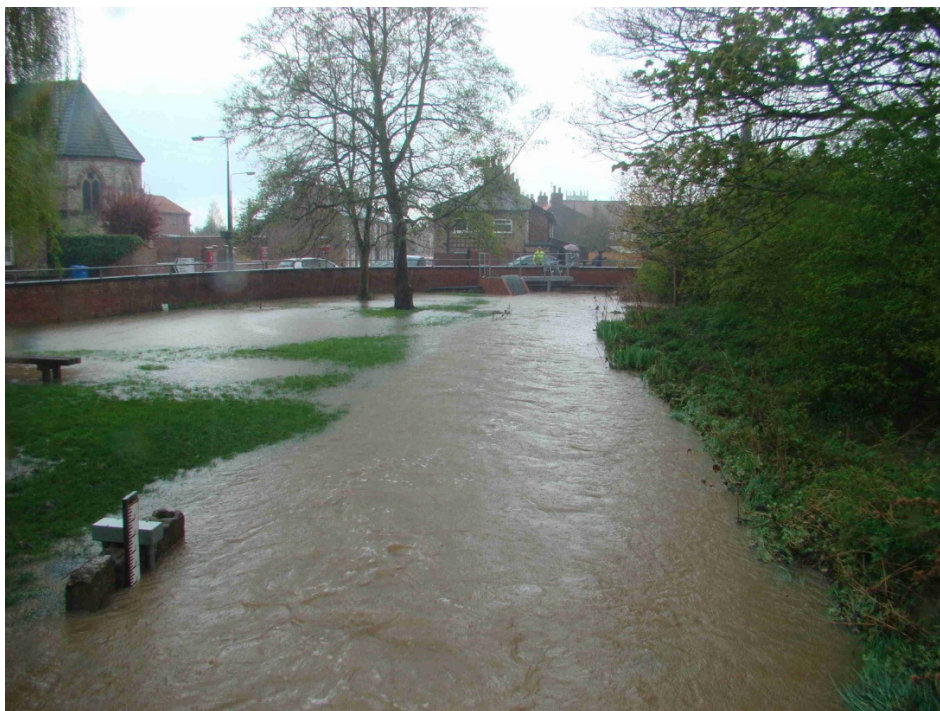
Figure 3 Photograph of Jubilee Gardens on 19 April 2012

The Jubilee Gardens above London Bridge was flooded during the incident, and water apparently unable to enter the culvert at the rear of the post office overflowed into Betterton Court. The car park flooded and water flowed out into Chapmangate then Market Street, through St Peters square and down the Market Place, before re-entering the drainage system in Railway Street. The highway gullies in Market Street and St Peters Square which at first drained water into the system were eventually overwhelmed. At this point the system was full to capacity.

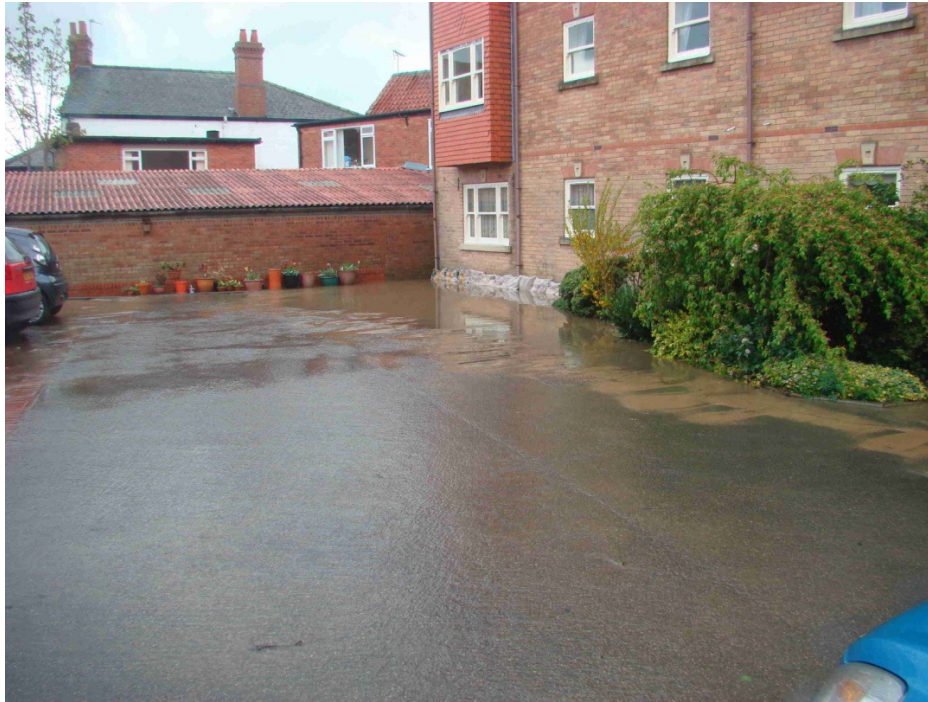
Figure 4 Photograph of Betterton Court Car Park on 19 April 2012

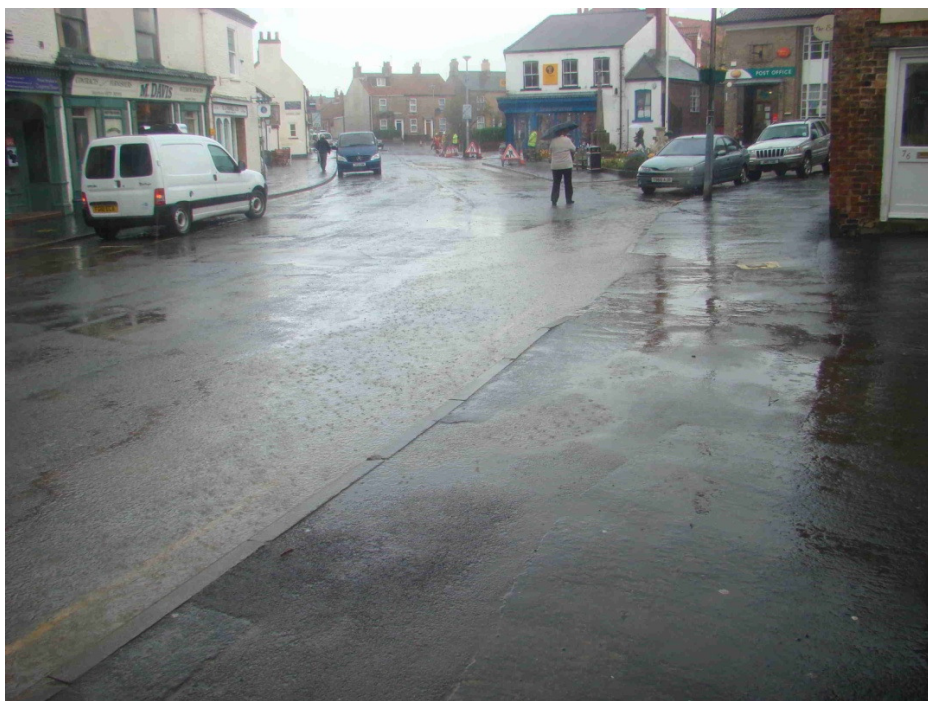
Figure 5 Photograph of Market Street on 19 April 2012

Many other commercial properties in Chapmangate, Market Street and Market Place were affected by highway flooding causing disruption to normal trading. Traffic passing through the standing water on the road caused bow waves pushing water towards properties.

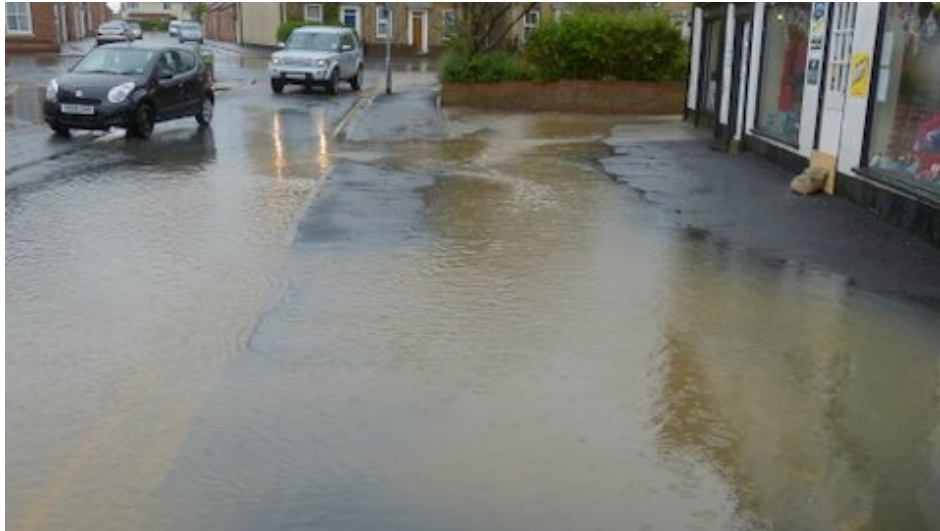
Figure 6 Photograph Chapmangate on 19 April 2012

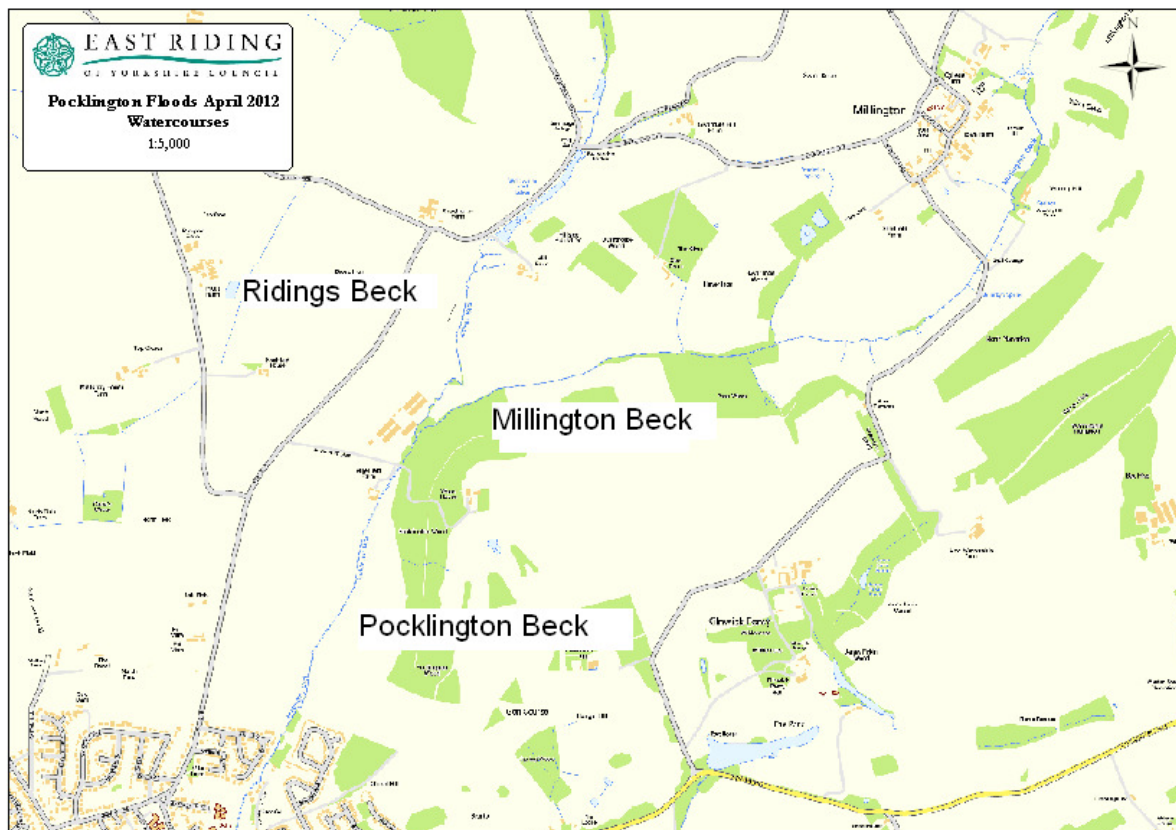
Figure 8 Watercourses feeding the Beck

Groundwater fed watercourses in two valleys, namely Deep Dale and Millington Dale, combine to become the Pocklington Beck. Maintenance is all riparian responsibility up to the edge of the town where the Environment Agency have enained the Beck and can use their permissive powers to take any actions deemed necessary to reduce flood risk.

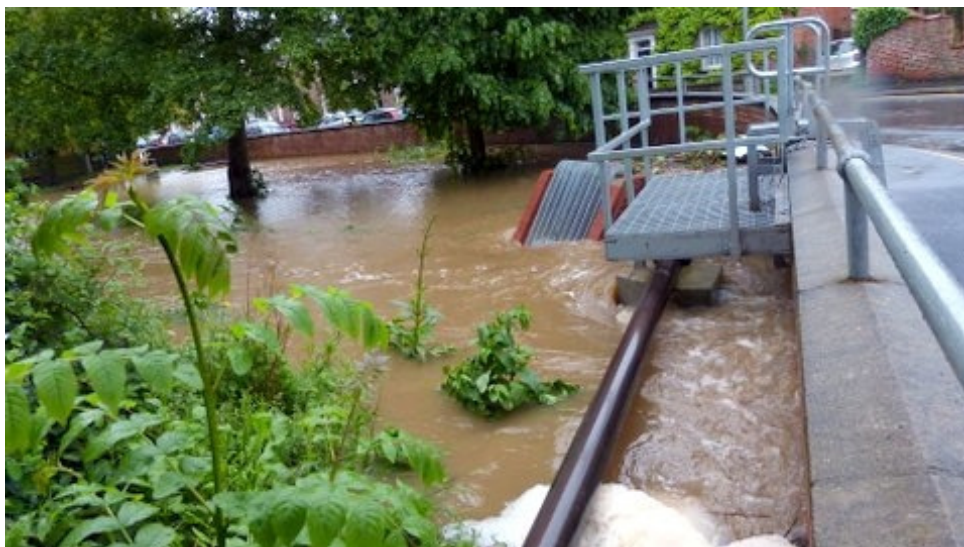
In April 2012 the Beck overtopped its banks above the culvert entrance near the rear of the main Post Office. The flood water then overflowed through Betterton Court out onto Chapmangate down Market Street, leading to overland flows through the town centre.

Figure 11 Photograph London Bridge in June 2012

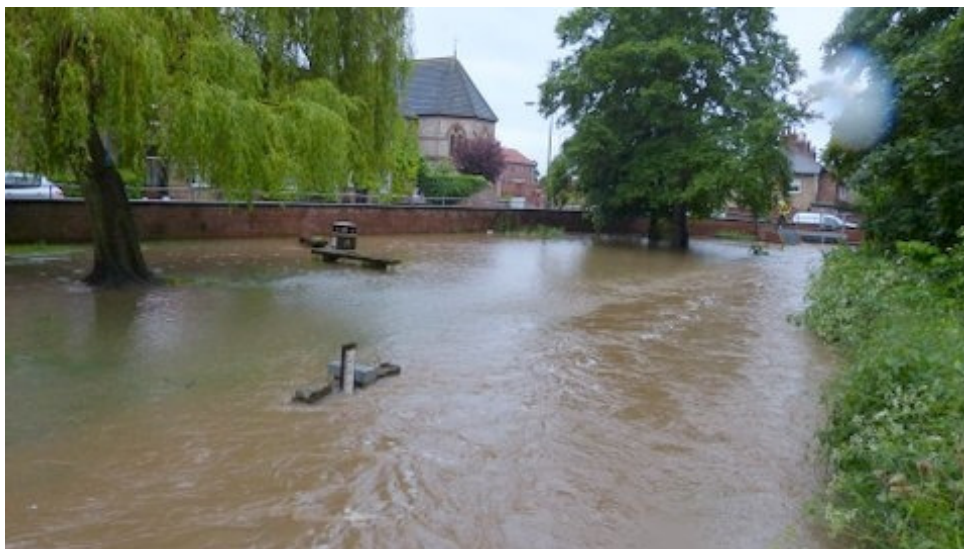
Figure 12 Photograph EA Gauging Station 2012

Data supplied by the EA from the gauging station in Jubilee Gardens indicates that the beck level rose at 2:00pm on 18<sup>th</sup> and remained at an elevated level until 9:00am on 19<sup>th</sup> when the level rose further dramatically, passing alarm level at 10:00am, peaking at 12:00 noon before subsiding to the previous level by 6:00pm on the 19<sup>th</sup>.

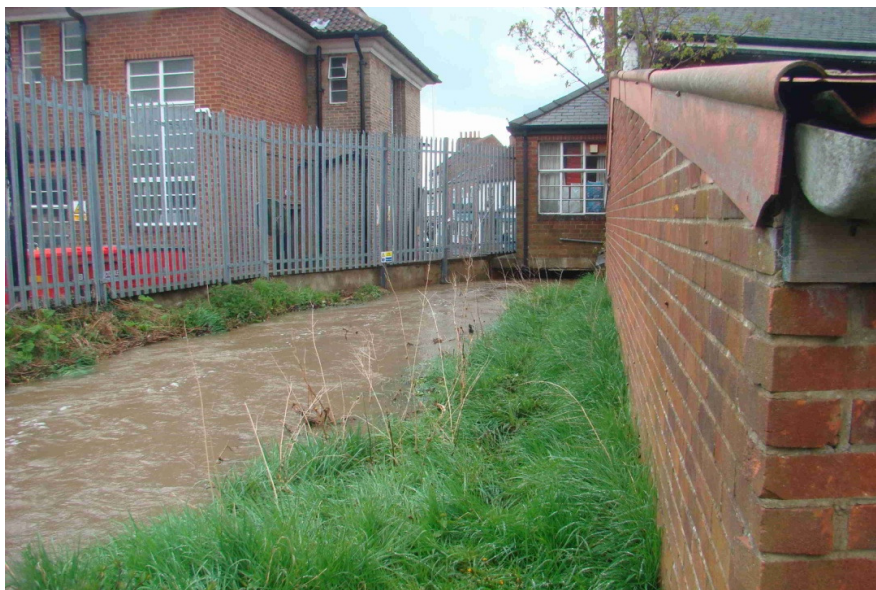
The EA issued an appropriate Flood Warning and had operational staff in attendance at the London Bridge Inlet ensuring the screens were clear and checking the culvert inlet at the rear of the Post Office.

Figure 13 Photograph of the Beck behind the Post Office

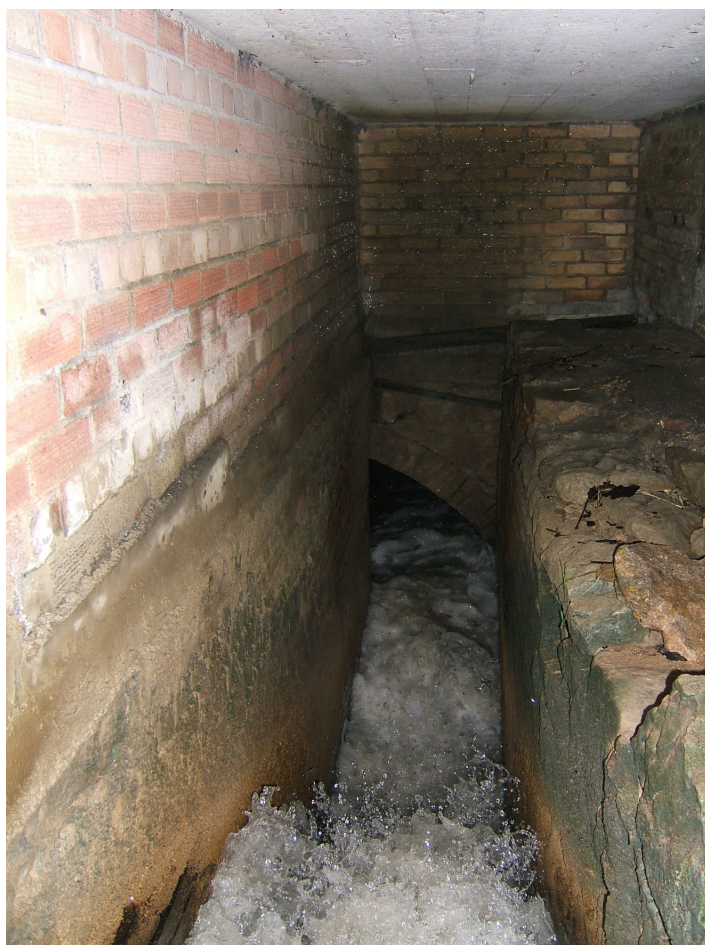
An EA inspection of the culvert at the rear of the Post Office confirmed a flow restriction at that point. However improvement works might be limited as the culvert structure appears to support the buildings above.

Figure 14 Photograph of the Culvert Entrance (2007)

As a result the flows exceeded the capacity of the culvert causing the overflowing at the rear of the Post Office and into Betterton Court. Once this excess flow had passed the overflow stopped and flow levels in the Beck returned to normal indicating the system was running freely.
