Flood Investigation Report

Ex Hurricane Bertha 10 August 2014:

East Riding Flooding Events

January 2015

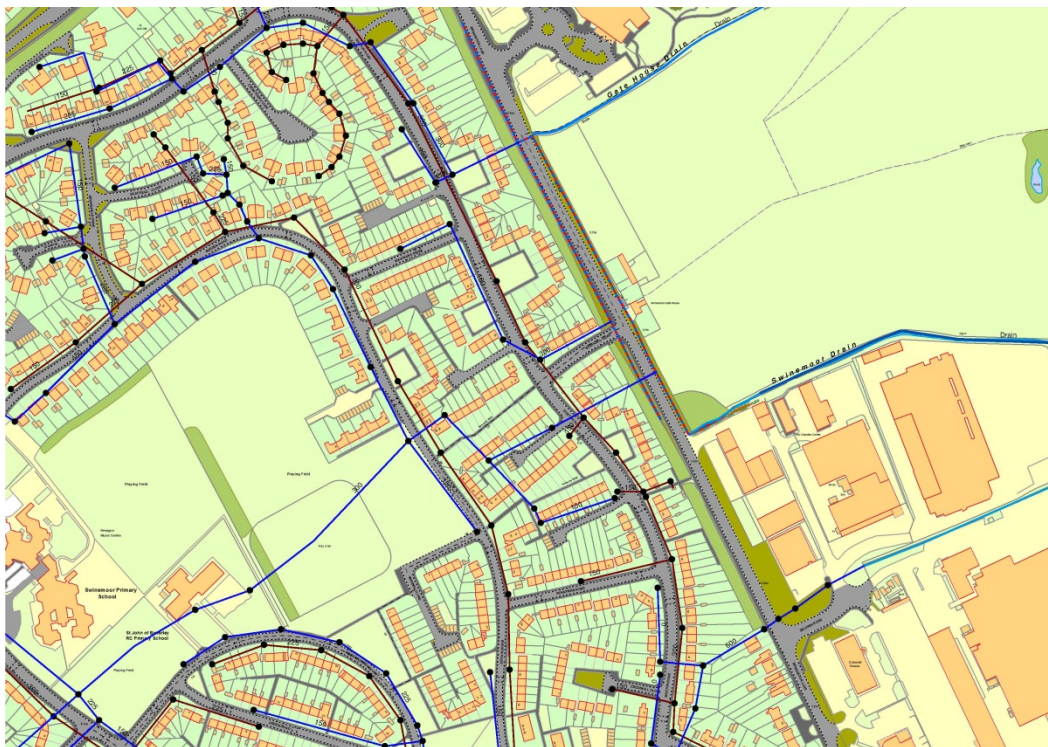
Figure 2: Drainage System on the Swinemoor Estate, Beverley

The estate is served by a separate drainage system, which means that rainwater feeds into dedicated surface water sewers in the area. These sewers, together with the foul sewers, are maintained by YWS. The surface water sewers on the Swinemoor Estate discharge into culverted ditches which run along both sides of Swinemoor Lane. The Council is the riparian owner of these culverts, and are therefore responsible for maintaining them. The culverts discharge into Beverley and North Holderness Internal Drainage Board maintained open watercourses which cross Swinemoor, to discharge into the Barmston Drain.

All of the road side gullies within the public highway, and connections into the surface water sewers are the responsibility of the Council as highway authority to maintain.

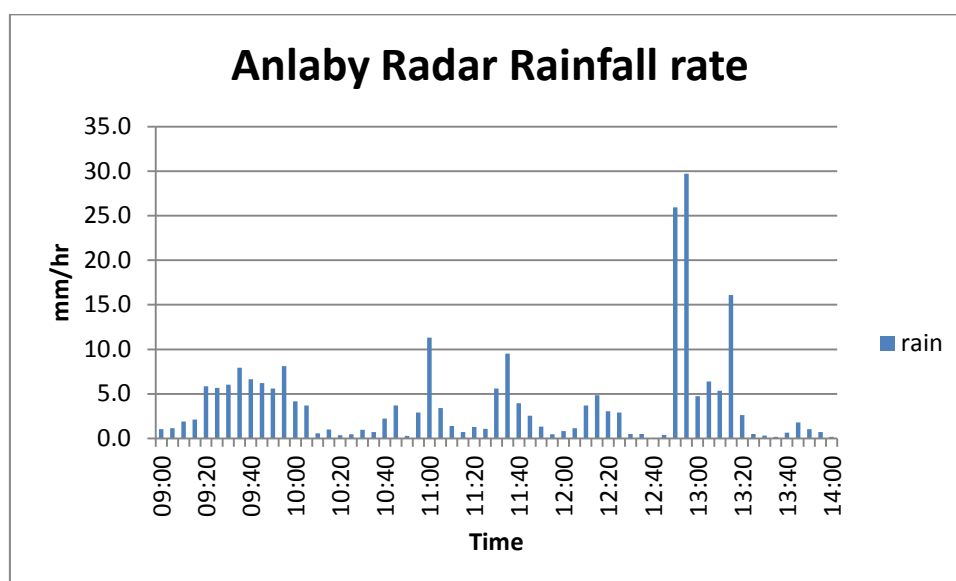
Rained all morning from 9:00am, heaviest rainfall at 1:00pm.

By 11:00am 7.5mm of rain had fallen on Anlaby in 2.0 hrs.

By 14:00 19.6mm had fallen in 5 hours.

Indicating that the rainfall was of exceptional intensity from 12:30 onwards.

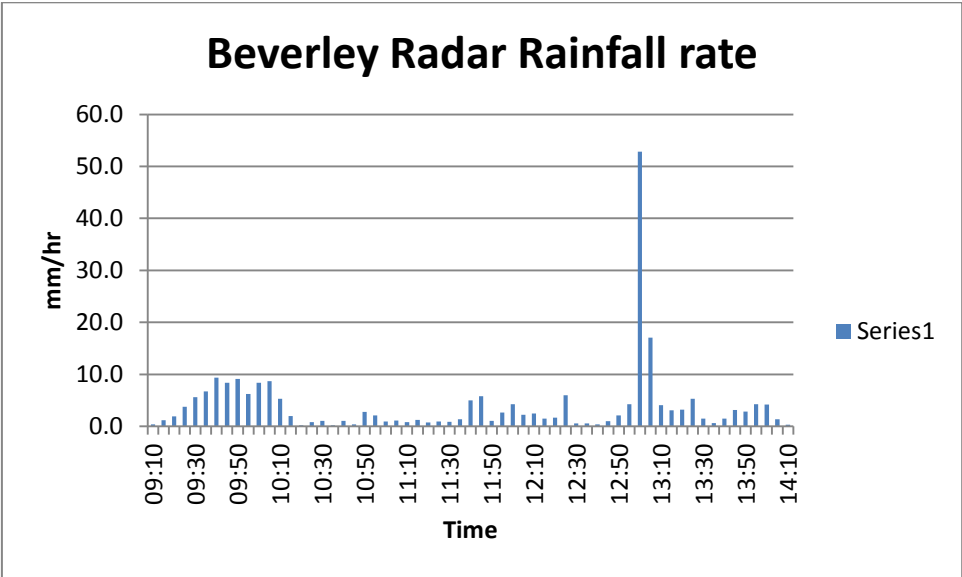
Rained all morning from 9:00am, heaviest rainfall at 1:00pm.
By 12:00 noon 9.3mm of rain had fallen on Beverley In 3.0 hrs.
By 14:00 19.6mm had fallen in 5 hours.
Indicating that the rainfall was of exceptional intensity from 13:00 onwards.

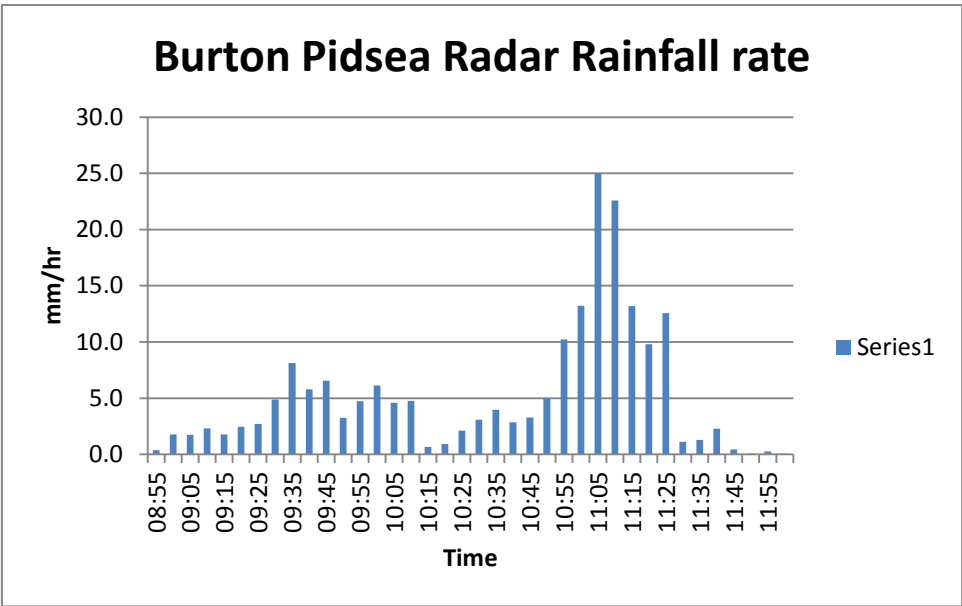
Rained all morning from 9:00, heaviest rainfall at 11:00am.
By just before 11:00am 7.8mm of rain had fallen on Burton Pidsea in 2.0 hrs.
By 12:00 16.3mm of rain had fallen on Burton Pidsea in 3.0 hrs

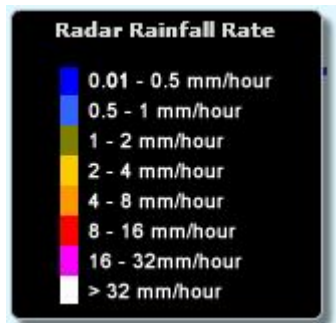
Below is an image taken from the Met Office Hazard Manager web site showing rainfall radar, the lighter the colour the more intense the rainfall. (White patches across East Riding indicating rainfall of more than 32mm/hr in places).

This also illustrates the variation in the intensity of the rainfall across the areas affected.

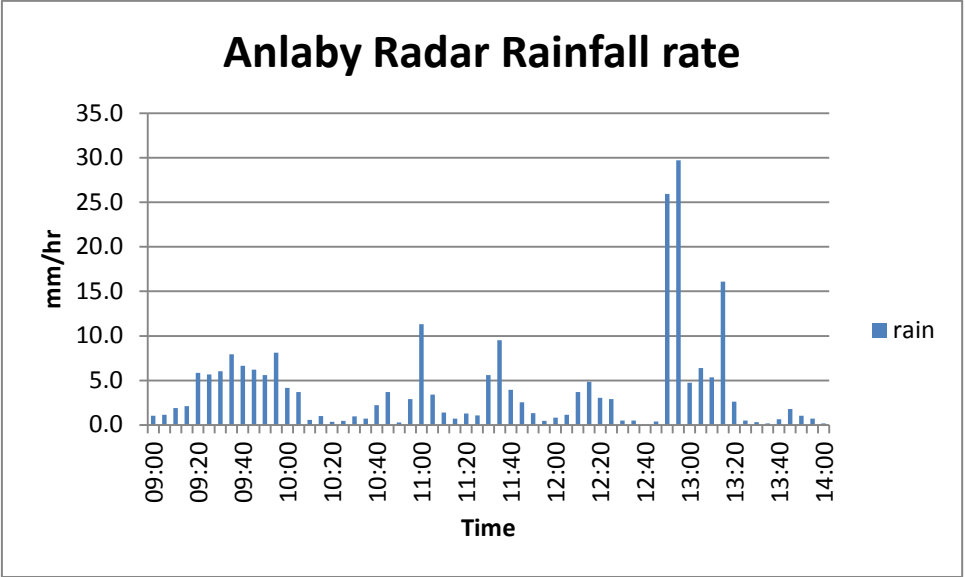
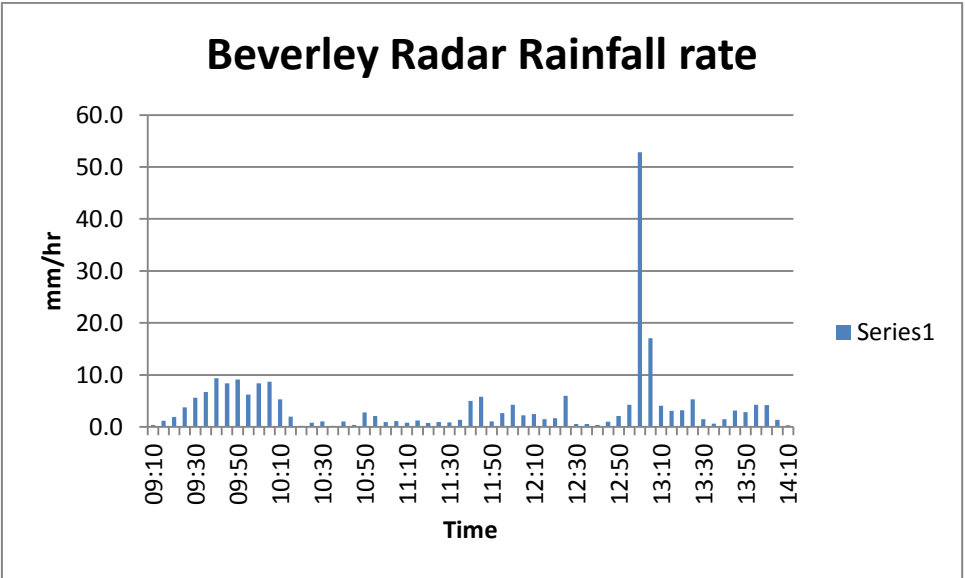
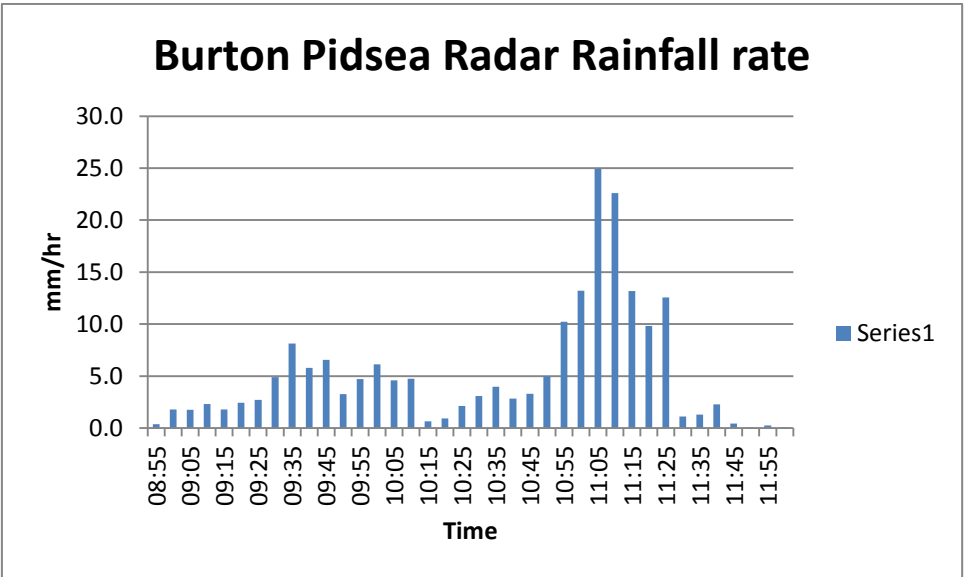
See also on the following page, graphs showing the rainfall intensity estimated from Met Office Radar images over 5 minute periods throughout the event.

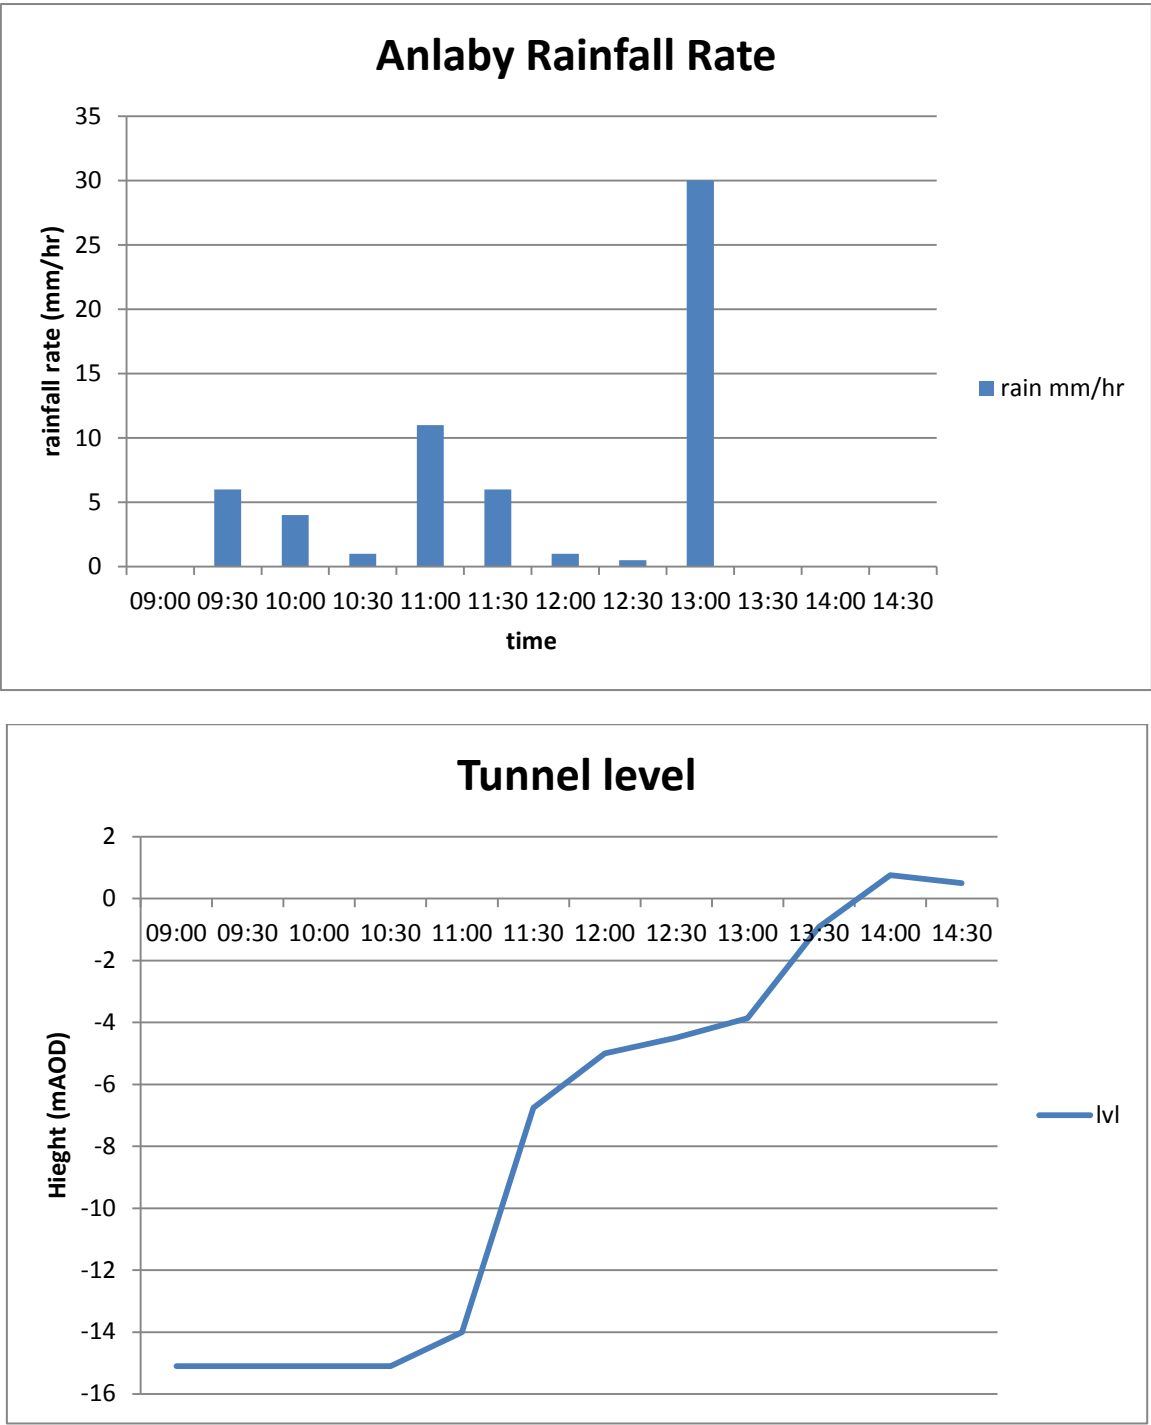
Figure 3: Comparing YWS Tunnel level at WHPS with Rainfall data

The ground level in Hull is around 1.0m (just above sea level) so flooding will occur once levels approach 1.0m. The Tunnel is of course below ground level.

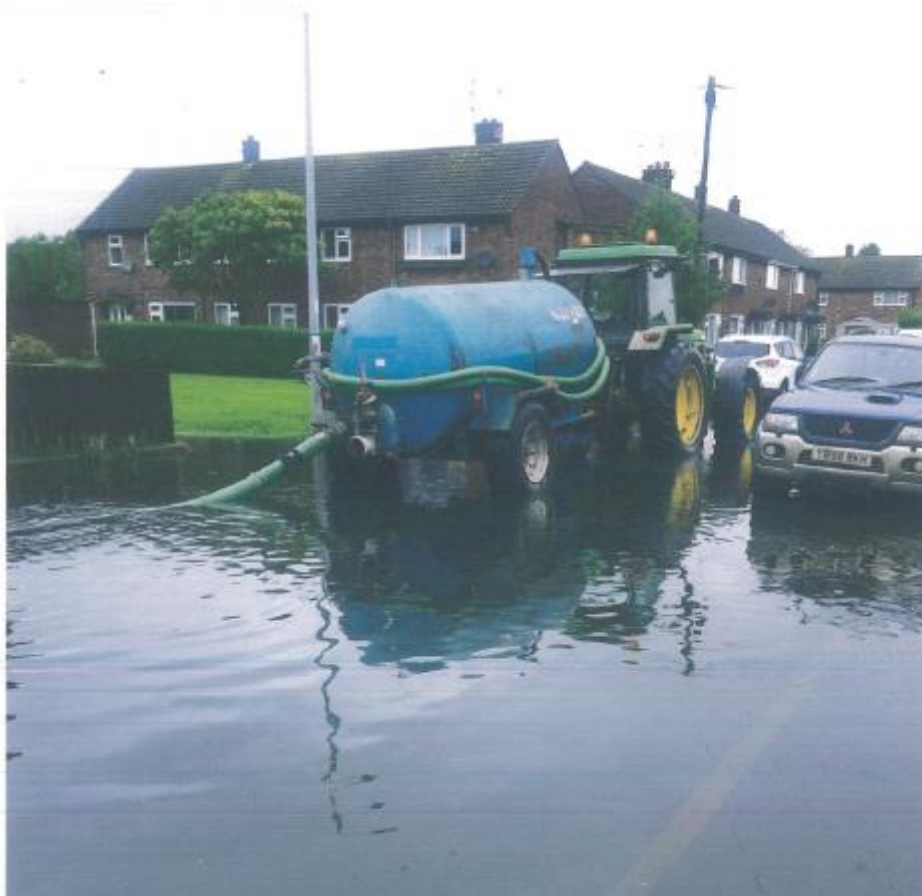
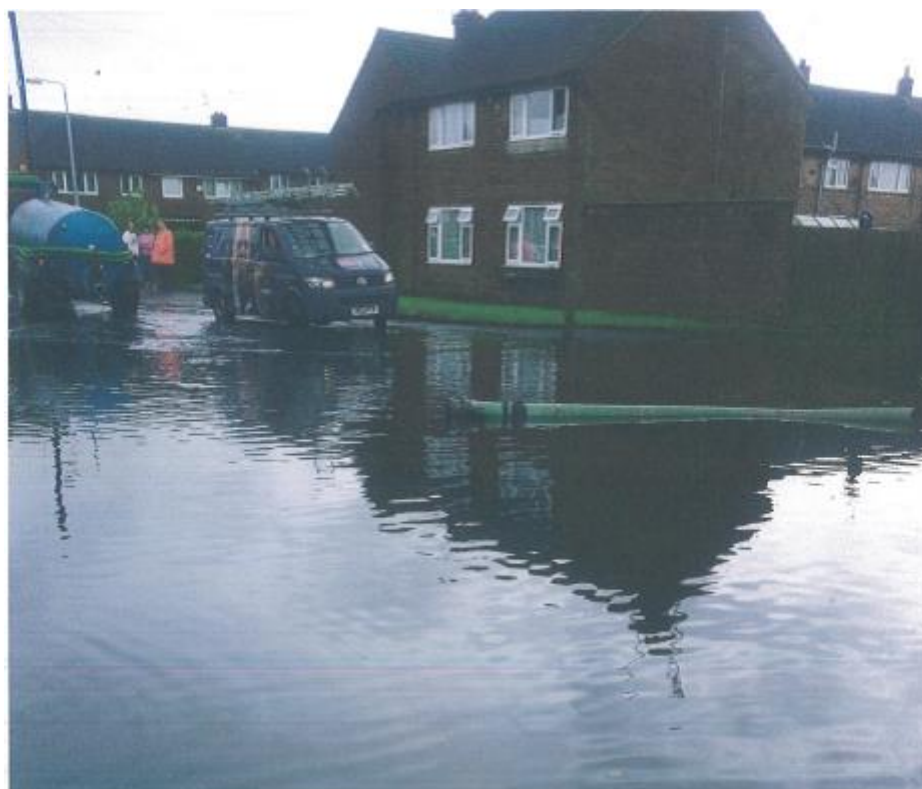
Photo 9: Sigston Road, Beverley

YWS surveyed the surface water sewers around Burden Road and Storkhill Road, during which mass tree root ingress was found, which has now been removed. Further CCTV surveys are due to be carried out on the surface water system on Sigston Road, and Windsor Close by YWS.

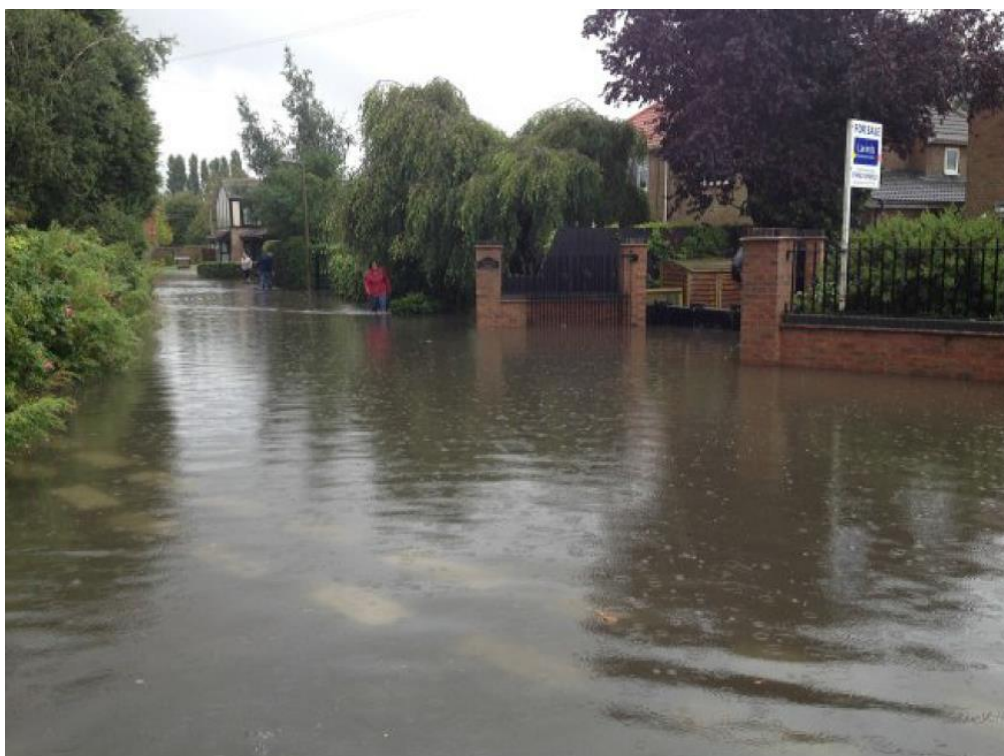
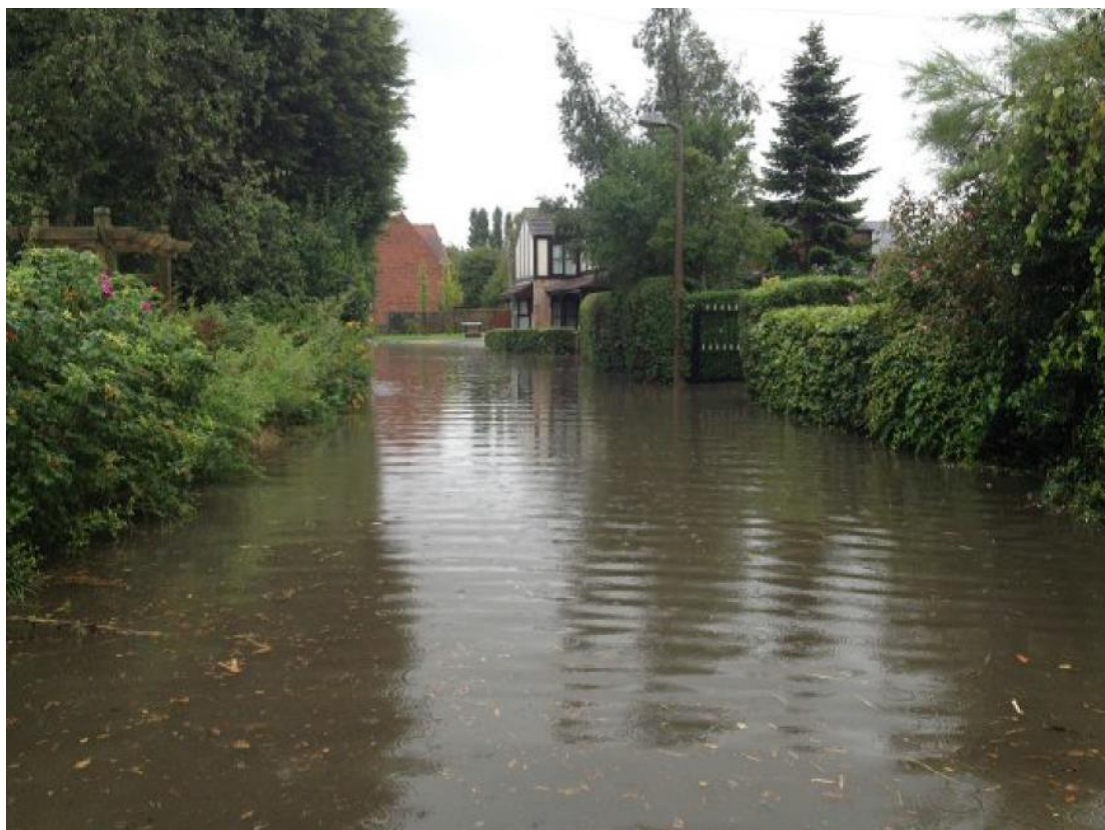
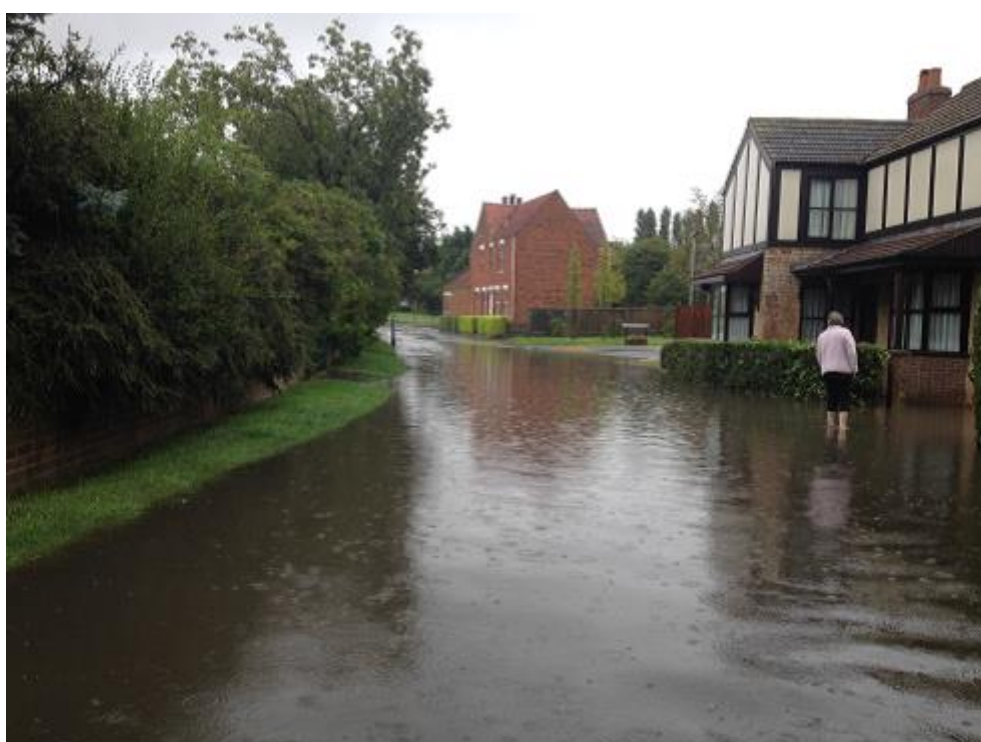
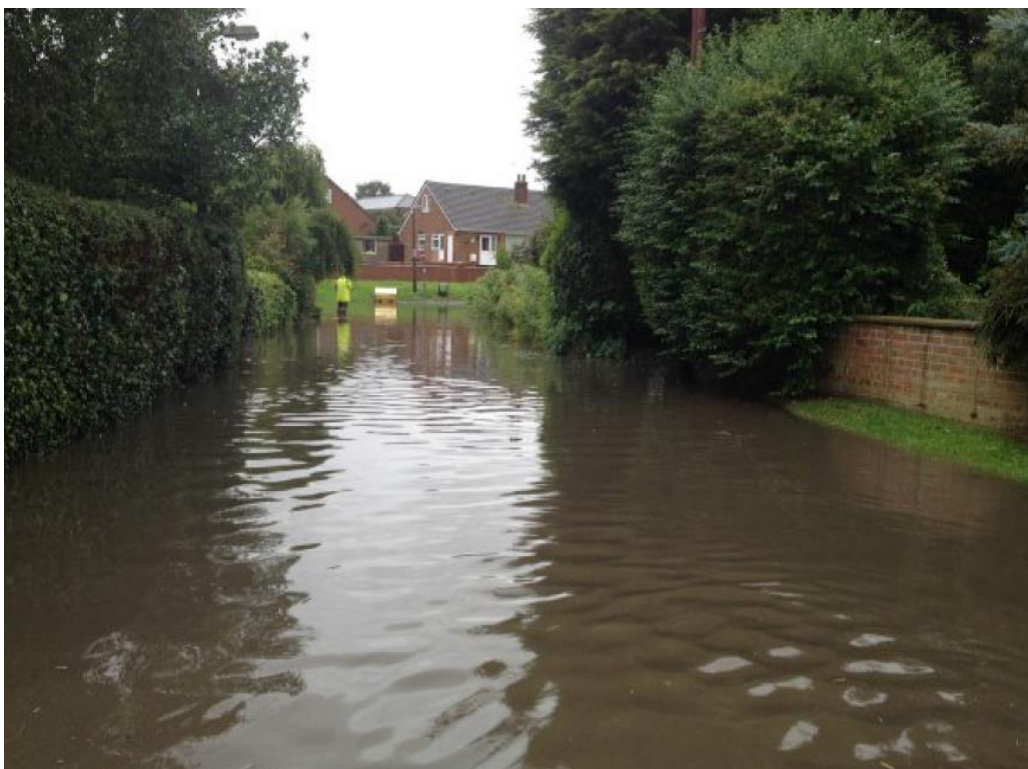
Photo 14: School Lane, Keyingham

In Keyingham there was extensive highway flooding in School Lane, Willowfield Drive, Crompton Drive and Westerdale Close with 4 properties flooding internally. Riparian culverts and the sewer system were overwhelmed, leading to overland flows. Subsequently sewer and culvert cleaning and CCTV inspections have been undertaken and some repairs and modifications to culverts completed.

In Keyingham the Council, on a without-prejudice basis have cleaned and surveyed a riparian culvert through the village, (formerly an open ditch). It has also replaced an existing manhole cover on the culvert in School Lane with a grating to allow water into the culvert more readily. In addition it has carried out repairs to a manhole at the rear of Compton Drive, proved the piped system in the ditch to the rear of School Lane; further works are ongoing.
