Flood Investigation Report

South Cave Flooding on 20 July 2014

December 2014

EAST RIDING
OF YORKSHIRE COUNCIL

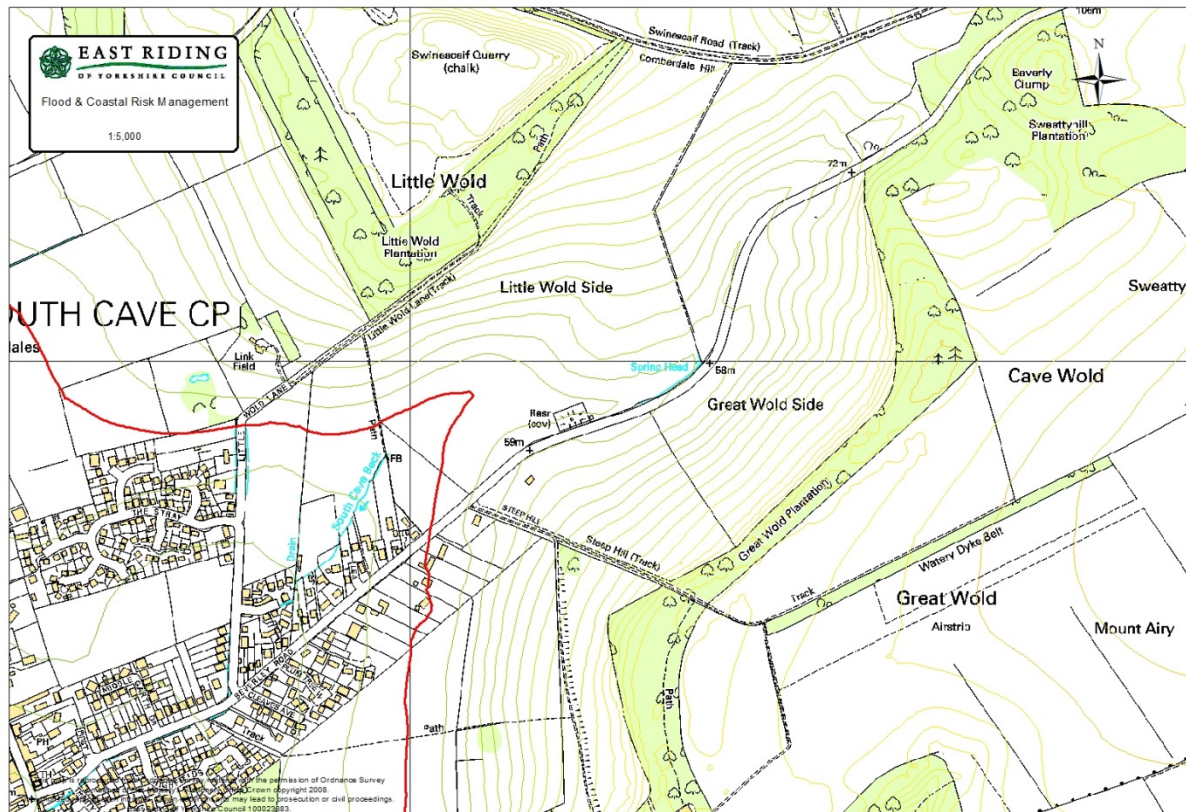
Figure 1: South Cave Beck Catchment Area

South Cave Beck (see figures 1 & 2) is a tributary of Mill Beck. The base flow is spring-fed groundwater. The main source is a spring at the foot of the chalk escarpment at Great Wold Side, (south and east of Beverley Road) but it is also fed from other localised points along the same spring line (broadly along the 50m contour, shown red in Figure 1 above) which converge in the valley to flow in a south westerly direction along Little Wold Lane.

The village lies at the bottom of the Wolds, the catchment for the Beck is a steeply sided valley which runs south east into the village. The profile and geology lead to rapid run-off during heavy rainfall and subsequent flash flooding due to overloading of the drainage in the village. There will also be significant flows from surface run-off within the village itself, from highway drainage, roof-water and hard paved areas, which will also discharge into the Beck.

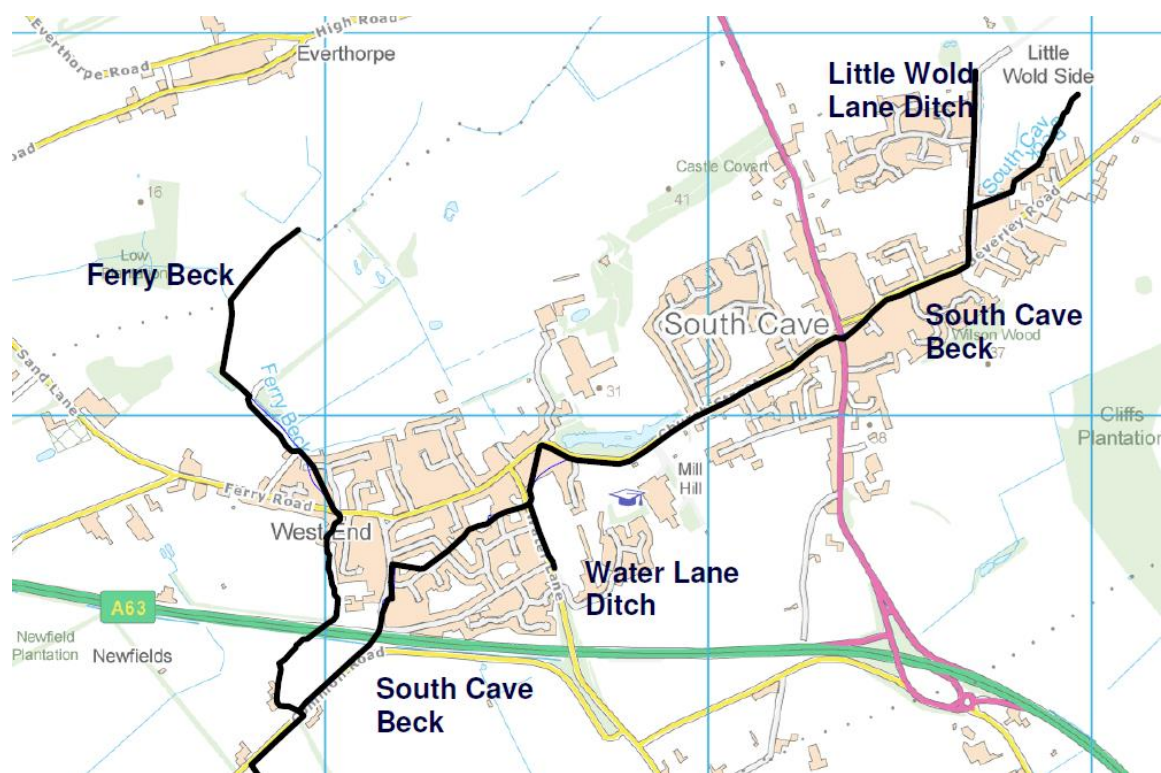
Figure 2: Watercourses in South Cave

The South Cave Beck flows through the village in open channel with some culverted sections, before crossing under the A63 and joining with Ferry Beck, then on to Mill Beck.

The Beck runs adjacent to Beverley Road (see figure 2) and the bank is low in places and so during times of high flow, overtops its bank into the highway. This led to water flowing across the frontage of properties lower down and has subsequently caused flooding. It also leads to additional surface flows into the Market Place with water running down from three directions towards the Sheep Wash (an entrance to the culvert) and then follows the contours of the land, down Church Street where low-lying properties are also affected.

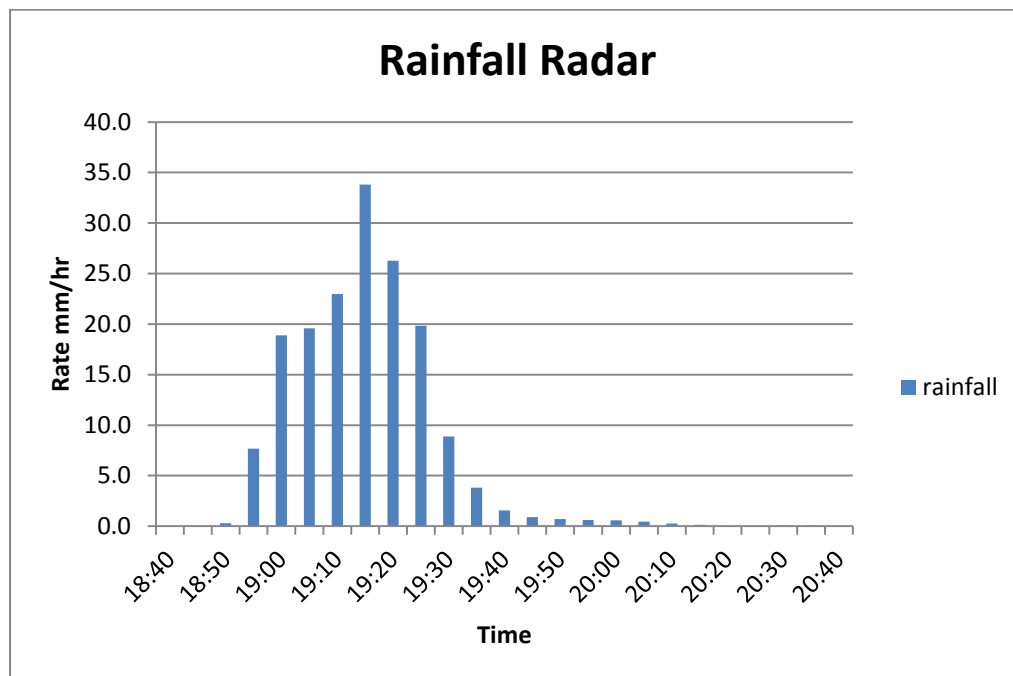
From the Met Office rainfall Radar data, Peak rate 34mm/hr

At this location total of 13.7mm fell between 19:00 and 20:00, an estimated return period of 2 years.

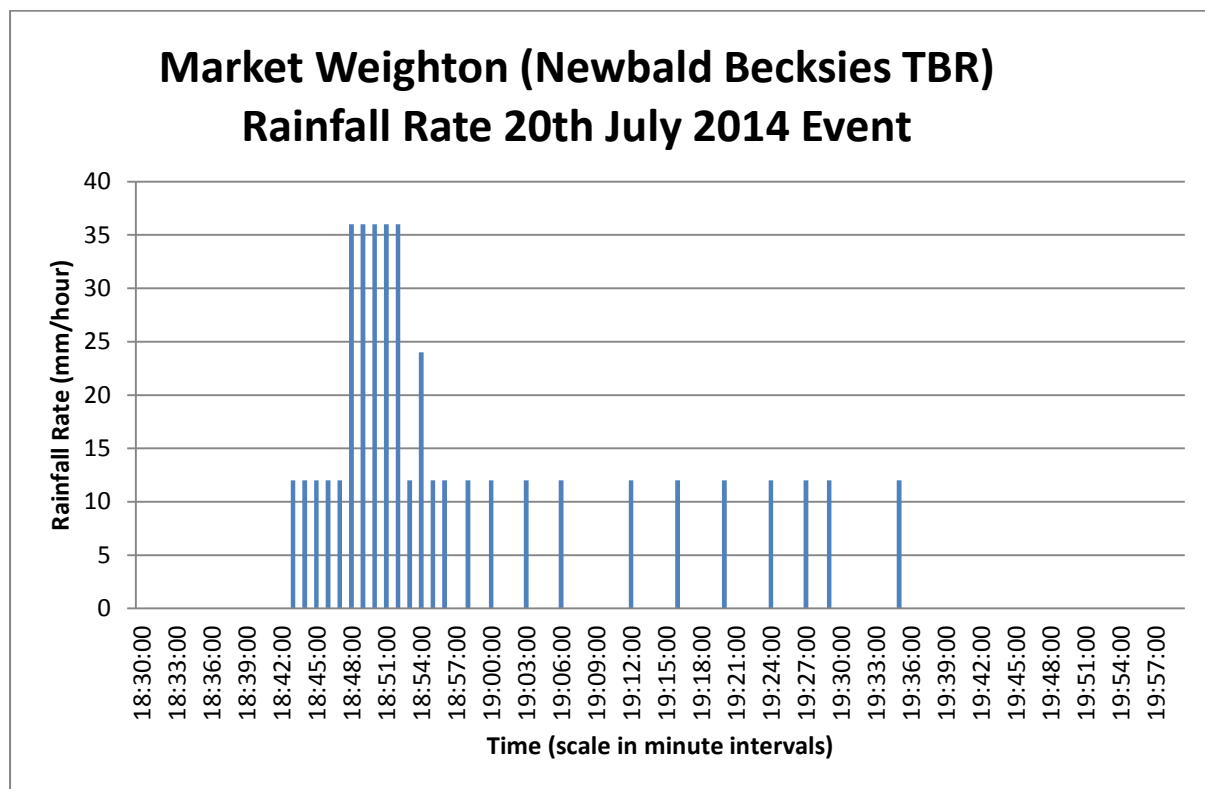
EA rainfall data from the rain gauge at North Newbald

This shows the peak rainfall rate of 36mm/hr in a 5 minute period, with 7.2mm falling in one hour.

Although the rain gauge is only 5km (3 miles) to the north of South Cave the recorded rainfall was much less than the estimated rainfall from the EA’s estimate based on radar data. This is consistent with the nature of summer storms, which often result in very localised intense rainfall such as has been experienced during the summer of 2014.
