Flood Investigation Report

Cottingham Flooding July 8 2014

October 2014

EAST RIDING
OF YORKSHIRE COUNCIL

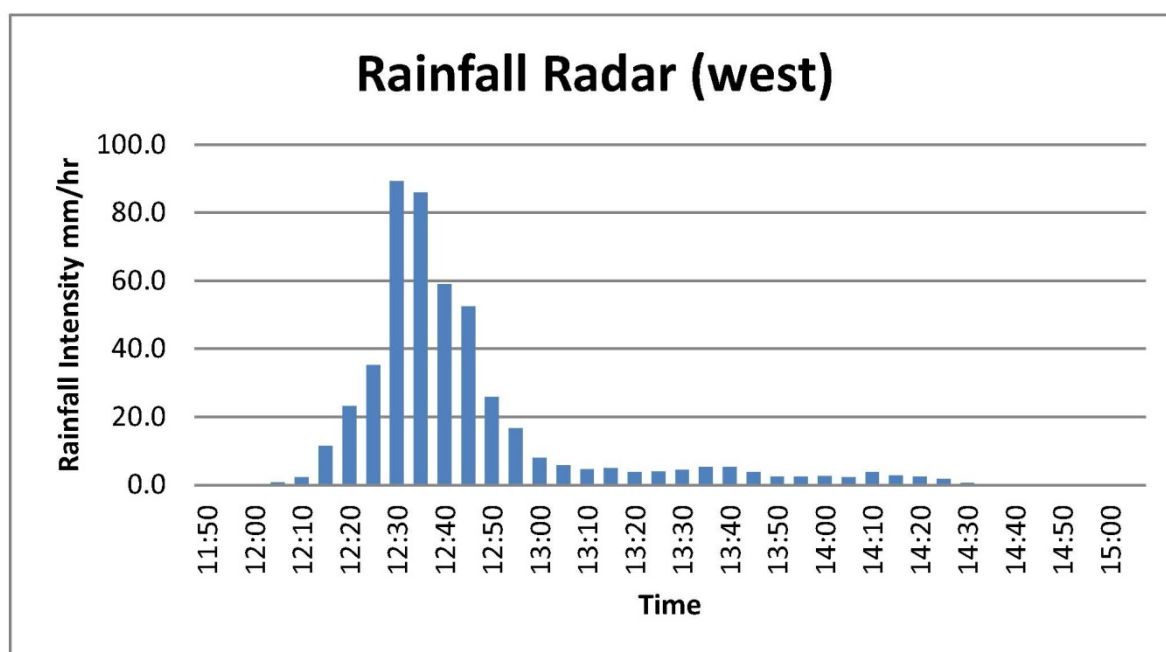
Graph of the estimated rainfall intensity at the west end of the village based on radar data supplied and interpreted by the Met Office.

The data shows that the peak intensity is different at each data point, which would be consistent with the storm cell being small and tracking across the area quickly, most likely missing some if not all the data collection points. The recorded rainfall pattern is also very peaked, showing very high intensity for short periods during spells of moderate to heavy rainfall.

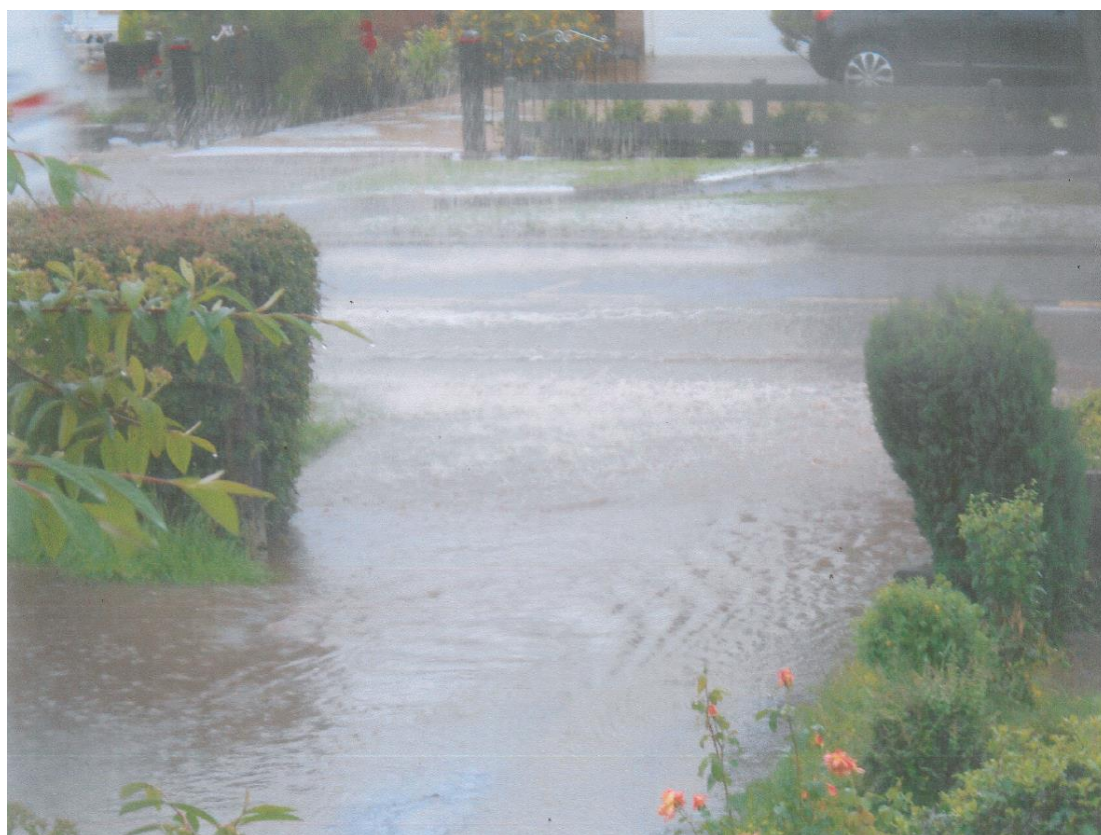
Photo 4: Eppleworth Road

Eppleworth Road (see photo 4) opposite the Dene was affected when the riparian culvert on the north side of the road was overwhelmed, it is believed by run-off from the land to the north.

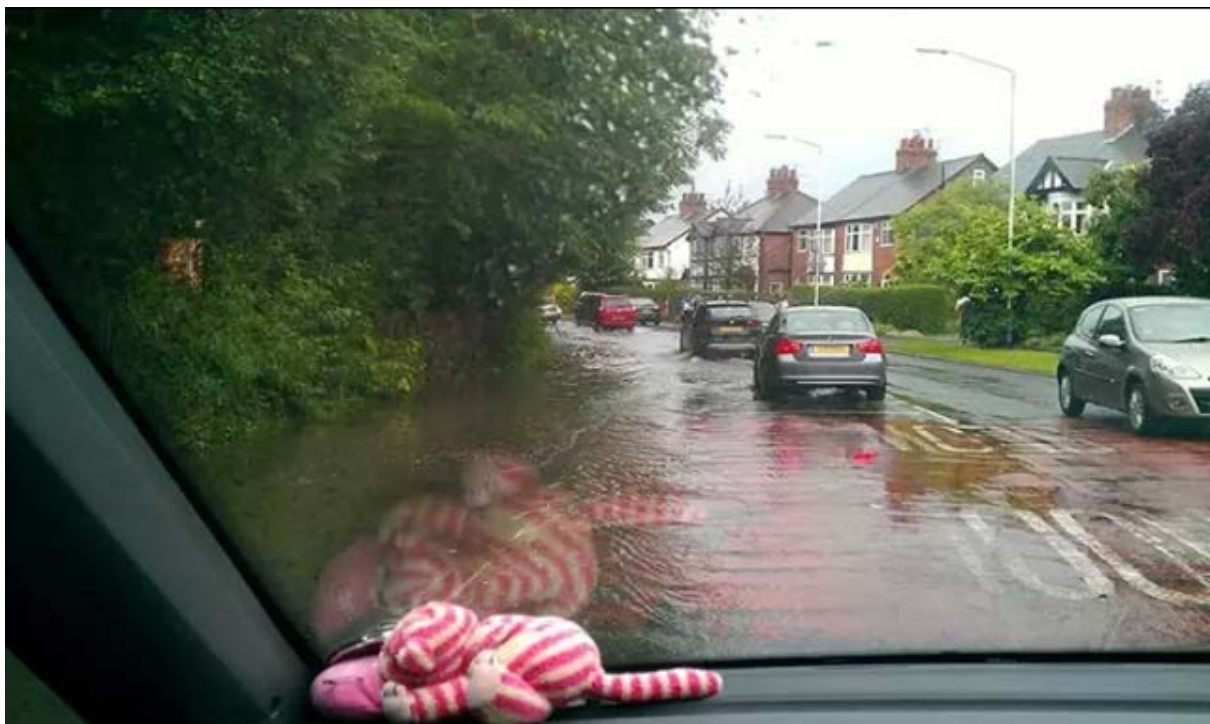
Photo 10: Harland Way

In some areas such as Mill Beck Bridge between Hallgate and Broad Lane Close (see photos 11 & 12) the watercourse overtopped its banks briefly causing some flooding to footpaths. The high level of flow in the watercourses will also have restricted the discharge from other surface drains which should outfall into them. In general the watercourses remained within their banks and did not overflow. However large overland flows of surface water were unable to enter the drainage system in some areas. Lower areas such as the bottom of Harland Way were flooded along the route of a watercourse, which was also overwhelmed.
