BIOMINERALIZATION IN NEW ZEALAND GEOTHERMAL AREAS

B.W. MOUNTAIN¹, L.G. BENNING², D.J. GRAHAM¹

¹Institute of Geological and Nuclear Sciences, Wairakei Research Centre, Taupo, New Zealand

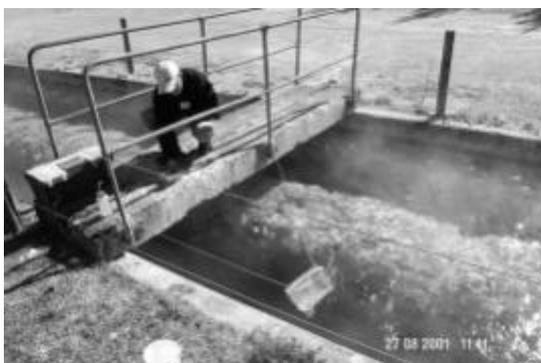
Figure 1. Main Drain at Wairakei. Wastewater flows from left to right. Plastic tray containing glass slides hangs from bridge.

Main Drain. Two plastic trays containing glass slides were placed in the Main Drain approximately 100 metres upstream from the drop structure to Wairakei Stream (Fig. 1). This drain contains the combined wastewater from the western borefield. The chemistry of the water is fairly uniform throughout the drains with a pH ~8.5, 1900 ppm Cl and 570 ppm SiO₂. Under normal conditions, flow rate at the sample site is about 1 metre/second, however, this rate can increase during heavy rainfall. Temperature is normally uniform but can fluctuate dramatically if the station goes on bypass or there is a heavy rainfall. In March 2001, the temperature of the right drain was uniform at about 62°C, while that of the left drain had a strong gradient with a temperature of 62°C at the surface and progressing downwards to a temperature of about 42°C at the bottom (~1.0 m).

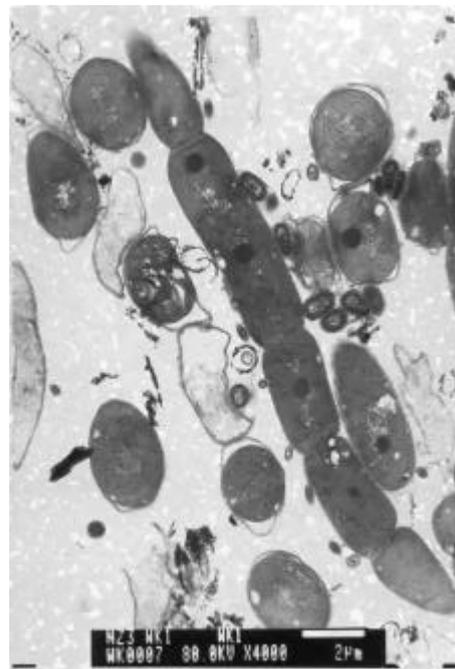
Figure 3. Transmission electron microscope photograph showing filamentous bacteria from Wairakei main drain. Scale bar is 2 µm.

length, composed of amorphous silica. These fibres form a complex meshwork enclosing abundant void space. The fibres represent silica sheaths on, or replacements of, filamentous bacteria. This was confirmed by TEM that showed the presence of unmineralized filamentous bacteria (Fig. 3). Further evidence was found when underwater photographs were taken. The tips of the fans show fine filaments moving in the current that represent unmineralized bacteria. These fibres collapse when samples are removed from the water and thus are not visible.

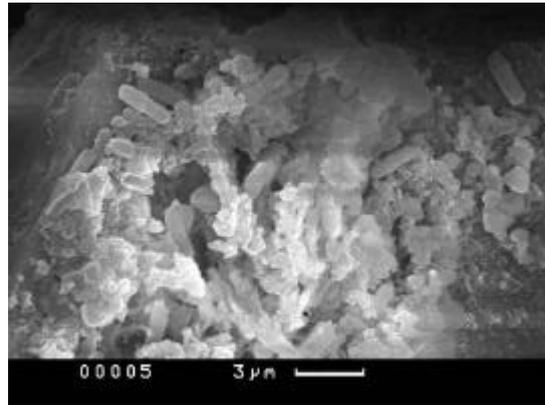
Figure 4. Silicified coccoid bacteria from W59 side drain.

SEM examination of a specimen of amorphous silica showed an irregular agglomeration of rough anhedral grains. No other minerals were found and the explanation for the gray colouration is uncertain. Interestingly, careful searching revealed the presence of coccoid formed particles composed of amorphous silica (Fig. 4). These are interpreted to be the silicified remnants of bacteria. This is an example of the extreme resilience of some primitive forms of life. These bacteria are able to survive in fresh borewater at ~85°C that contains very little nutrients.

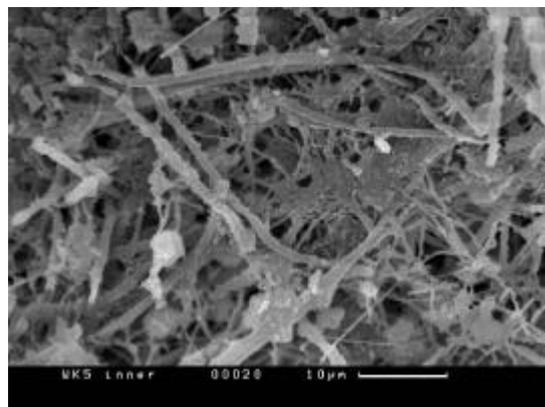
Figure 5. Silica casts of filamentous bacteria from Kiriohineke Stream. At least two different species of bacteria are interpreted to be present based on the bimodal width distribution.

The plastic tray and slides placed in the stream in March 2001 were rapidly encased in silica. After two months a layer approximately 1 cm in thickness covered the slides making their recovery difficult. The silica deposits were similar to those from the main drain, however, they lacked the oriented nature of the fibres and contain distinct green layers. These layers are attributed to the growth of cyanobacteria at times when the water temperature was lower. How these are preserved when temperature rises is uncertain. In general, SEM studies show textures similar to those found in the main drain with one interesting exception. Some samples show a distinct bimodal size distribution of filament size suggesting the presence of two species of filamentous bacteria (Fig. 4). At times when water temperature was lower, a filamentous cyanobacteria such as *Calothrix* could grow imparting a green coloration to the silica. Deeper portions of the silica fibre meshwork showed an increase in amorphous silica spheres. This indicates that the bacterially induced silica is promoting abiogenic silicification of the void spaces. Presumably, given sufficient time, the void space would be entirely filled with amorphous silica.

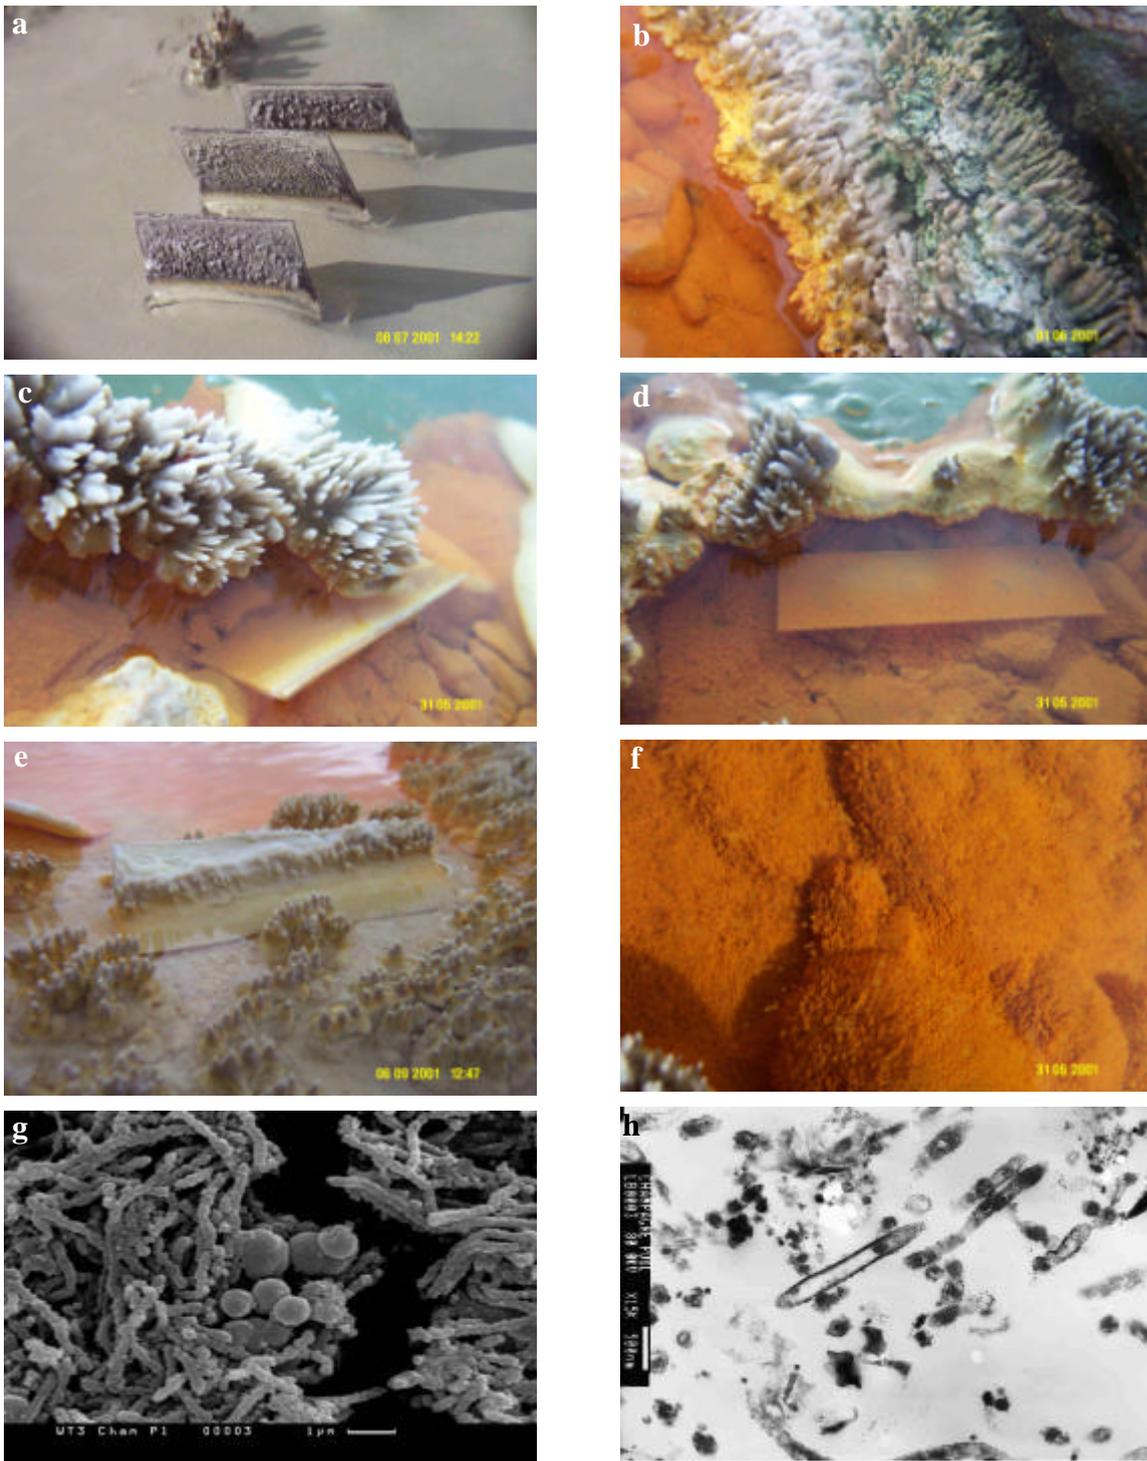
Figure 6. (a) Three glass slides inserted in mud near one of the north springs, Rotokawa. Water temperature is 74°C and air temperature at top of slide ~45°C. Water depth is approximately 0.5 cm. No mineralization occurs in water. A thin sulphur layer occurs at water surface and dark gray silica mineralization grows above. Slide dimensions 25 x 75 mm. (b) Northwest margin of Champagne Pool, Waiotapu showing orange precipitate in water, yellow native sulphur layer, conical microstromatolites and greenish cyanobacteria. Field of view 0.5 m. (c) Glass slide protruding from Champagne Pool next to islands of microstromatolites. Note sulphur layer and cloudy silica mineralization on slide. (d) Glass slide wholly immersed in Champagne Pool. Slide is covered with orange precipitate but no sulphur or silica mineralization. Note sulphur layer around microstromatolites. (e) Glass slide partially immersed in Champagne Pool outlet. Microstromatolites on slide have grown over a five month period. (f) Bottom of Champagne Pool. Orange precipitate is attached to bottom by fine filaments that move in the current. Field of view 20 cm. (g) SEM photograph of orange precipitate from Champagne Pool. Note the filamentous shape of the sulphur and antimony-rich precipitates. Spheres are amorphous silica beads. Scale bar is 1 μ m. (h) TEM photograph of Champagne Pool orange precipitate. Dark rims are coatings of amorphous antimony sulphide and sulphur on filamentous bacteria. Scale bar is 500 nm.

A complex series of biomediated silicification features are present around the margins of the pool (Jones et al., 1997). Figure 6b shows the east margin of the pool. The bottom is covered with an orange precipitate, identified as amorphous antimony sulphide by Hedenquist (1986). Immediately adjacent to the water is a rim of native sulphur that overhangs the water surface. This is followed by a series of conical microstromatolites up to 3 cm in height. Towards the top of the sinter, these microstromatolites are covered with a greenish layer suggesting that cyanobacteria are present. The microstromatolites also form islands in the pool where the undulating bottom has come close enough to the surface to allow native sulphur to accumulate creating a "raft" that is slightly above the surface. These rafts then allow the growth of the microstromatolites (Fig. 6c and 6d). SEM examination of a small microstromatolite spine shows that their bases are composed of subhedral

Hedenquist (1986) noted the metal-rich composition of the orange precipitate in Champagne Pool. In order to examine the possibility that bacteria were involved with this mineralization, samples of the orange precipitate were analyzed by SEM and TEM. Figure 6g shows that it is composed of filamentous chains of an antimony-rich precipitate. Other minerals present were amorphous silica and kaolinite. The unusual texture of the precipitate suggests a bacterial origin. This is supported by TEM work (Fig. 6h) where the entire sample appeared to be composed of bacteria sheathed in a dark material representing the antimony-rich precipitate. X-ray fluorescence analysis of a dried sample of the orange material showed that it is composed of sulphur (70%), SiO_2 (13%), Sb (1.1%), As (0.6%) and Al (0.6%). In
